Eurasian water-milfoil (*Myriophyllum spicatum*) Fall Bed Mapping Survey Sand Lake - WBIC: 2661100 Barron County, Wisconsin

Endangered Resource Services, LLC Matthew S. Berg, Research Biologist St. Croix Falls, Wisconsin October 3, 2020

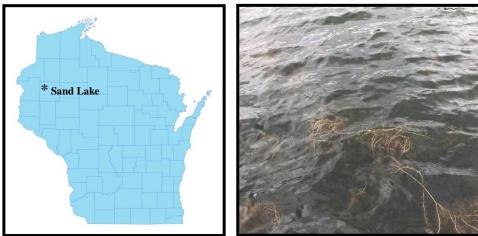
Canopied EWM near the boat landing 10/3/20

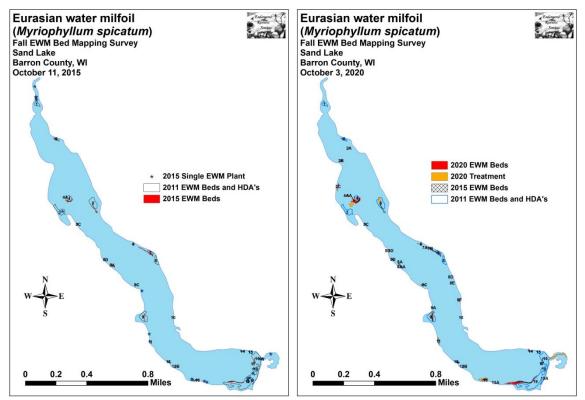
Figure 3: 2015 and 2020 Fall EWM Bed Maps

On October 3^{rd} , 2020, we searched the lake's visible littoral zone for EWM. Water clarity was fair, and, with dead calm conditions, we estimated we could see down approximately 7-8ft into the water column. We located and mapped 30 beds ranging in size from < 0.01 acre (Beds 19A) to 1.04 acres (Bed 19) (Figure 3) (Appendix I). Collectively, they totaled 3.18 acres (Table 1). This was an increase of 1.43 acres (+81.71%) from the 1.75 acres we mapped in 2015 and 2014 (Table 2). In general, it appeared the 2020 treatment provided only limited relief as almost all of the treatment areas sill had plants present to varying degrees.
