Amnicon and Dowling Lakes Aquatic Plant Management Plan

AIS Education, Prevention and Planning

Douglas County, Wisconsin

April 26, 2017

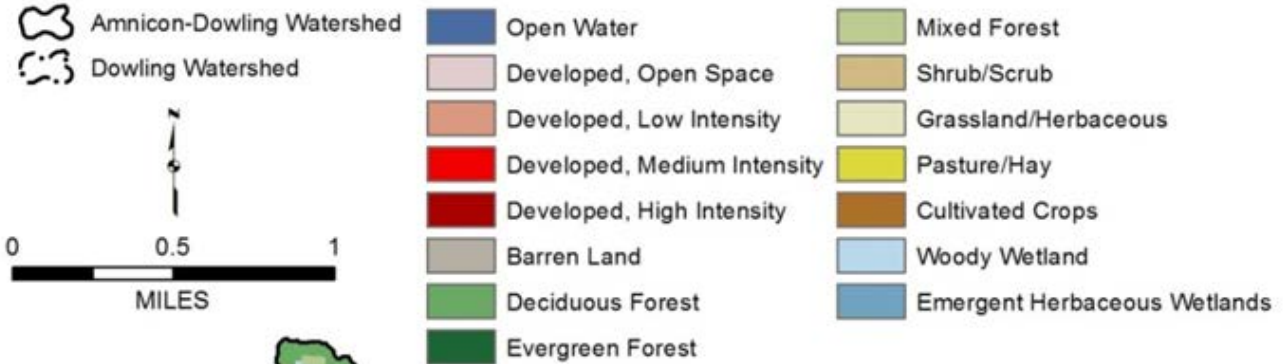
Figure 5 – Amnicon and Dowling Lake Watersheds and Land Use

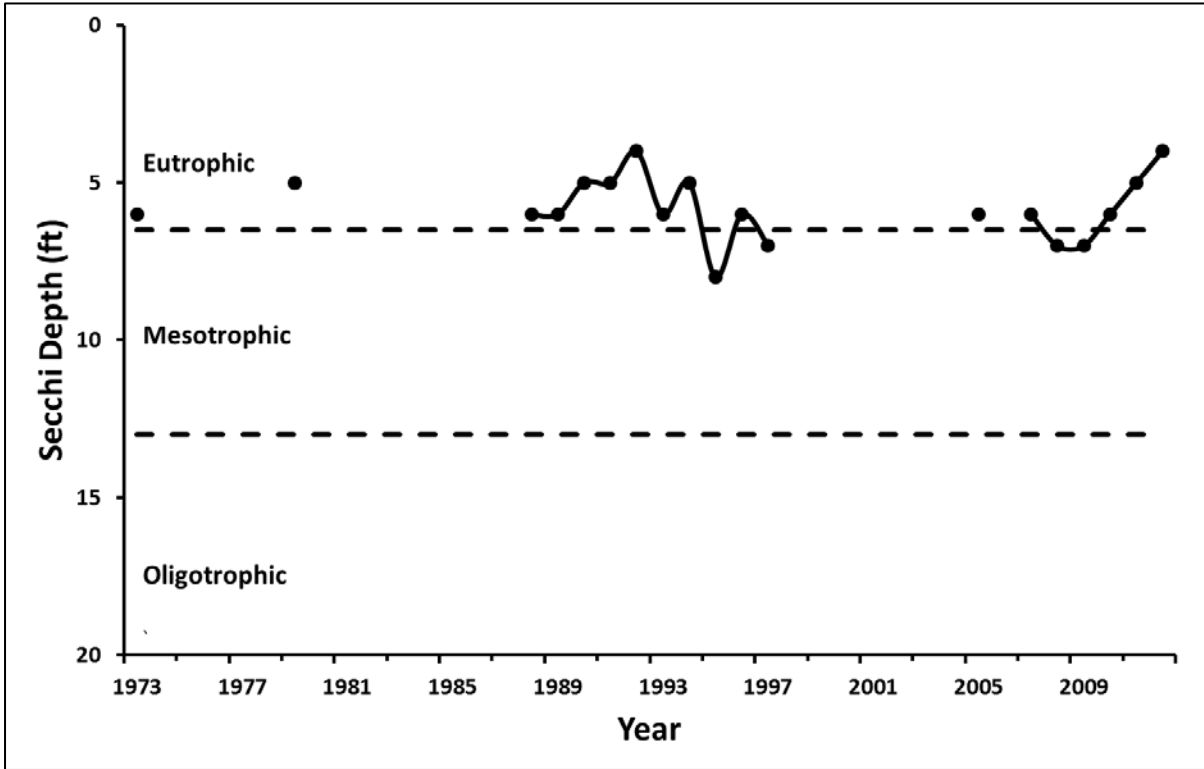
Secchi data is available for Amnicon Lake at one monitoring station 163120 (Deep Hole) from 1973 through 2013 (Figure 7). Mean summer (June-August) Secchi depths range from 4 feet to 8 feet with an overall average of 6 feet. The overall mean summer Secchi depths classify Amnicon Lake as a eutrophic system. However, mean summer values range from eutrophic to mesotrophic conditions. Secchi data were also collected at monitoring station 163301 (NW Tomahawk Island) during the summer of 1994 with an overall average of 6 feet.

Figure 7 – Mean Summer (June-August) Water Clarity in Amnicon Lake

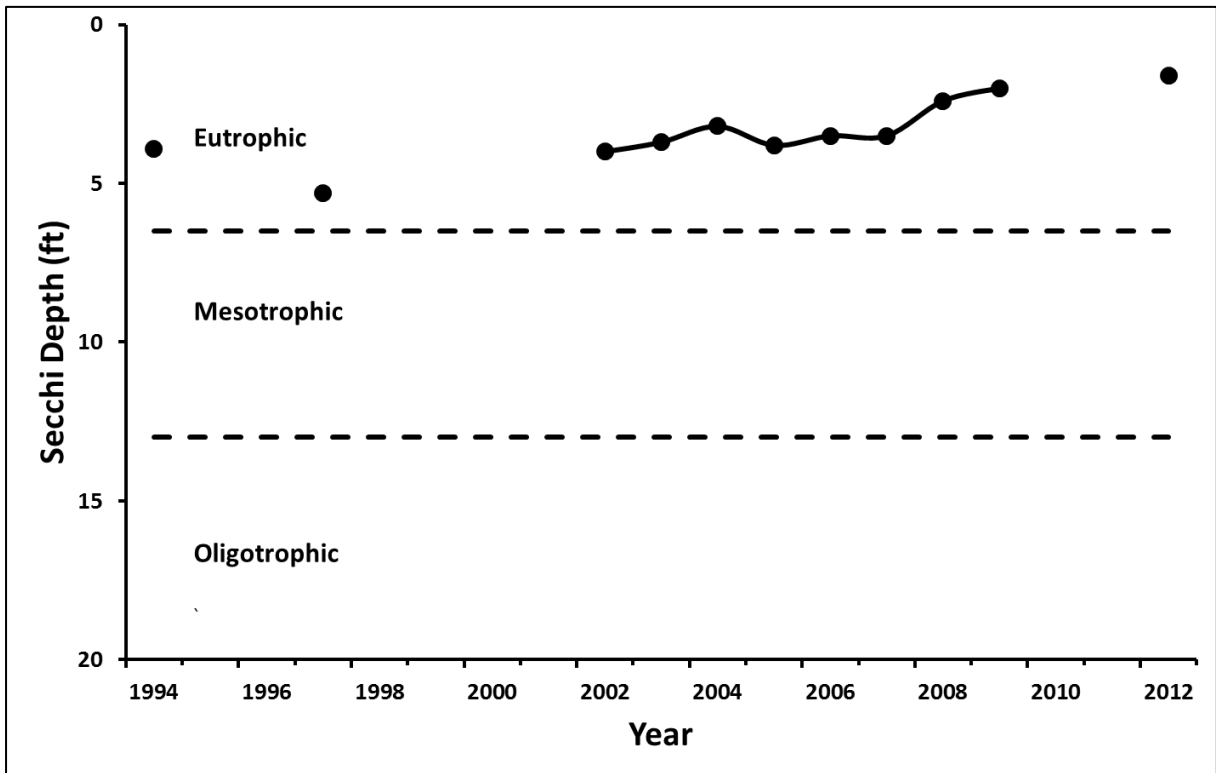
Dowling Lake Secchi depth data are available for one monitoring station (Deep Hole 163091) from 1994 through 2012 (Figure 8). Mean summer (June-August) Secchi depths range from 1.6 feet to 5.3 feet with an overall average of 3.6 feet. The overall mean summer Secchi depths classify Dowling Lake as a eutrophic system.

Figure 8 – Mean Summer (June-August) Water Clarity in Dowling Lake

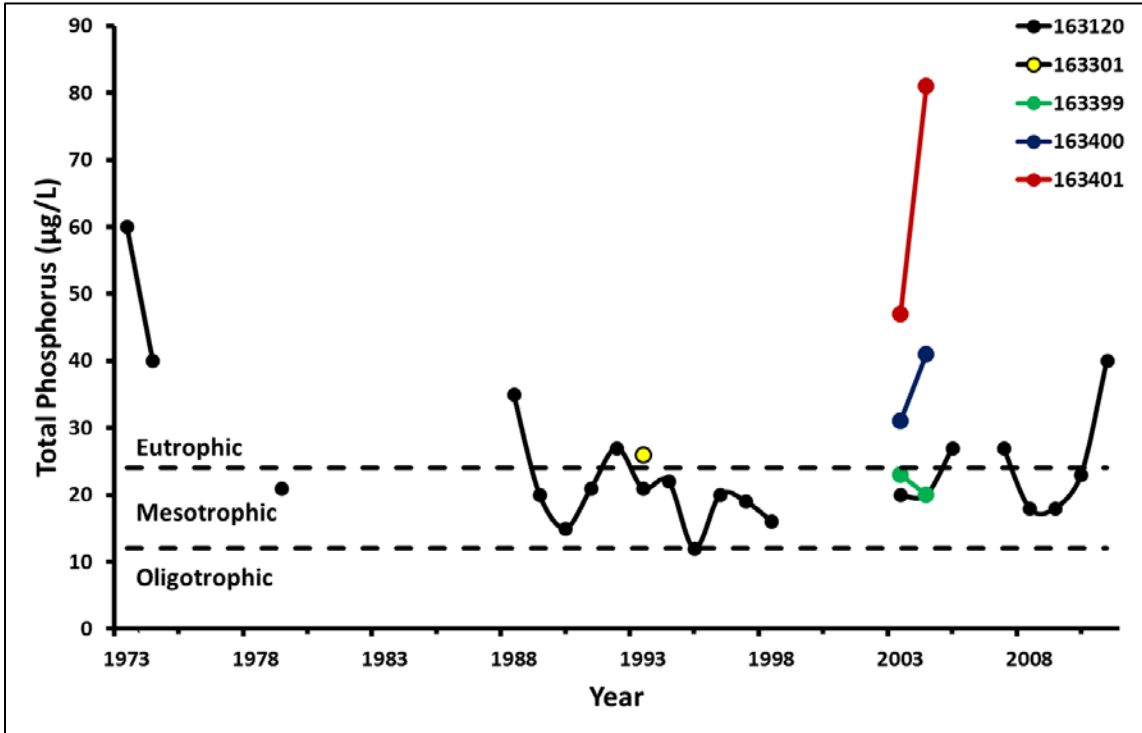
Figure 9 – Mean Summer (June-August) Near-Surface (0-6 feet) Total Phosphorus in Amnicon Lake

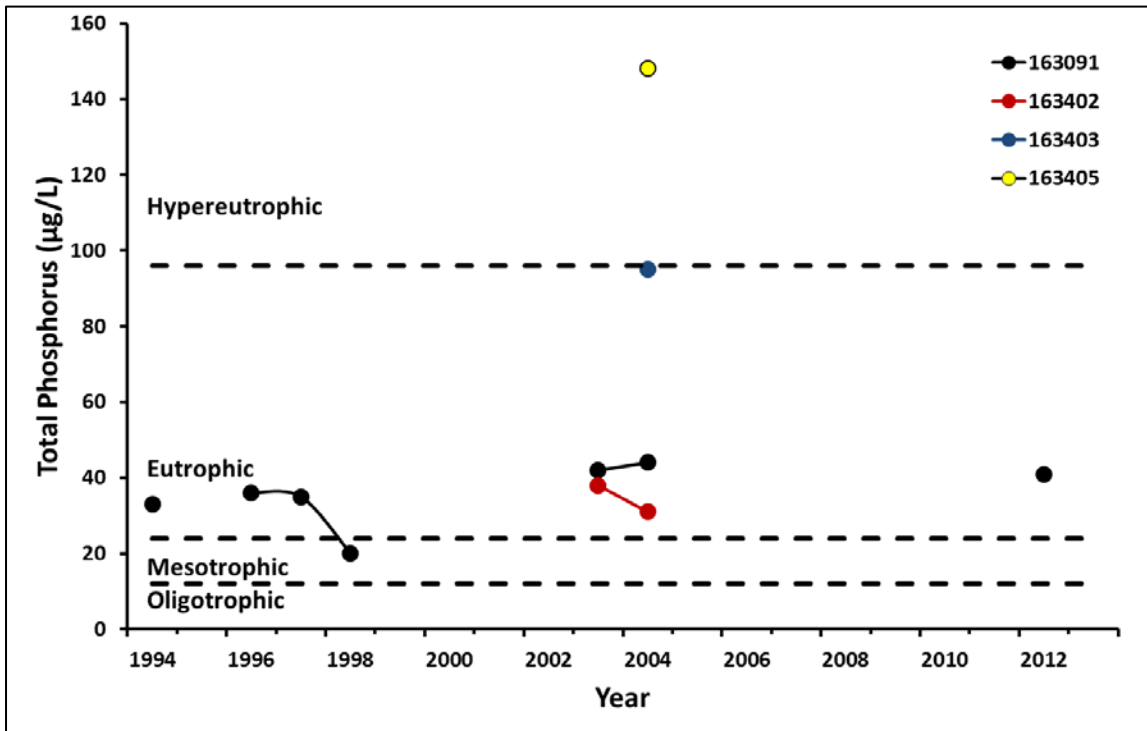
Total phosphorus was monitored at four stations in Dowling Lake from 1994 through 2012 with a near-surface (0-6 feet) summer average of 78.5 µg/L classifying Dowling Lake as a eutrophic system (Figure 10). The greatest number of monitoring events occurred at station 163091 (Deep Hole) in 1994, 1996-1998, 2003-2004, and 2012 with mean summer surface values ranging from 20 µg/L to 59 µg/L and a mean value of 36 µg/L. Station 163402 (Outlet) was monitored in 2003 and 2004 with surface water values of 38 µg/L and 31 µg/L respectively and an overall average of 35 µg/L. Stations 163403 (Intermittent Tributary to Dowling Lake North Shore) and 163405 (Intermittent Tributary to Dowling Lake South Shore) were monitored in 2004 and yielded very high phosphorus levels of 95 µg/L and 148 µg/L respectively. Phosphorus values at depths greater than 6 feet ranged from 20 µg/L to 80 µg/L among the four monitoring sites. Near-surface summer averages for the four monitoring sites (36 µg/L, 35 µg/L, 95 µg/L, and 148 µg/L) yield an overall mean of 78.5 µg/L. If the tributary stations are removed from the data set (163405 and 163403), Dowling Lake does not exhibit any mean phosphorus values that fall within the hypereutrophic range but is still considered eutrophic with a mean average phosphorus value of 35.5 µg/L.

Figure 10 – Mean Summer (June-August) Near-Surface (0-6 feet) Total Phosphorus in Dowling Lake
