**Curly-leaf pondweed (*Potamogeton crispus*)
Point-intercept and Bed Mapping Surveys, and
Warm-water Macrophyte Point-intercept Survey
Lake Como - WBIC: 2152100
Chippewa County, Wisconsin**

Endangered Resource Services, LLC
Matthew S. Berg, Research Biologist
St. Croix Falls, Wisconsin
May 28, June 14, and July 14-15, 2018

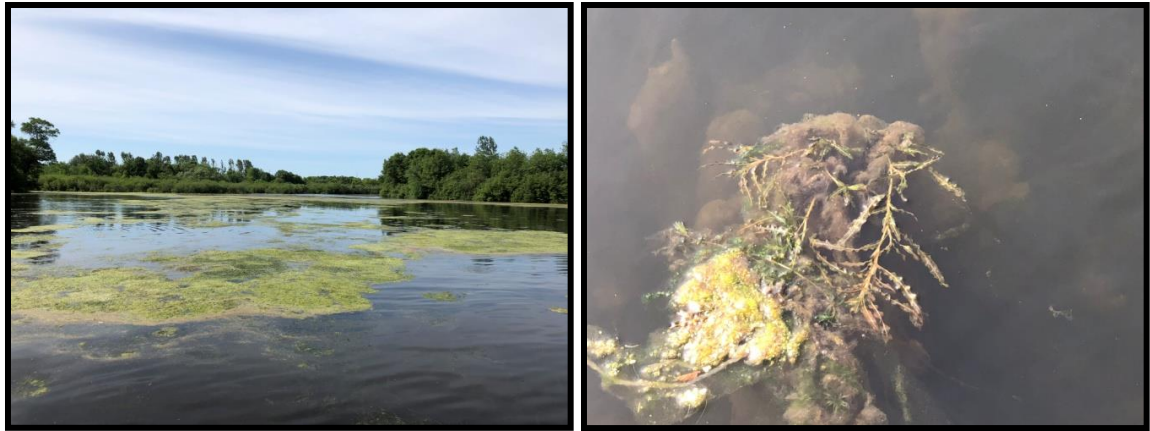
Figure 4: Canopied CLP Covered in Filamentous Algae Near the Duncan Creek Inlet 6/14/18

On June 14th, we found very little additional Curly-leaf pondweed. Despite searching the entire lake, the only significant CLP occurred in a single 1.64 acres high density area near the Duncan Creek Inlet (Figure 3) (Appendix III). Although CLP was canopied, it wasn't a true bed as the area was dominated by Common waterweed (*Elodea canadensis*) and Coontail (*Ceratophyllum demersum*) with the CLP occurring as scattered patches that never had a rake fullness of more than 2. Fortunately, there were few residences in the area, and flowing water created a natural navigation channel that likely meant this particular area was only a minor navigational impairment at worst. A bigger issue was the thick mats of filamentous algae that covered all the other plants and tended to clog the water intakes on the motor (Figure 4).

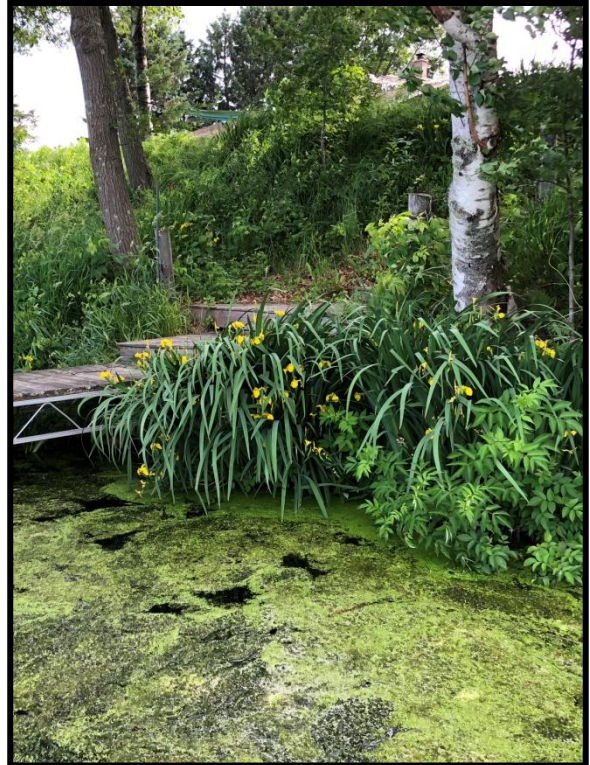
Figure 13: Yellow Iris Distribution/Clusters near the Duncan Creek Inlet

In addition to Curly-leaf pondweed, we found four other exotic plant species growing in and adjacent to Lake Como: Yellow iris, Common forget-me-not, Reed canary grass, and Narrow-leaved cattail. Yellow iris was restricted to a few large clusters along the western shoreline just downstream from the Duncan Creek Inlet. Plants were growing on either side of a dock, and there were several smaller satellite clusters nearby (Figure 13).

The presence of Yellow iris on Lake Como is troubling as this species can rapidly take over both shoreline and adjacent wetland areas. Because of this, we **STRONGLY** encourage the lake association to make contract with the resident in the Duncan Creek Inlet and work to **IMMEDIATELY** remove these plants. An informational bulletin should also go out to other lake residents warning them to look for and eliminate plants on their property before a minor problem becomes a significant one. Iris plants and pods should be bagged to prevent seed dispersal, and they should then be disposed of well away from the lake or any other wetland. June is the best month to look for this species as the bright yellow fleur-de-lis are most common at this time of year (Figure 18). When not in bloom, its leaves could be confused with Northern blue flag (*Iris versicolor*) – a native and non-invasive iris species.

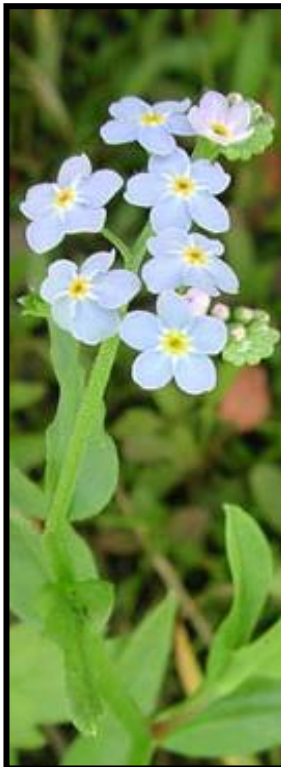
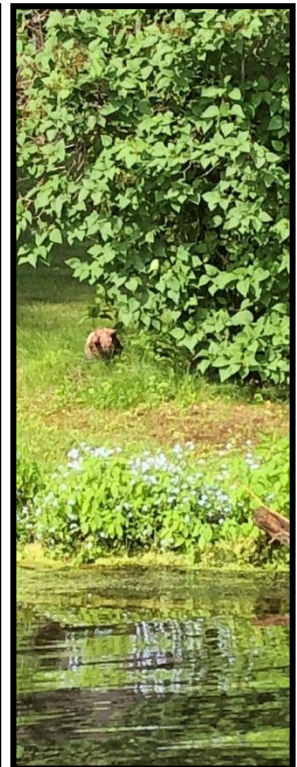
Figure 14: Common Forget-me-not Distribution/Cluster on the Shoreline

Common forget-me-nots were similarly few in number with a few 10's of plants noted in a couple of disturbed areas south and east of the main public boat landing ramp on the western shoreline (Figure 14). A plant that prefers cold-water seeps and streams, there doesn't appear to be much additional habitat for this species on the lake.

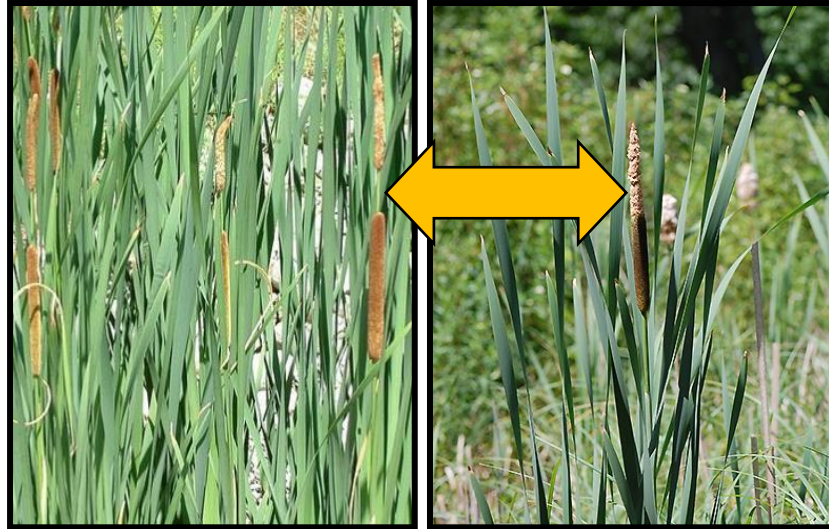
Figure 16: Exotic Narrow-leaved and Native Broad-leaved Cattail Identification

Native to southern but not northern Wisconsin, Narrow-leaved cattail (*Typha angustifolia*) and its hybrids with Broad-leaved cattail are becoming increasingly common in northern Wisconsin where they also tend to be invasive. We found a single small patch of these exotic cattails immediately north of the dock at the main boat landing on the lake's west side.

Besides having narrower leaves, the exotics can be told from our native cattails by having a relatively narrower and longer "hotdog-shaped" tan female cattail flower whereas our native species tends to produce a fatter and shorter "bratwurst-shaped" dark chocolate colored female flower. Narrow-leaved cattail and its hybrids also have a male flower that is separated from the female flower by a thin green stem while the native Broad-leaved cattail has its male and female flowers connected (Figure 16) (For more information on select exotic invasive plant species, see Appendix VIII).

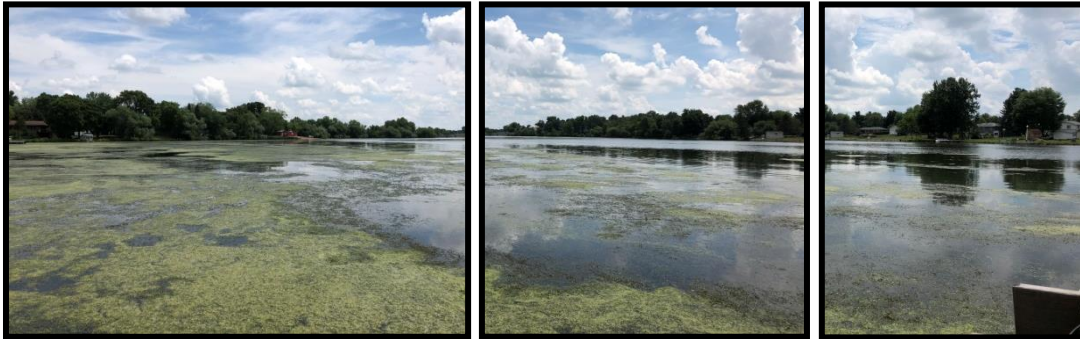
Figure 17: Dense Canopied Common Waterweed/Coontail along the Eastern Shoreline Facing the City Beach/Dam 7/15/18

Common waterweed and Coontail do not have roots and can rapidly reproduce vegetatively in nutrient-rich waters. Because of this ability, these native species can act like exotics and quickly become invasive. This seems to be the case in Lake Como where dense “haystacks” of vegetation dominated by these species and filamentous algae fill the entire water column in most areas on the lake that are less than 6ft deep. Although the band of canopied plants that borders the shoreline can be quite narrow where the lake drops off rapidly, in many areas, like on the east side of the south basin (Figure 17), it is so wide that plants are severely restricting both lake access and general navigation. Several lake residents and BCLA board members mentioned they would like to consider herbicide applications to relieve this impairment; however, the ability of these species to rapidly proliferate under current conditions may allow their populations to recover from a herbicide treatment within a very short period of time. Because of this, mechanical harvesting, although it has a significant initial cost, may give better results in the long run. Ultimately, the BCLA, COB, LEAPS, and the WDNR will have to decide which type of active management, if any, makes the most sense when balancing recreation, economic, and ecological considerations.
