**Curly-leaf pondweed (*Potamogeton crispus*)
Point-intercept and Bed Mapping Surveys, and
Warm-water Point-intercept Macrophyte Survey
Upper Clam Lake (WBIC: 2656200)
Burnett County, Wisconsin**

Endangered Resource Services, LLC

June 1, 3, 17, and August 29-September 2, 2019

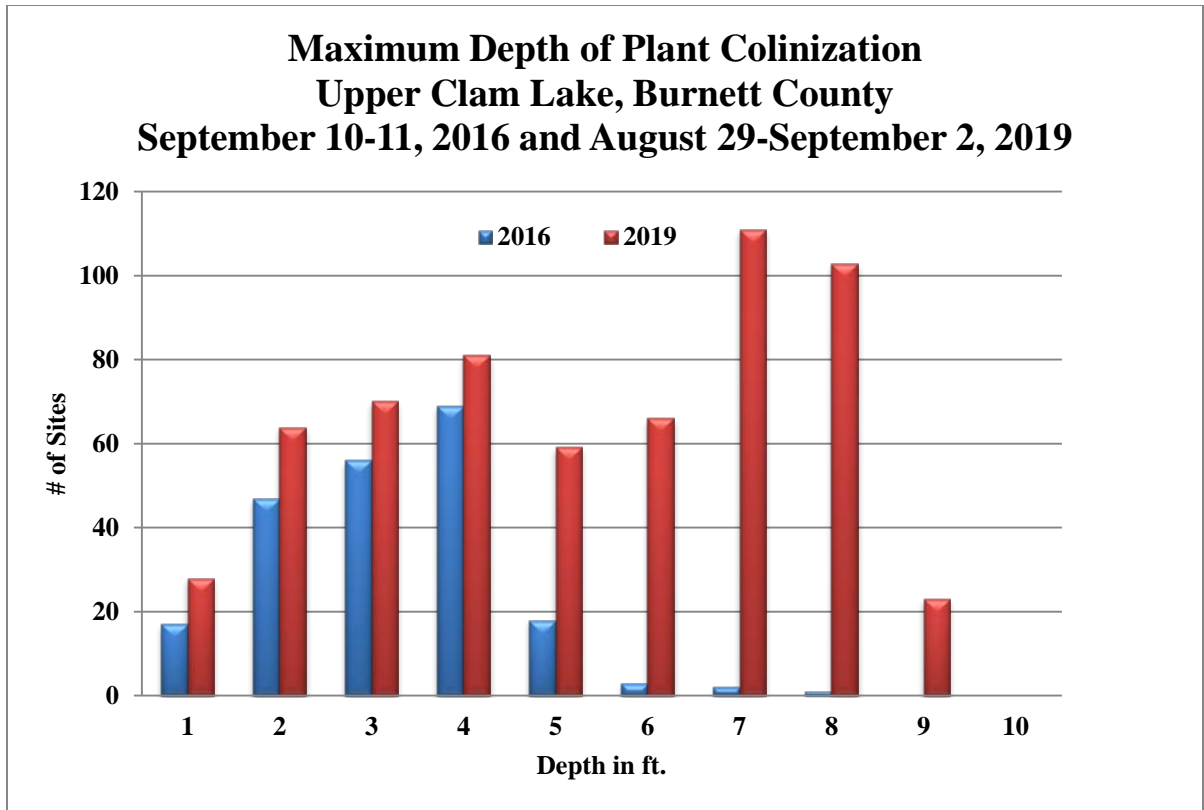
Figure 8: 2016 and 2019 Plant Colonization Depth Chart

Growth in 2019 was slightly skewed to shallow water as the mean plant depth of 5.2ft was less than the median depth of 5.5ft. Both of these values were more than 2ft higher than in 2016 when the mean and median depths were both 3.0ft (Figure 8). They were also higher than any other survey dating back to 2009 suggesting that vegetation is spreading back into deeper water.

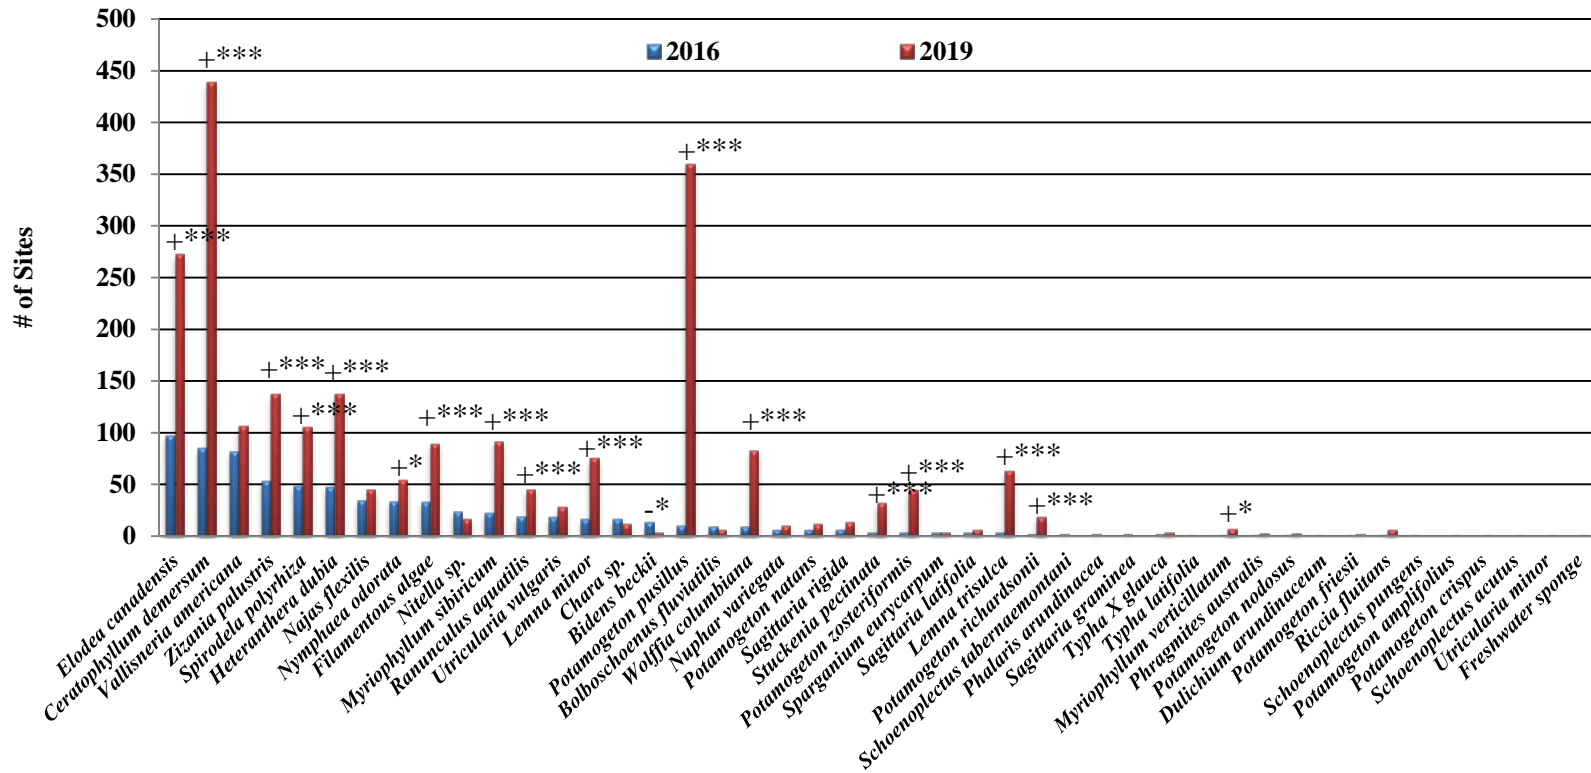
Figure 11: Macrophytes Showing Significant Changes from 2016-2019

Significant differences = * $p < 0.05$, ** $p < 0.01$, *** $p < 0.001$

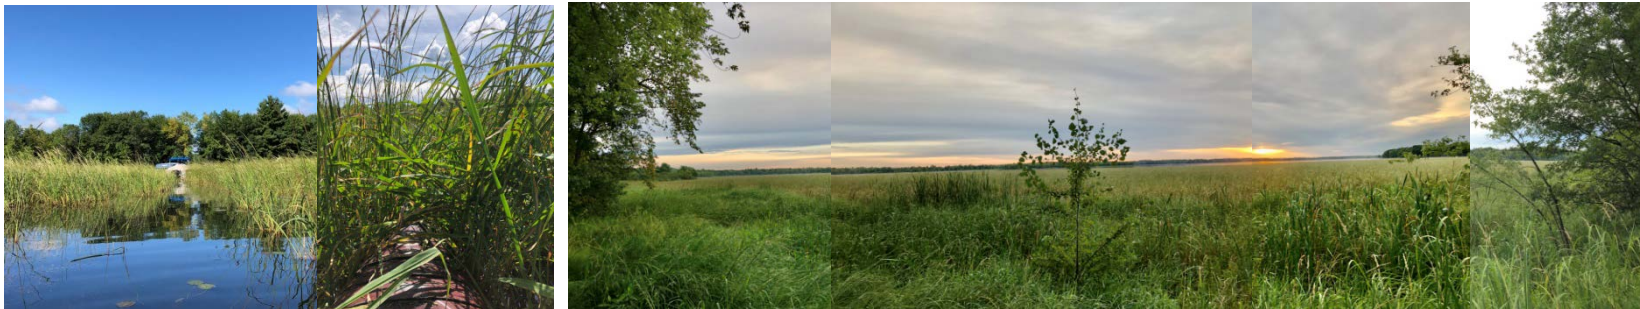
**Figure 19: Shoreline Impairment and Typical Density in the Southwest Bay –
Panorama of Northern Wild Rice on the Southwest Shoreline of the Southwest Bay 8/31/19**

In 2019, rice underwent a highly significant expansion ($p < 0.001$) in distribution. Present at 137 points with 24 additional visual sightings, it was tied for Water star-grass as the fourth most widely distributed species (22.64% of points with plants present/20.54% of the littoral zone). Of these, we rated 68 a rake fullness of 3, 39 a 2, and the remaining 30 a 1 for a mean rake fullness of 2.28 (Figure 18) (Appendix VII). Although this was also an increase in density from 2016, it was not significant ($p = 0.14$). Most of the beds offered significant human harvest potential, and we found many places were so dense that using a canoe and pole was impossible. This forced us to survey by kayak, and it took us three days to push and pull our way through the “forest” of rice. Although wonderful for wildlife and those harvesting, these dense areas of rice clearly made things difficult for those accessing the lake from their shorelines in these southern bays; especially if they were doing so infrequently (Figure 19).

Broken out by region, the southwest bay had more rice than at any point since our first survey in 2009. Viewed from Lone Star Road on the bay’s southwest side, a wall of rice extended out from shore (Figure 19). On the open water margin, the rice was more fragmented, but the majority of areas were still extremely dense (Figure 20), and harvest trails crisscrossed the bed.

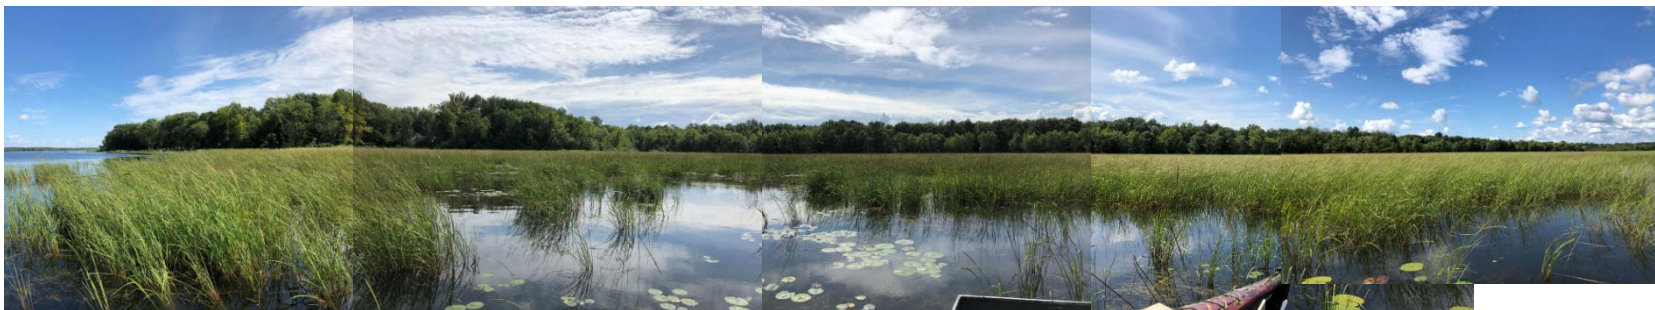
Figure 20: Panorama of Northern Wild Rice in the Southwest Bay Facing Southwest 8/31/19

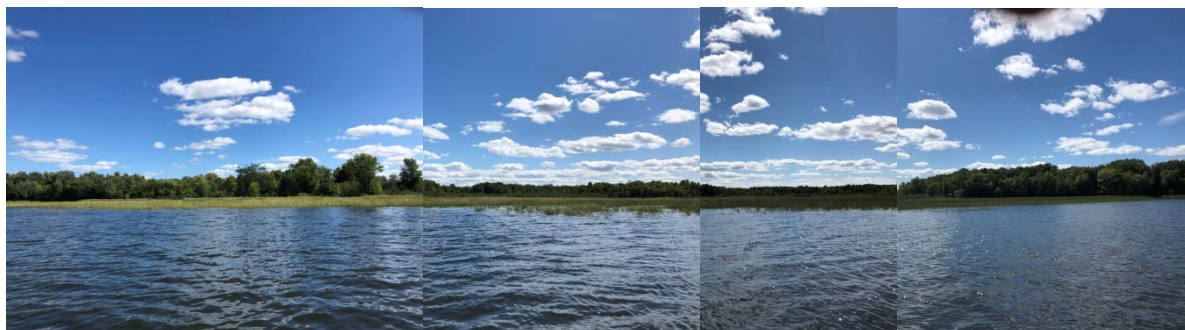
Figure 21: Panorama of Northern Wild Rice in the South-central Bay 8/30/19

The south-central bay also had harvestable density. A nearly continuous wall of plants reached the landing on the southwest side of the bay and stretched almost uninterrupted back up the creek inlet (Figure 21).

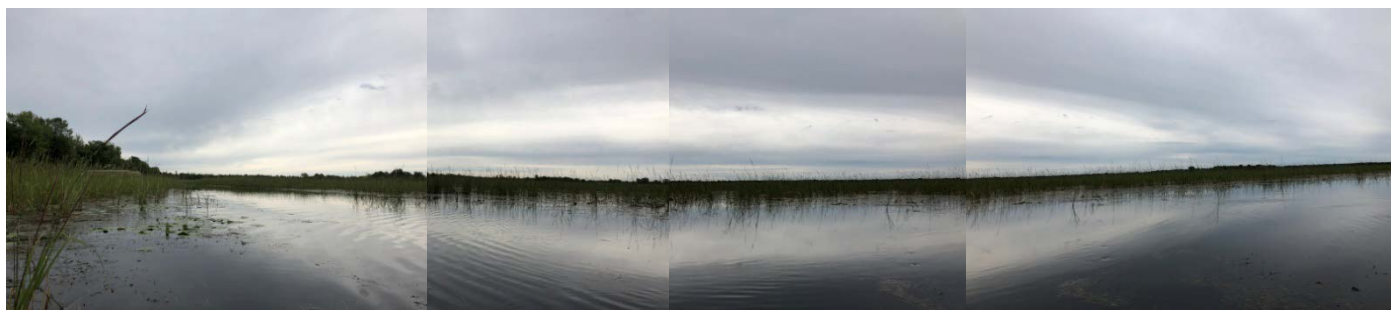
Figure 22: Panorama of North Shoreline in the Southeast Bay Facing East Towards the River Inlet 8/31/19

In the southeast bay, much of the river inlet was impassable by canoe and nearly so by kayak as it took us an entire day to survey 50 points in this area. Along the north shoreline, residents seemed to be having significant difficulty keeping a path open as both the patchy rice and submergent vegetation made motor travel difficult (Figure 22).

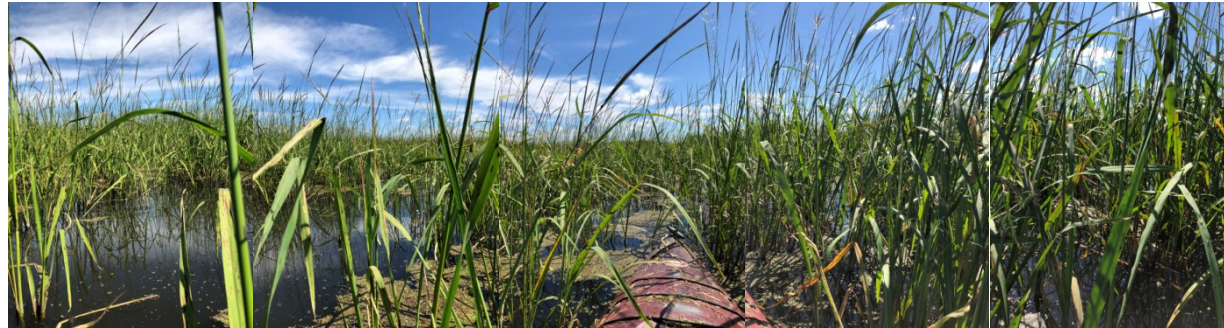
Figure 23: Panorama of Northern Wild Rice from SE Side of Former Enclosure Facing South 9/2/19

In the entrance to the southeast bay south of the river inlet (the former Carp enclosure), rice also created an almost impenetrable wall that was only accessible by kayak (Figure 23). Density was high throughout most of the bay, but we did find a sizable area of open water in the southwest corner of the bay (Figure 24).
