GRANITE LAKE, BARRON COUNTY

2021-30 Comprehensive Lake Management Plan WBIC: 2100800

Prepared by: Dave Blumer, Lake Educator & Heather Wood, Lake Management
Assistant

November 2020

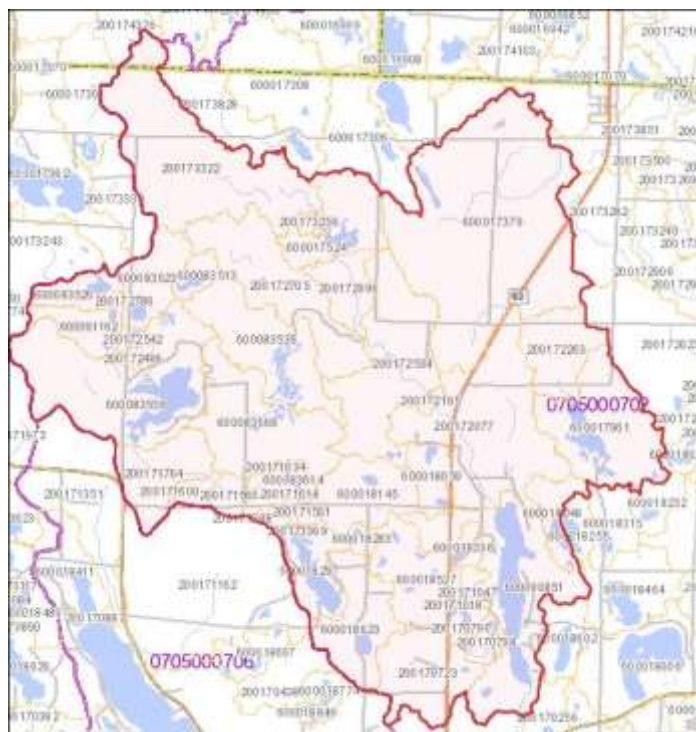
Figure 4: WHD-Plus Catchments (pale yellow lines) in the Granite Lake watershed (red line) WDNR

WHD-Plus Catchments are 16 digit HUC sub-watersheds that are high-resolution watersheds derived from the 1:24k hydro geodatabase and the 10-meter National Elevation Dataset. Watersheds were delineated for over 160,000 streams and lakes in WI and boundary/contributing waters including those that are included in the Granite Lake watershed (Figure 4). For future management purposes, each catchment is broken down by land use including urban, agriculture, grassland, forest, open water, wetland, barrens, and shrubland allowing more targeted land use changes.

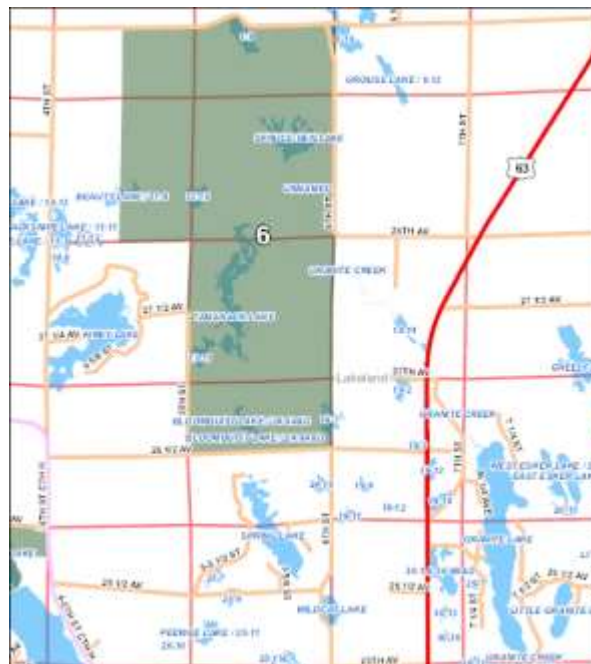
Figure 8: Barron County forest land (green coloring) in the Granite Lake watershed (Barron Co. GIS).

Nearly 60% of the watershed that drains to Granite Lake is forested, including a large block of Barron County forest (Figure 8). This likely means there is some level of timber harvest and other forestry practices occurring on both public and private land. Protecting and enhancing these forests is an important part of protecting Granite Lake.

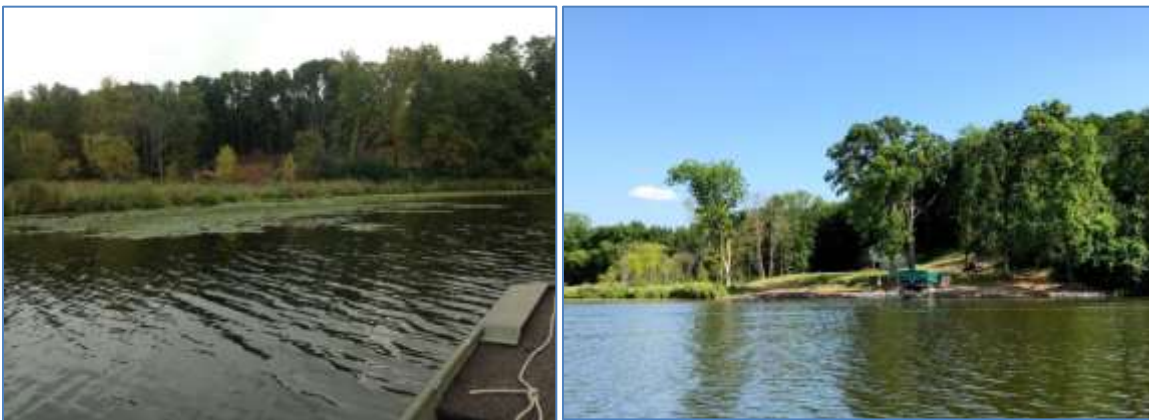
Figure 11: New lakeside development (2016-left), same site (2018-right)

Each of these alterations decreases the ability of the shoreland area to serve its natural functions: removal of trees and native plants eliminates the food and shelter on which wildlife depends, natural beauty is replaced with manmade materials, water cannot soak into the ground thereby increasing stormwater runoff that carries fertilizers, pesticides and other pollutants to the lakes and streams. If 50% of a lot is converted to impervious surfaces, half of this lot is no longer capable of filtering rainwater or providing the food and shelter on which wildlife depends. Figure 11 is a real-life example how a new development project can change the landscape in just two years.

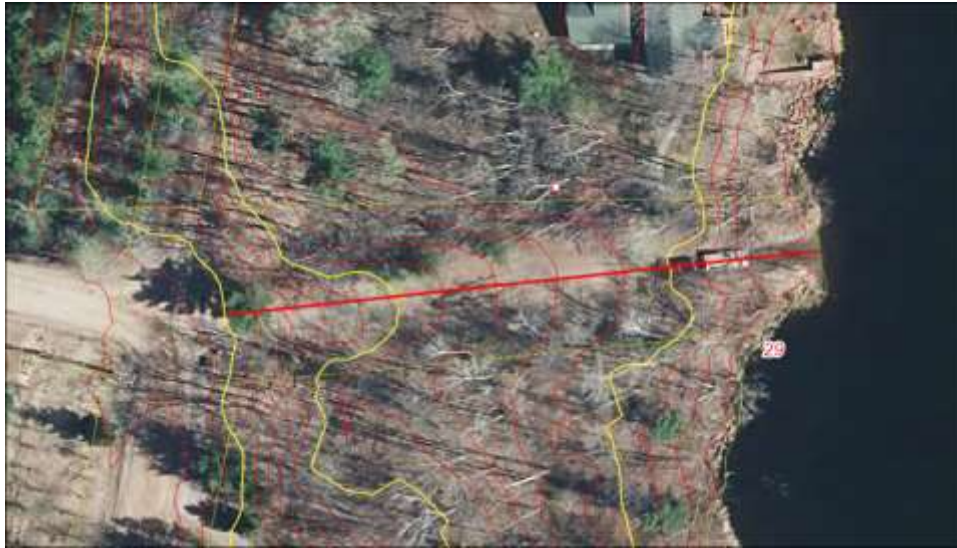
Figure 17: Lakeland Township boat landing on the west side of Granite Lake – 2-ft (red) and 10-ft (yellow) contours. Red line is 300-ft long.

A larger planning project to improve accessibility, reduce runoff, and prevent erosion could be completed by an engineer and installed with support from a WDNR lake protection grant.

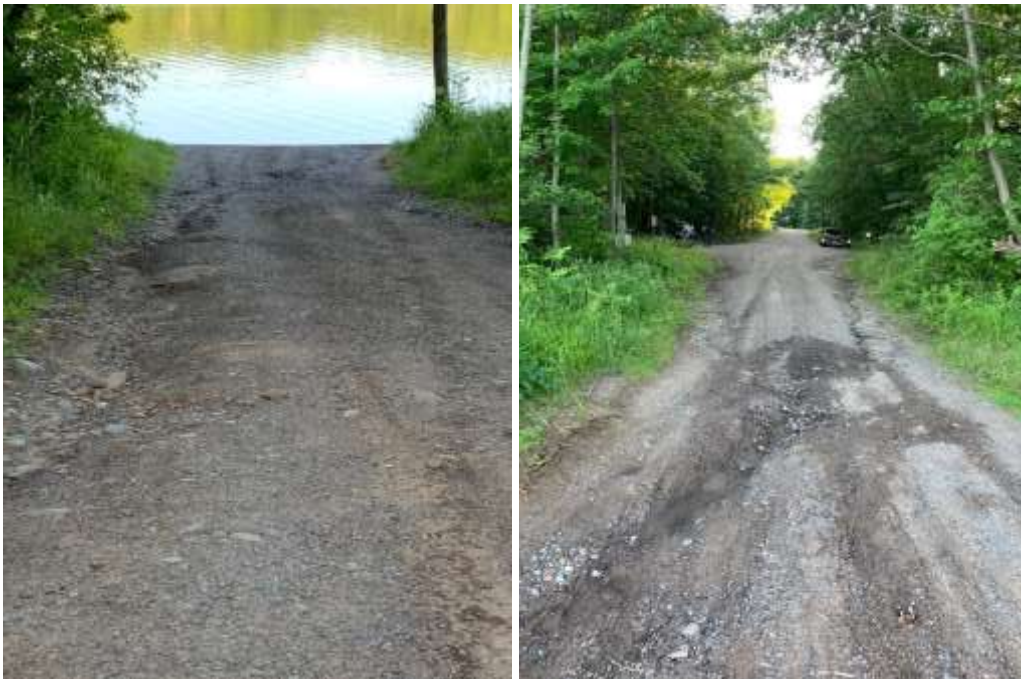
Figure 18: Erosion from the public boat landing facing the lake (left) and facing away from the lake (right)

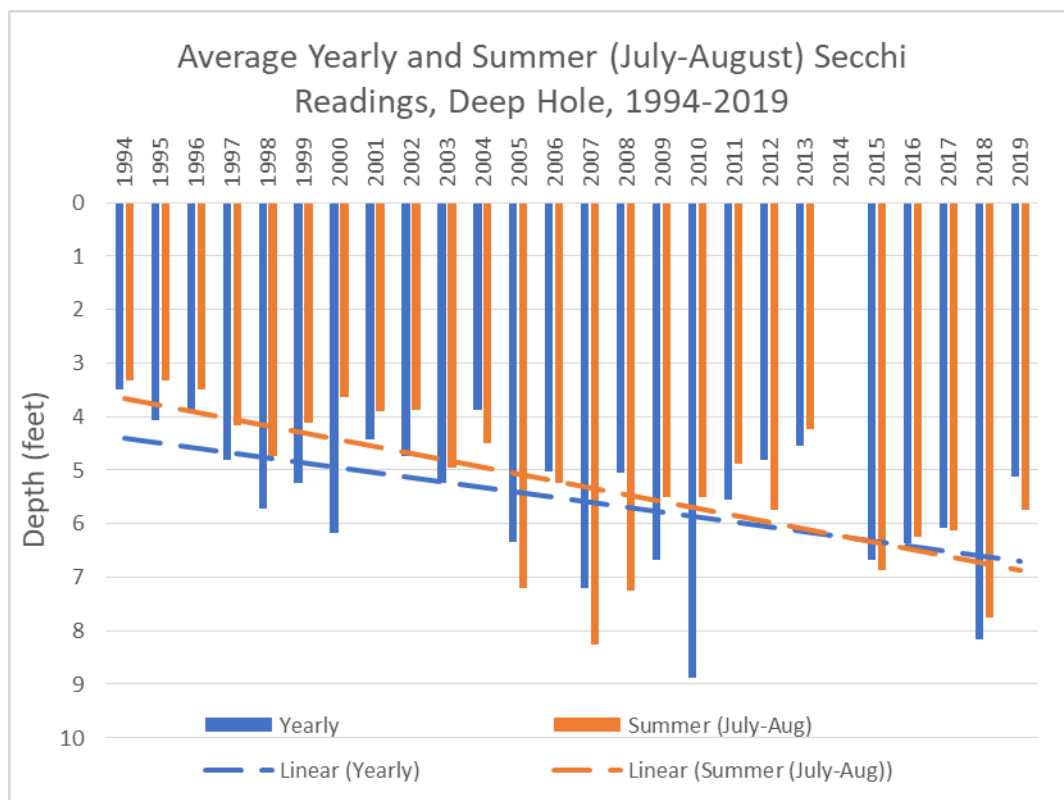
Figure 24: Secchi disk readings of water clarity in Granite Lake from 1994-2019

The Secchi measurements taken in Granite Lake at the Deep Hole are shown in Figure 24. There has been slight improving trend in water clarity over the past 25 years. Between 2005 and 2010 water clarity averaged a little more than 5.0-ft during the summer. After dropping a bit from 2011 to 2013 it picked up again starting in 2015.

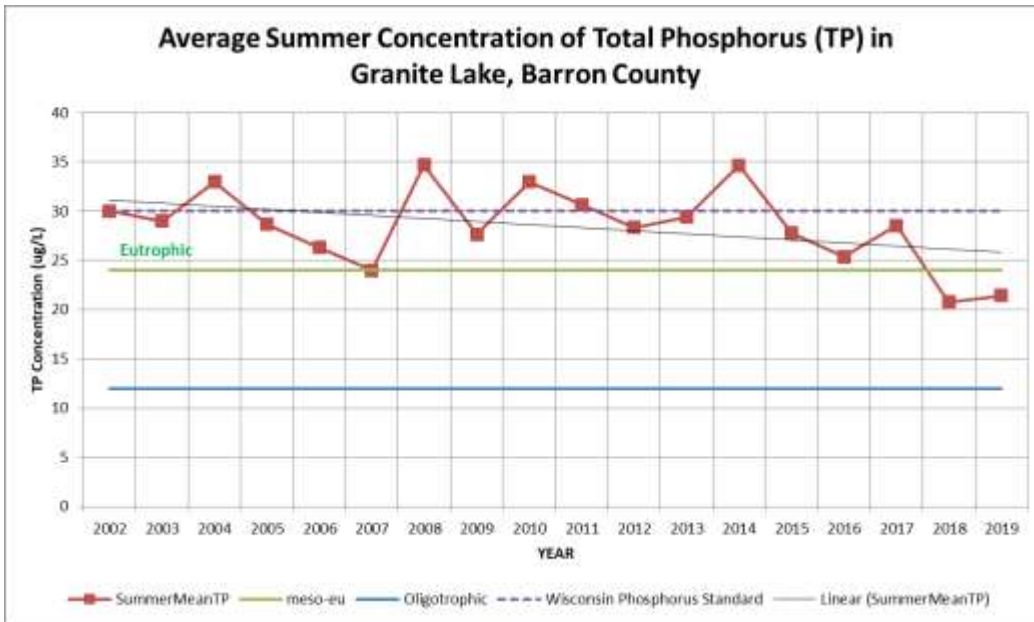
Figure 25: Average summer surface concentration of TP in Granite Lake based on CLMN data

Near-surface TP concentrations measured throughout the open water season have ranged from 16 to as much as 72- $\mu\text{g}/\text{l}$ (Figure 25). The mean summer (July and August) concentrations ranged from a low of 20.8- $\mu\text{g}/\text{l}$ in 2018 to a high of 34.7- $\mu\text{g}/\text{l}$ in 2008 which is pretty close to the mean reported for northwest Wisconsin lakes (28.0 $\mu\text{g}/\text{L}$) by Lillie and Mason (1983). Monthly concentrations are high in the spring and again in the fall likely due to spring and fall turnover (Figure 26). The acceptable phosphorus concentration based on Wisconsin phosphorus standards for a stratified, drainage lake greater than 5 acres is 30- $\mu\text{g}/\text{l}$ (WDNR, 2020). In Figure 25, the purple dashed line represents what is considered the state standard for TP in Granite Lake. In only five of the last 17 years has the summer mean exceeded the state standard.

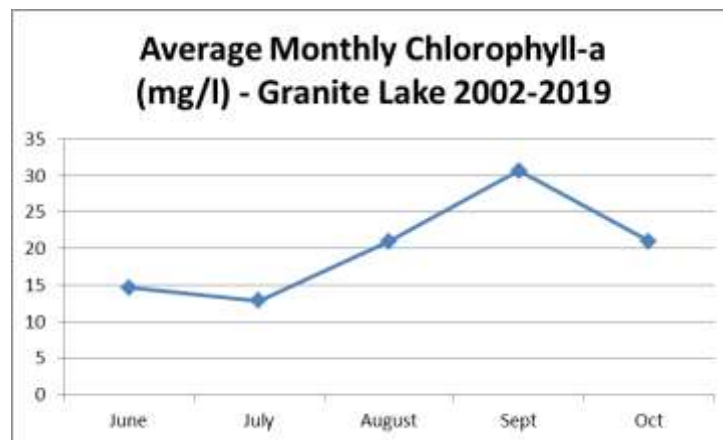
Figure 27: Average monthly Chl-A concentration (2002-2019 CLMN)

Chl-A is a measurement of algae in the water and has been measured in Granite Lake since 2002. The concentration varies throughout the year, generally peaking in late summer (Figure 27). The overall mean summer (June through August) Chl-A concentration from 2002 through 2019 was 16.1-µg/l (Figure 28). Aside from a couple of higher concentrations in 2013 and 2014, the trend for the last 10-yr has been decreasing.

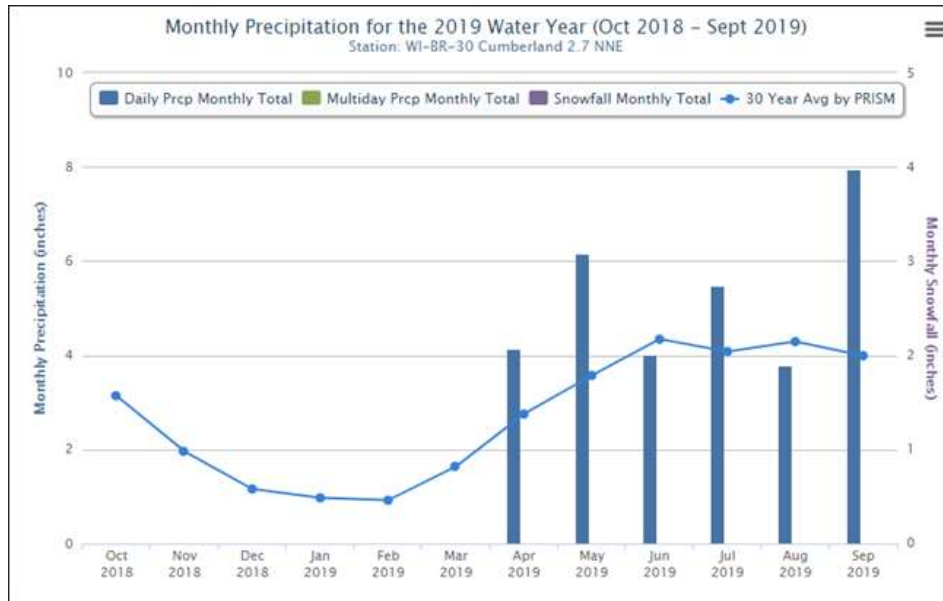
Figure 31: Monthly precipitation for the 2018-19 water year - Site WI-BR-30 - Southside

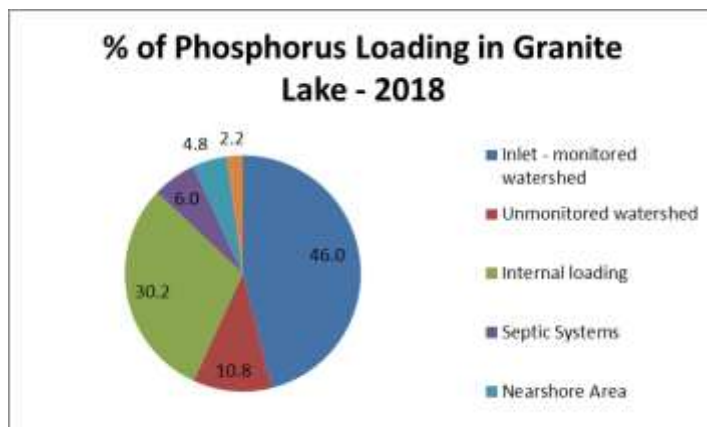
Figure 34: Phosphorus budgeting for Granite Lake – based on 2018 data

being carried in from the watershed and that which is being retained and recycled within the lake are the two biggest sources.

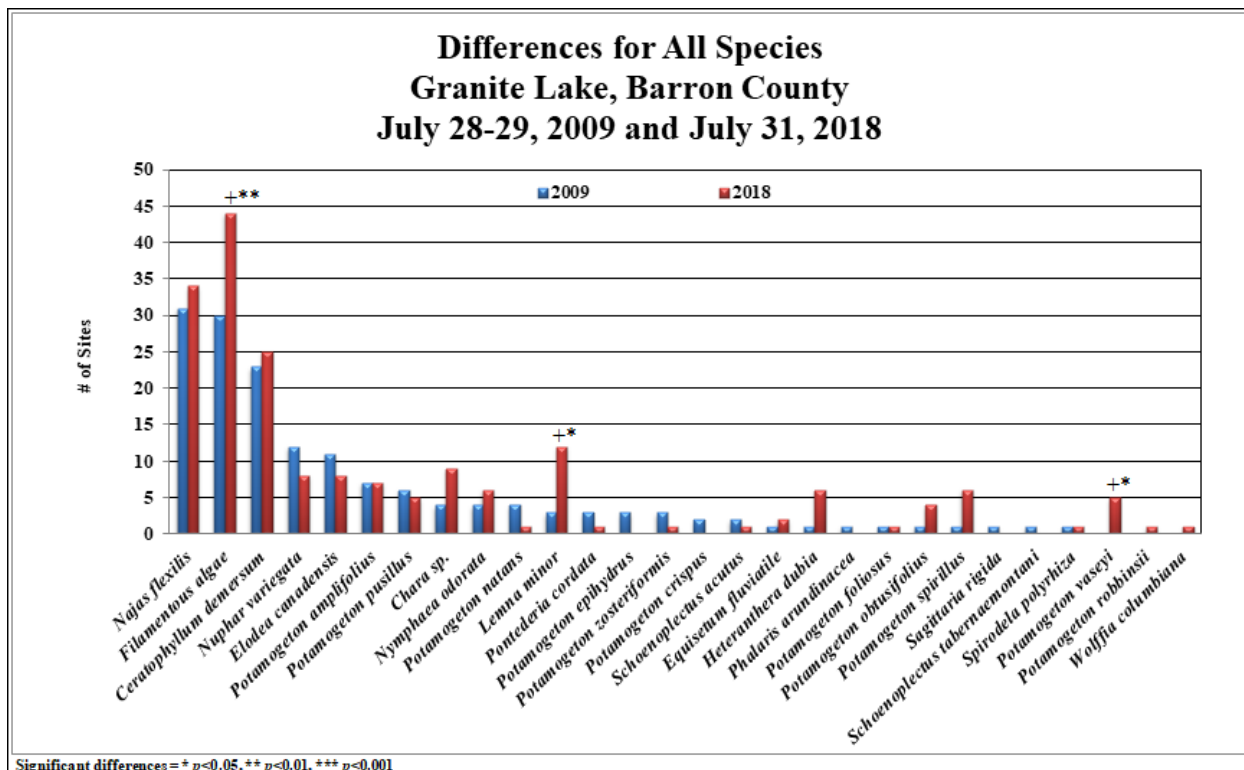
Figure 38: Aquatic plant changes from 2009 to 2018 (Berg, 2019)

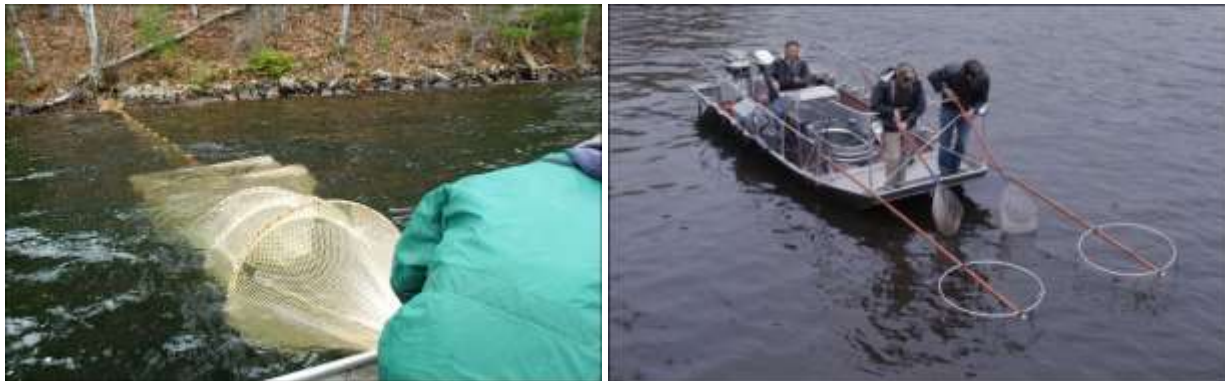
Figure 45: Fyke nets (left) and electro boom shocking (right)

From April 22 to April 24 fyke nets (Figure 45) were placed in Granite Lake. It is assumed that four different nets were installed as the WDNR reports 12 “net nights” of fish capture. A net night is defined as each fyke net placed in the water for a total number of days. Four nets placed in Granite Lake for three nights would equal 12 net nights. At the time this report was written only walleye results for fyke netting had been obtained. Over three days, 449 walleyes ≥ 10 inches in length were captured for an average of 37.4 fish per night. Any fish ≥ 10 inches is consider an adult fish and counted. Any fish over ≥ 15 inches is considered a quality fish – primarily due to the fact that at the present time the size limit for a harvestable walleye on Granite Lake is 15 inches. Of the 449 fish captured, 25% of them were ≥ 15 inches in length. The largest walleye captured was 20.5 inches. The average size of all walleyes captured was 14.5 inches, just under the 15 inch limit for harvest.

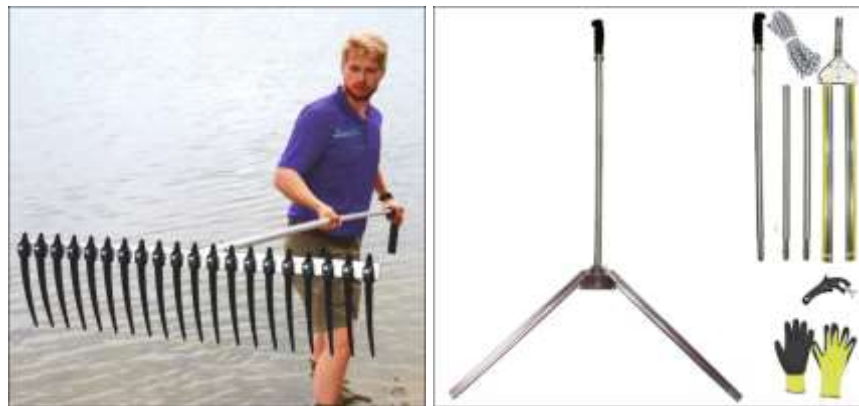
Figure 58: Example rakes and cutters (weedersdigest.com)

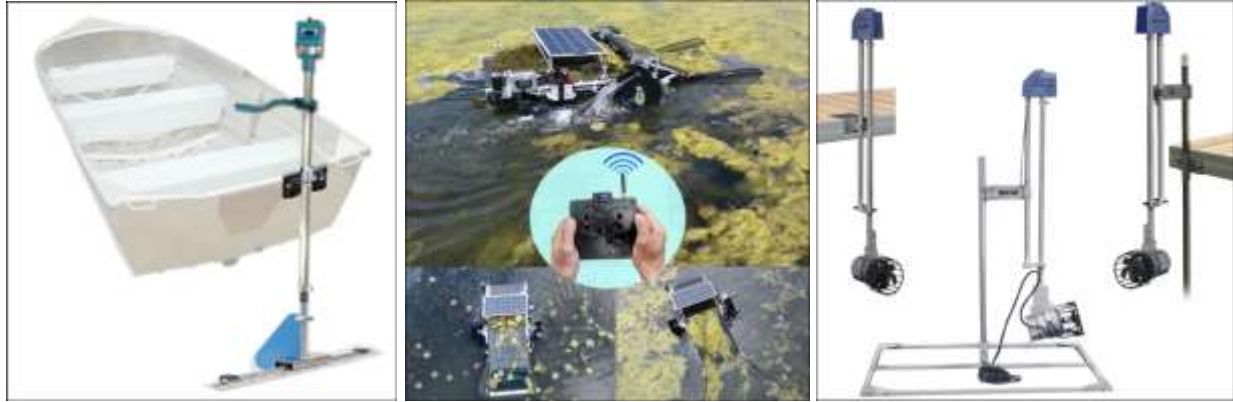
Figure 59: Assorted aquatic plant cutters, skimmers, and beach sweepers (weedersdigest.com)

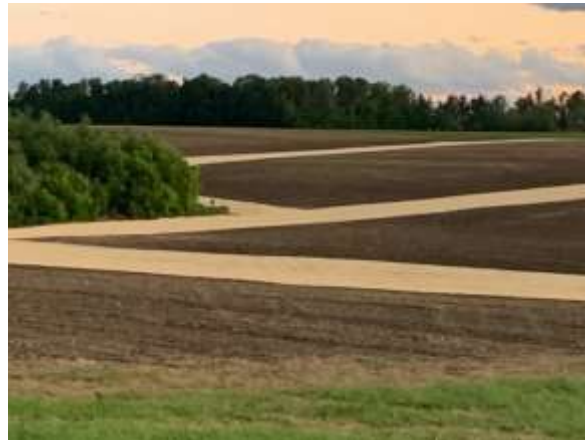
Figure 60: Newly installed grassed waterways south of Hwy 8 in Barron County (LEAPS)

protects farmland and natural resources through long-term easements. As previously mentioned the installation of grassed waterways (Figure 60), stream and wetland buffers, and restored wetlands can also reduce runoff and nutrient loading. Additional practices including livestock feeding and manure management strategies could further reduce phosphorous loading. There are at least four active manure storage pits and one abandoned manure pits within the watershed of Granite Lake (Figure 61). Figure 62 shows potential stream and wetland buffer sites recognized by Barron County. Table 20 reflects cost-sharing currently available in Barron County for agricultural BMPs. The GLA could work with Barron County to offset the costs to local farmers of implementing BMPs.
