**Eurasian water-milfoil (*Myriophyllum spicatum*)
Late Summer Bed Mapping Survey
Callahan Lake (WBIC: 2434700)
Sawyer County, Wisconsin**

Survey Conducted by and Report Prepared by:

Endangered Resource Services, LLC
Matthew S. Berg, Research Biologist
Saint Croix Falls, Wisconsin
September 5-6, 2020

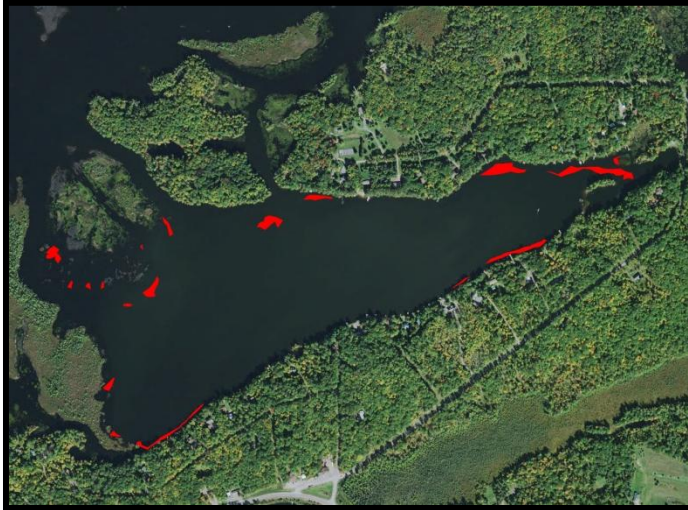
EWM beds on Callahan Lake 9/5-6/20

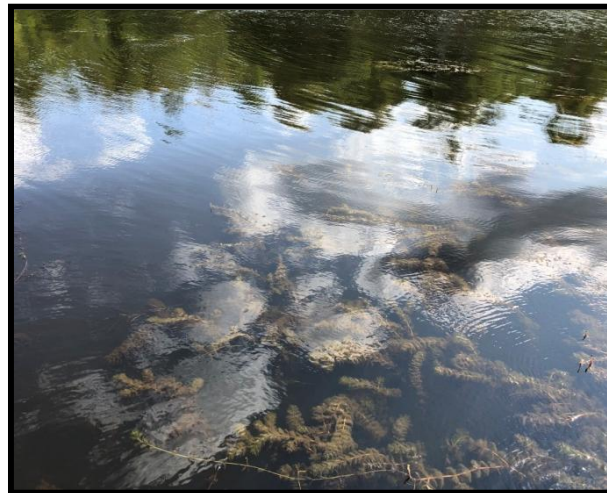
Canopied Eurasian Water-milfoil - Callahan Lake 9/5/20

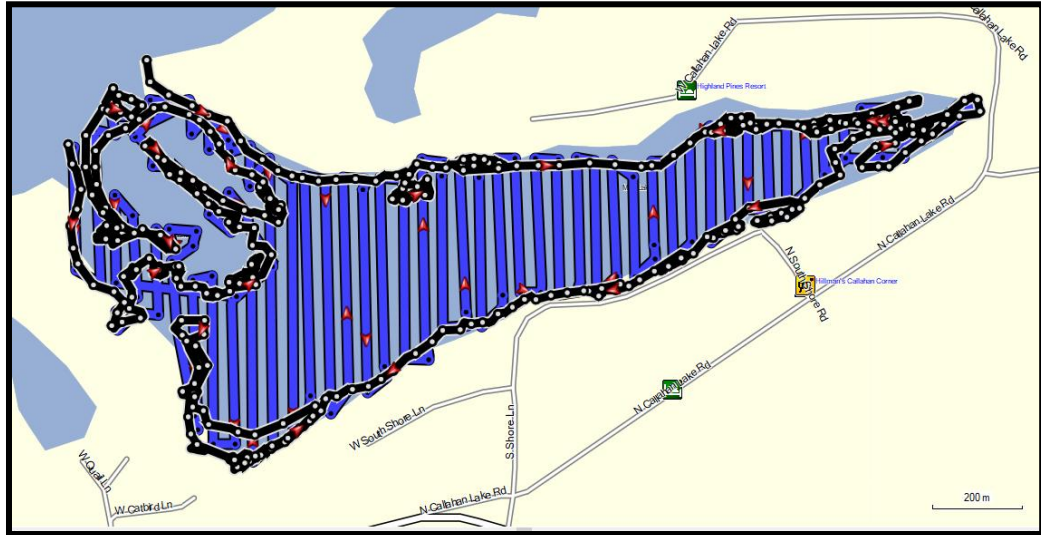
Figure 3: September 5-6, 2020 EWM Littoral Zone Survey – GPS Tracks

On September 5-6, 2020, we searched 12.1km (7.5miles) of transects (black) throughout the lake's visible littoral zone. This, coupled with the 17.7km (11.0 miles) of transects (blue) searched during the point-intercept survey, resulted in a total search of 29.8km (18.5 miles) (Figure 3). Collectively, we mapped 18 beds that covered 3.26 acres (2.36% of the lake's surface area) (Table 1). Outside of these areas, we marked 40 additional isolated plants (Figure 4) (Appendix I).

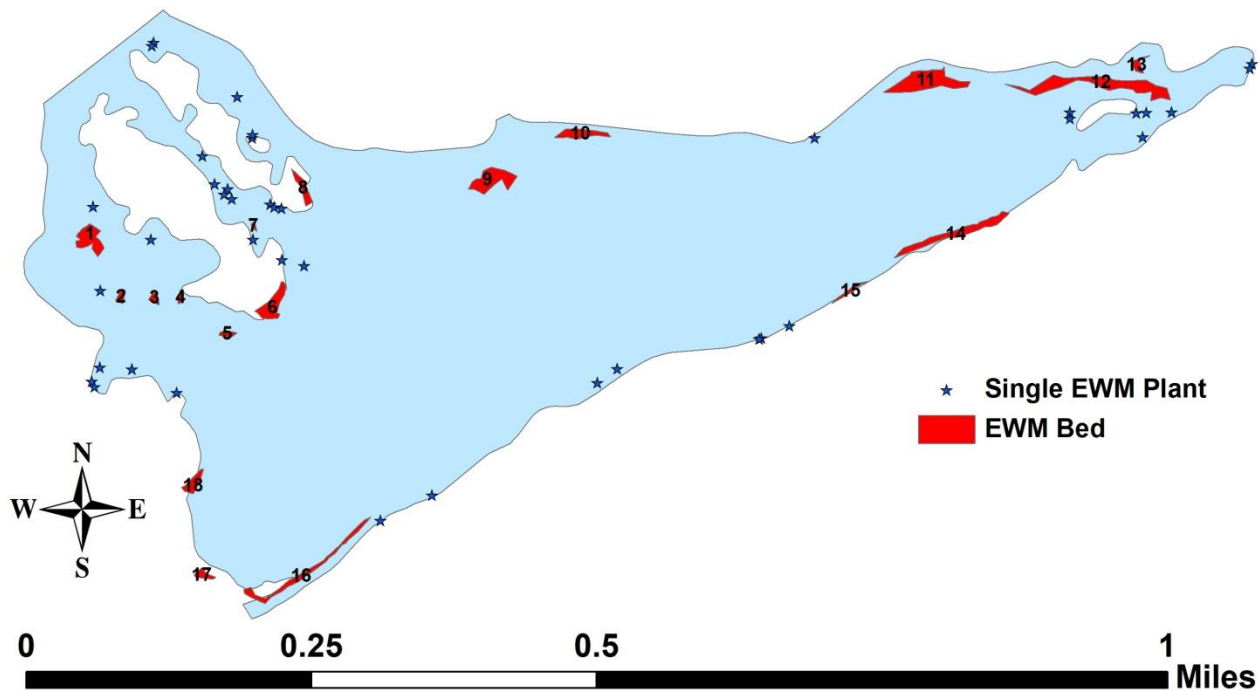
Appendix I: 2020 Eurasian Water-milfoil Bed Map

EWM Bed Mapping Survey

Callahan Lake

September 5-6, 2020
