**Eurasian water-milfoil (*Myriophyllum spicatum*)  
Late Summer Bed Mapping Survey  
Mud Lake (WBIC: 2434800)  
Sawyer County, Wisconsin**

EWM beds on Mud Lake 9/5-6/20

Endangered Resource Services, LLC  
Matthew S. Berg, Research Biologist  
Saint Croix Falls, Wisconsin  
September 5-6, 2020

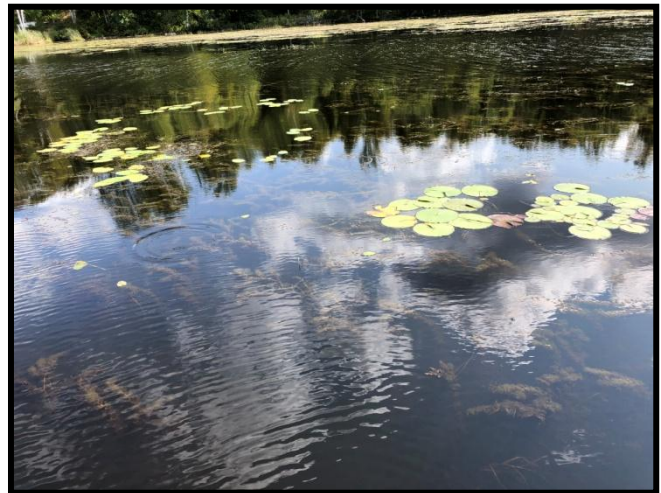
Canopied Eurasian Water-milfoil at the River Inlet - Mud Lake 9/5/20

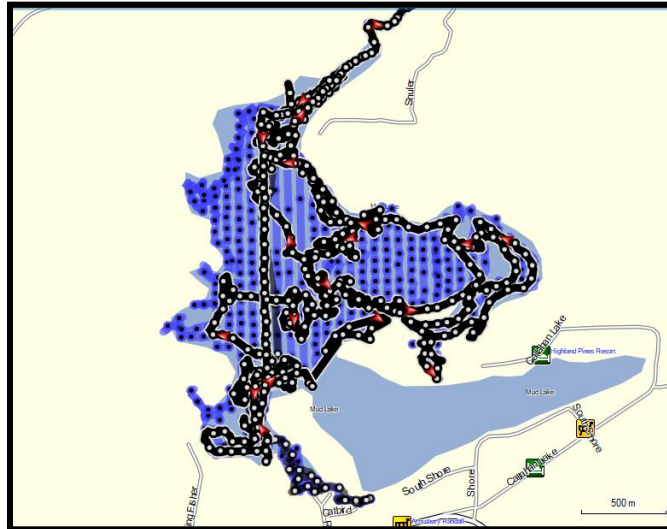
**Figure 3: September 5-6, 2020 EWM Littoral Zone Survey – GPS Tracks**

On September 5-6, 2020, we searched 36.8km (22.9 miles) of transects (black) throughout the lake’s visible littoral zone. This, coupled with the 42.8km (26.6 miles) of transects (blue) searched during the point-intercept survey resulted in a total search of 79.6km (49.5 miles) (Figure 3). Collectively, we mapped 28 beds that covered 11.06 acres (2.38% of the lake’s surface area) (Table 1). Outside of these areas, we marked 57 additional isolated plants (Figure 4) (Appendix I).

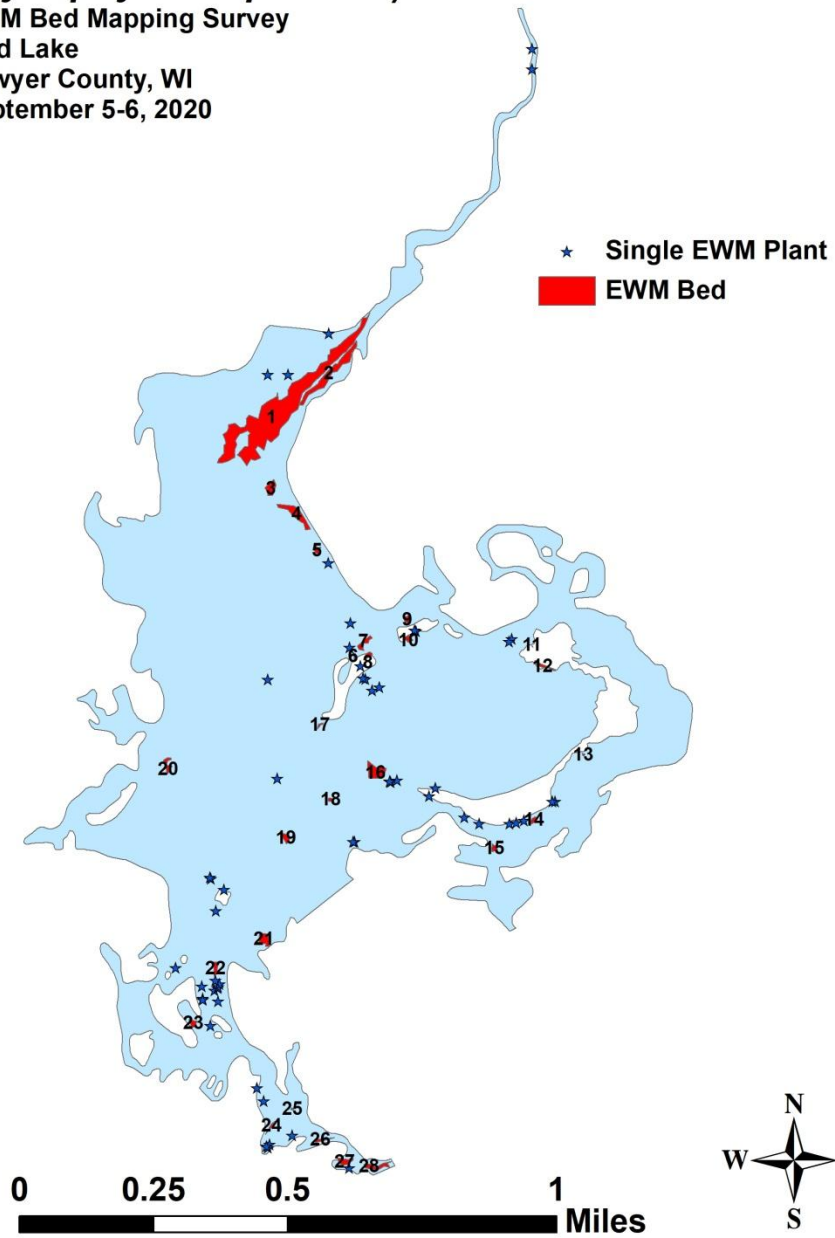
**Appendix I: 2020 Eurasian Water-milfoil Bed Map**

EWM Bed Mapping Survey

Mud Lake

September 5-6, 2020
