### 2022-2026 AQUATIC PLANT MANAGEMENT PLAN

### **Horseshoe Lake**

Dave Blumer, Project Manager/Lakes Scientist Megan Mader, Aquatic Biologist Lake Education and Planning Services LLC PO Box 26 Cameron, WI 54822

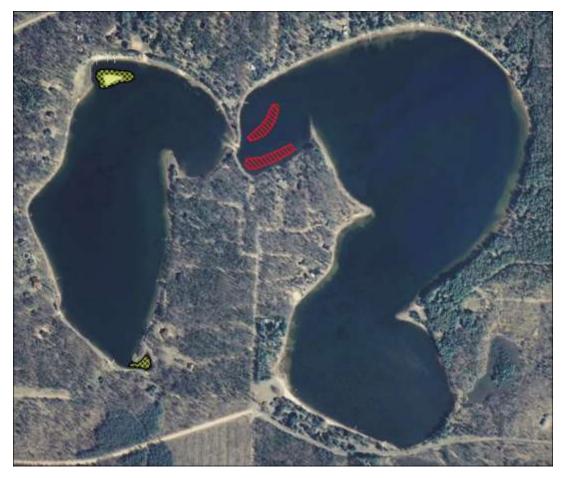
# 2022 Horseshoe Lake, Washburn County Preliminary EWM ProcellaCOR Treatment Proposal 11/5/2021

2022 Ho	rseshoe Lake	e, Washburn C	County Prel	iminary EW	/M Procella	COR Treatn	nent Plan 11-5-202	21 (LEAPS)
Treatment								
Location	Acre	Mean Depth	Acre-feet	PDU Rate	PDU / Site	Fl OZ/Site	Parts-per-billion	Part-per-million
Narrows-N	0.65	5.5	3.58	4	14.3	45.3	7.7	0.0077
Narrows-S	0.79	5.5	4.345	4	17.4	55.1	7.7	0.0077
Totals	1.44		7.92		31.7	100.4		
ProcellaCOR	PDU =	= 3.17 oz		fl. Ounces	gallons			
	# of PDU	31.7		100.4	0.78			
	Cost/PDU	\$70.00						
	Total Cost	\$2,217.60
