CLAM LAKES, BURNETT COUNTY

2022-26 AQUATIC PLANT MANAGEMENT PLAN
WDNR WBIC: 2656200 & 2655300

Prepared by: Lake Education and Planning Services, LLC
Cameron, WI 54822
Dave Blumer, Lake Educator
October, 2021

CLAM LAKE PROTECTION &
REHABILITATION DISTRICT
SIREN, WI 54872

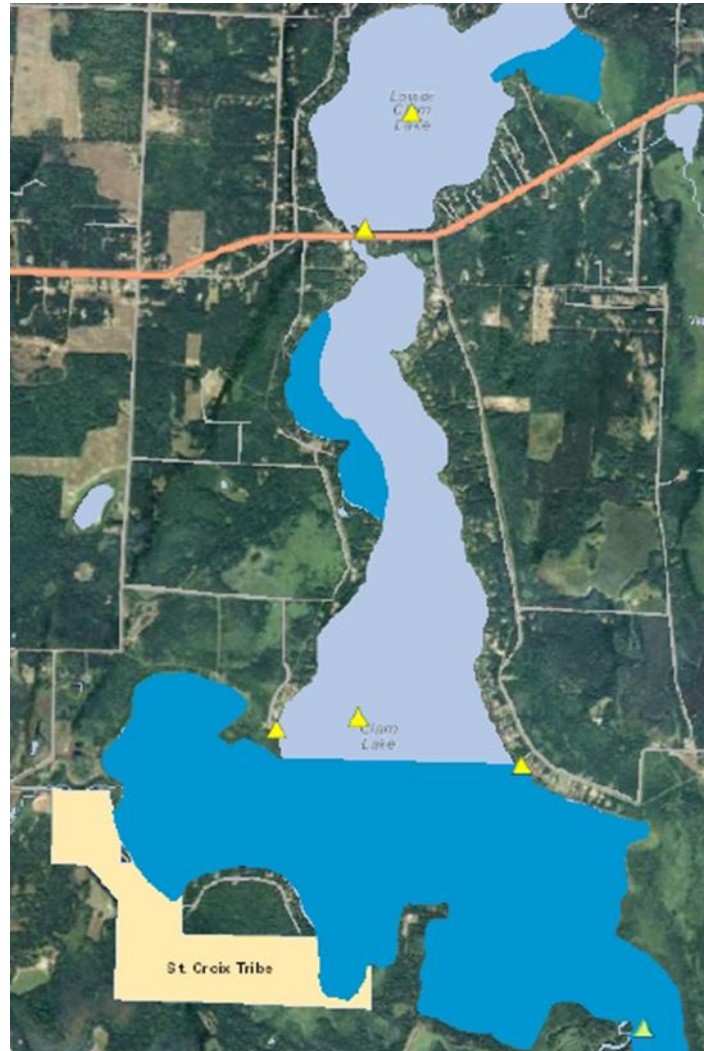
Figure 4: Sensitive areas (dark blue) in Upper and Lower Clam lakes (5)

The data and recommendations from the Sensitive Area Report were reviewed and incorporated into this management plan. In addition to site-specific recommendations, the report recommends that aquatic vegetation should be protected and any removal or control should be minimized. In sensitive areas, it is important to maintain vegetated shoreland buffers. Stumps and woody habitat, which provide fish cover, should not be removed from sensitive areas.

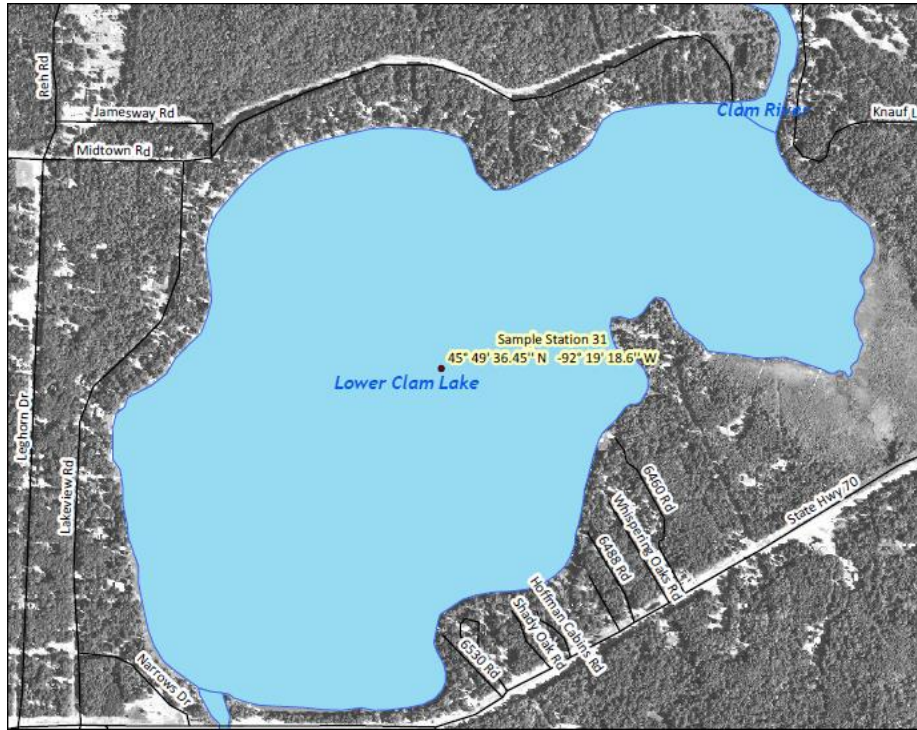
Water quality data reviewed here was collected by SCTES between 2012 and 2019 on Upper Clam Lake and between 2012-2014. Data of interest are Secchi disk readings of water clarity (Secchi), total phosphorus (TP), chlorophyll-a (CHL), temperature (temp) and dissolved oxygen (DO). The two sites where the data was collected include Site in Upper Clam Lake, and Site 31 in Lower Clam Lake (Figure 7).

Figure 7: St. Croix Tribal water quality sampling sites on Upper (top) and Lower (bottom) Clam lakes

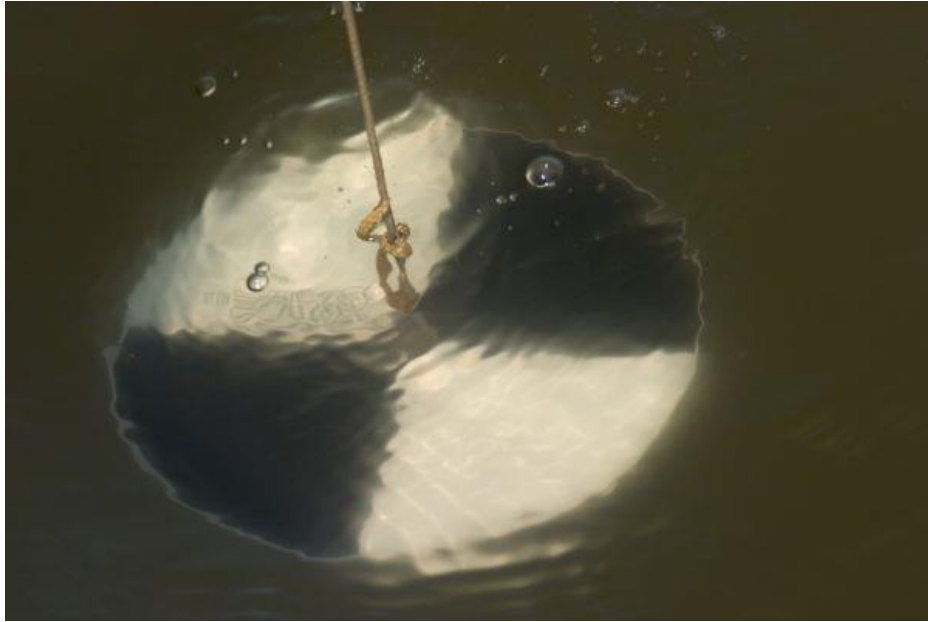
Water clarity is a measurement of how deep sunlight can penetrate into the waters of a lake. It can be measured in a number of ways, the most common being an 8” disk divided into four sections, two black and two white, lowered into the lake water from the surface by a rope marked in measurable increments (Figure 8). The water clarity reading is the point at which the Secchi disk when lowered into the water can no longer be seen from the surface of the lake. Water color (like dark water stained by tannins from nearby bogs and wetlands), particles suspended in the water column (like sediment or algae), and weather conditions (cloudy, windy, or sunlight) can impact how far a Secchi disk can be seen down in the water. Some lakes have Secchi disk readings of water clarity of just a few inches, while other lakes have conditions that allow the Secchi disk to be seen for dozens of feet before it disappears from view.

Figure 8: Black and white Secchi disk

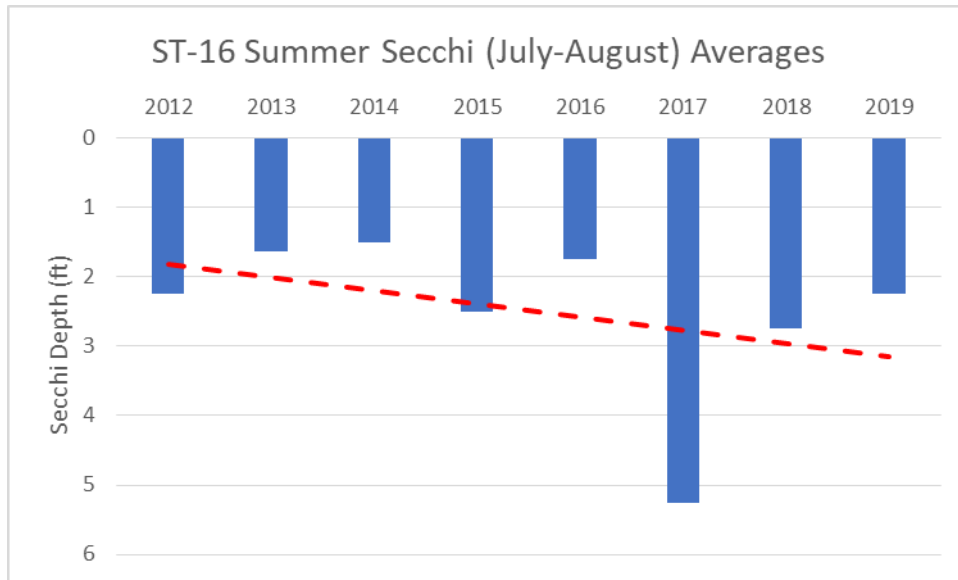
As is usually the case, water clarity declines as the summer season progresses. As water temperatures increase more algae grows. Boat traffic typically increases. All these things can reduce water clarity. The worst month for water clarity on Upper Clam Lake is typically August.

Figure 9: Summer (July and August) Secchi disk readings and trend line (red dash line) from Site 16 on Upper Clam Lake (SCTES)

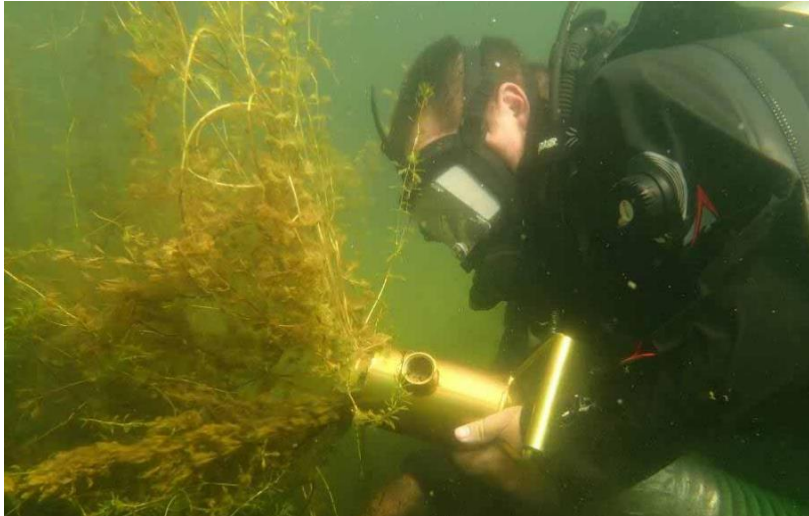
Figure 66: DASH - Diver Aided Suction Harvest (Chuck Druckery, 2016 Wisconsin Lakes Convention Presentation)

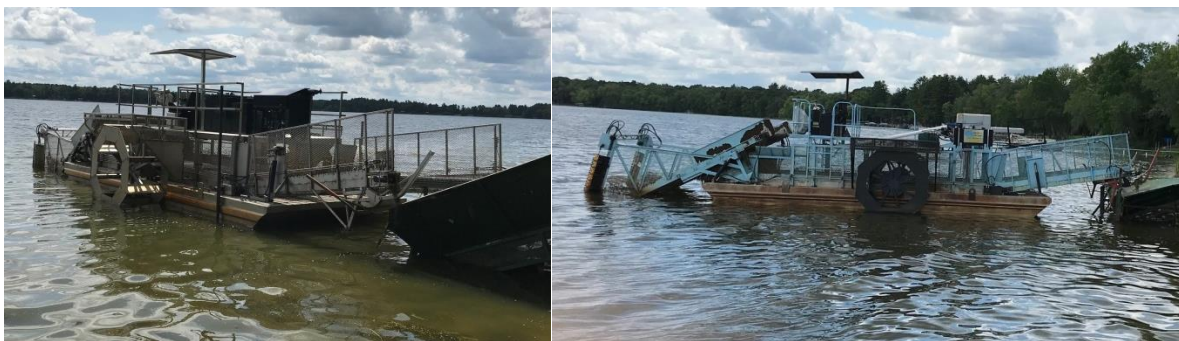
Figure 68: Two harvesters owned and operated by the CLPRD

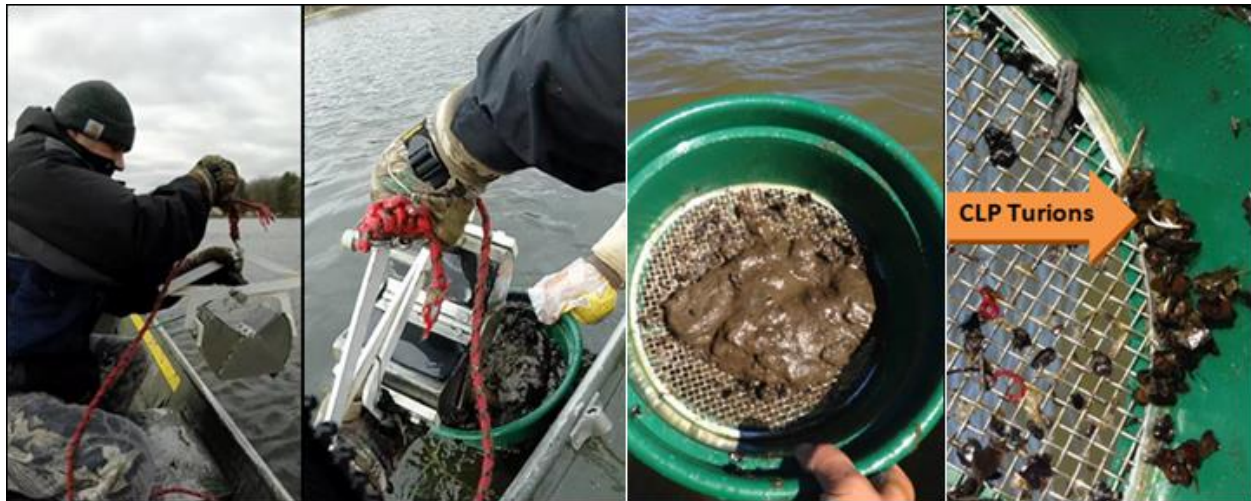
Figure 80: CLP turion density sampling (photo credits – Matt Berg)
