TREGO LAKE, WASHBURN COUNTY

2022-26 AQUATIC PLANT MANAGEMENT PLAN

Prepared by: Dave Blumer, Lake Educator/Manager & Megan Mader,
Aquatic Biologist/Lake Management Assistant

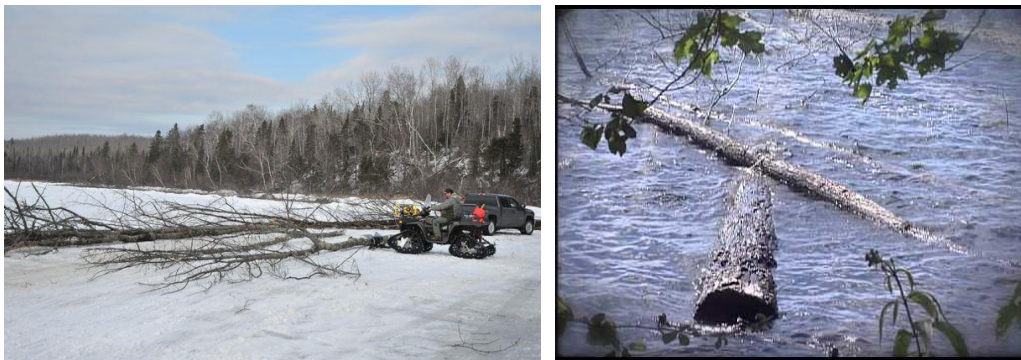
Figure 7: Coarse woody habitat-Fishsticks projects

Adding coarse woody habitat to a lake is relatively easy to do particularly when private landowners and lake associations are willing to partner with county, state, and federal agencies. Large-scale CWH projects, called “fishsticks”, are currently being completed by lake associations and local governments with assistance from the WDNR (Figure 7).

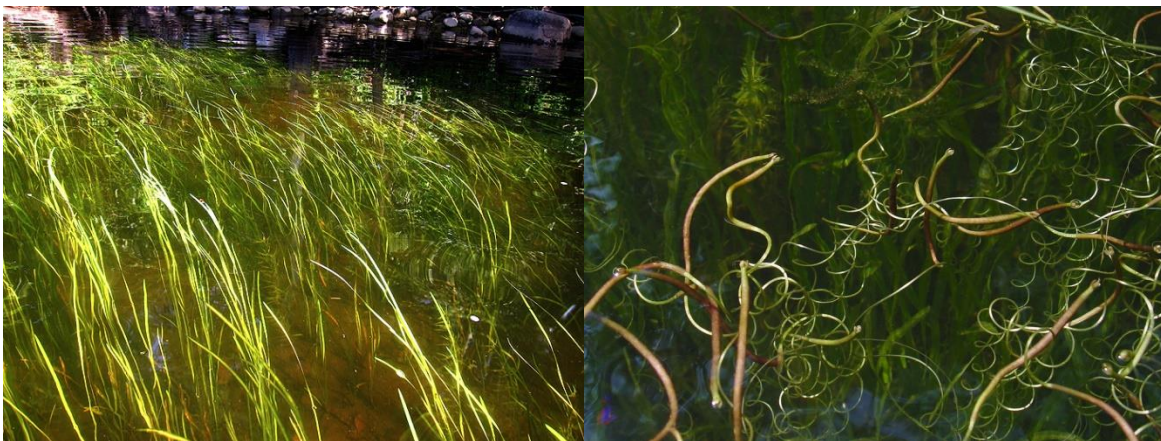
Figure 9: *Valisneria americana* (water celery) Present at 104/231 sites with vegetation

The four most abundant plant species during the 2020 PI survey were Water celery (Figure 9), Coontail (Figure 10), Flat-stem pondweed (Figure 11), and Northern wild rice (Figure 12).

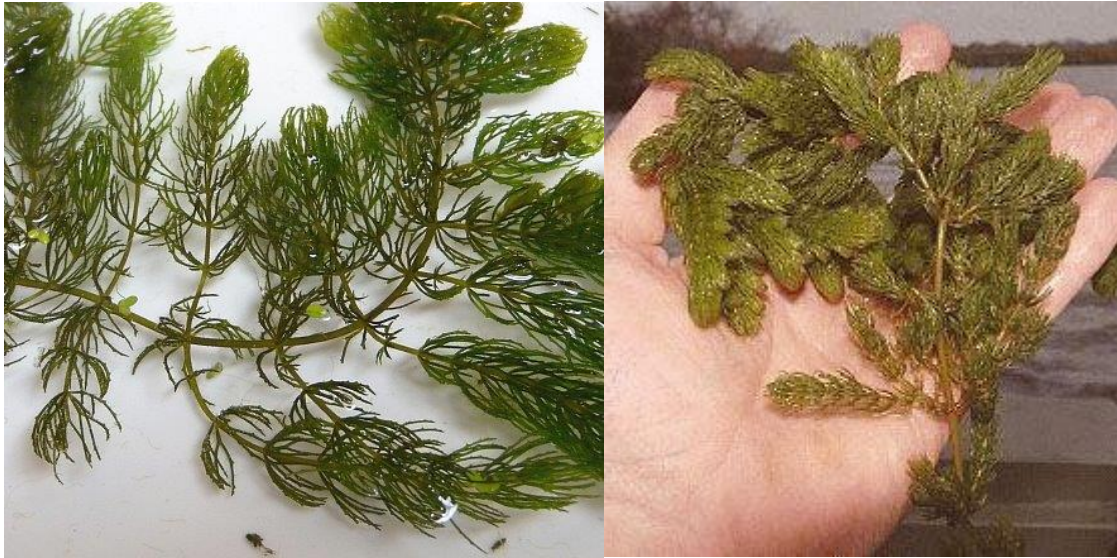
Figure 10: *Ceratophyllum demersum* (Coontail) Present at 89/231 sites with vegetation

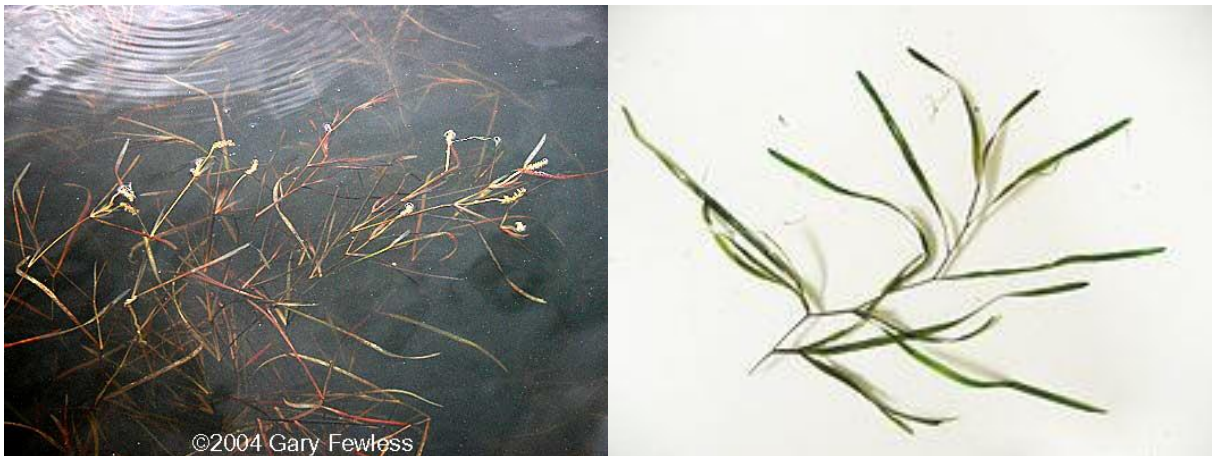
Figure 11: *Potamogeton zosteriformis* (Flat-stem pondweed) Present at 82/231 sites with vegetation

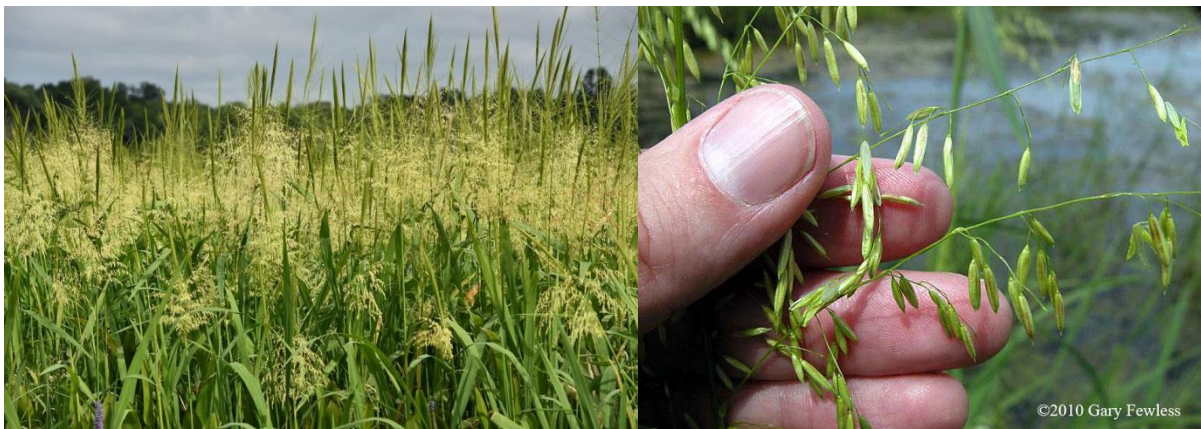
Figure 12: *Zizania palustris* (Northern wild rice) Present at 85/231 sites with vegetation

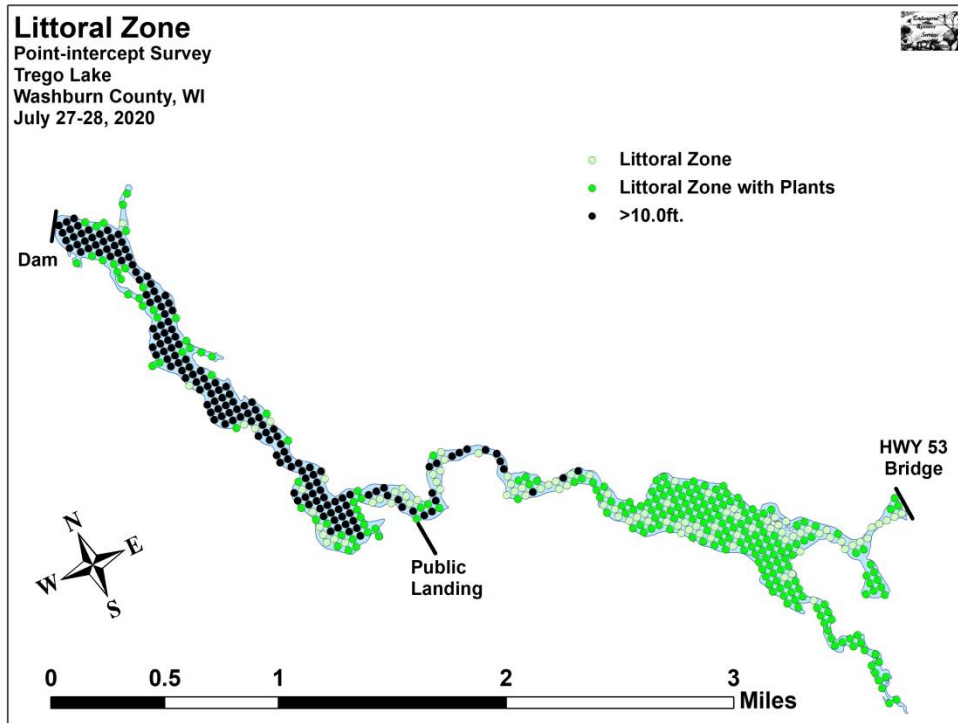
Figure 13: 2020 littoral zone (ERS)

Figure 13 shows the extent of the 2020 littoral zone and Figure 14 shows aquatic plant diversity at individual survey points. Figure 15 shows the density of vegetation at each point. From these figures, it is clear that the majority of

aquatic plant related problems – aquatic invasive species and native species – are focused in the east basin and Potato Creek area of the lake.

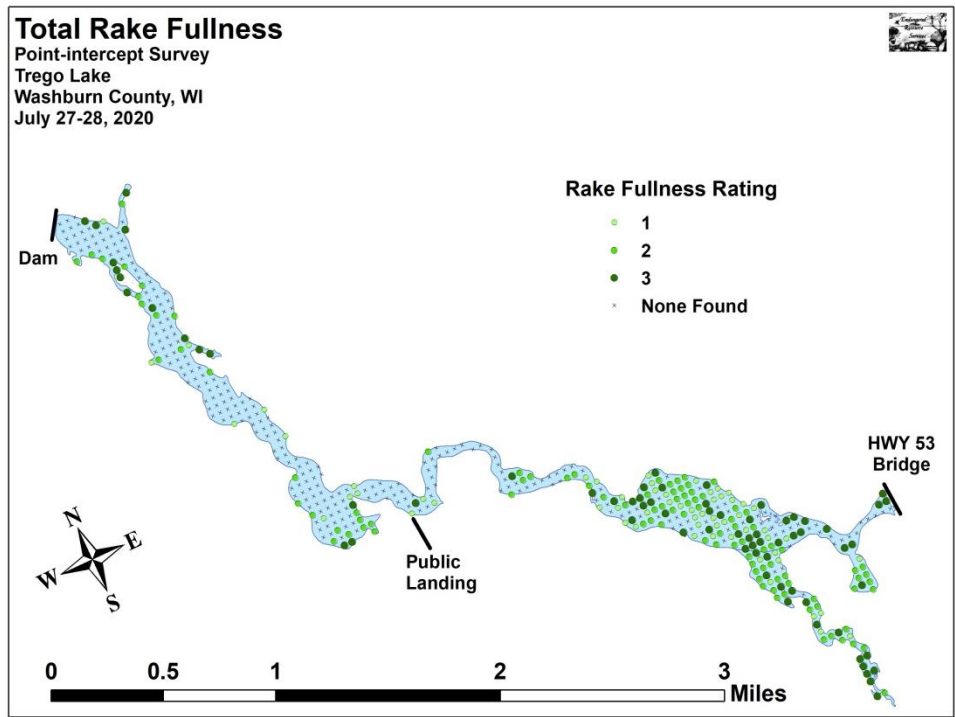
Figure 15: 2020 total rake fullness values (ERS)

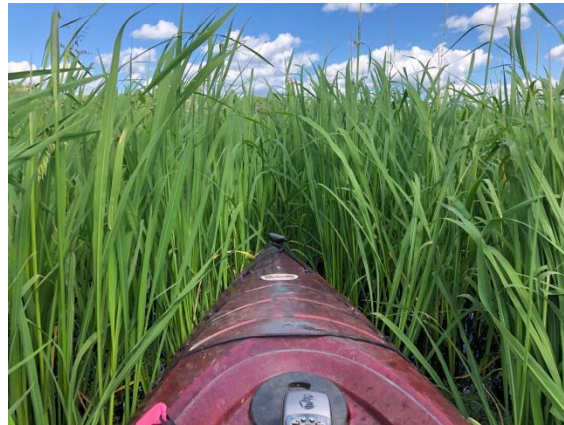
Figure 17: Wild rice in the east basin of Trego Lake, July 2020 (ERS)

According to a 2010 report from the Great Lakes Indian Fish and Wildlife Commission (GLIFWC) (David, 2010), significant beds of wild rice exist on Trego Lake/Flowage, and at least in 2010 they seemed to be expanding. Most of the rice is present in the primary inlets to the Flowage from the Namekagon River and Little Mackay/Potato Creeks on the east end of the Flowage. Figure 17 shows a photo from the plant surveyor going through wild rice in 2020. Figure 18 shows all the points in Trego Lake with wild rice during the 2020 PI survey. Figure 19 reflects an aerial photo of wild rice in Potato Creek and the east basin of Trego Lake from 2009.

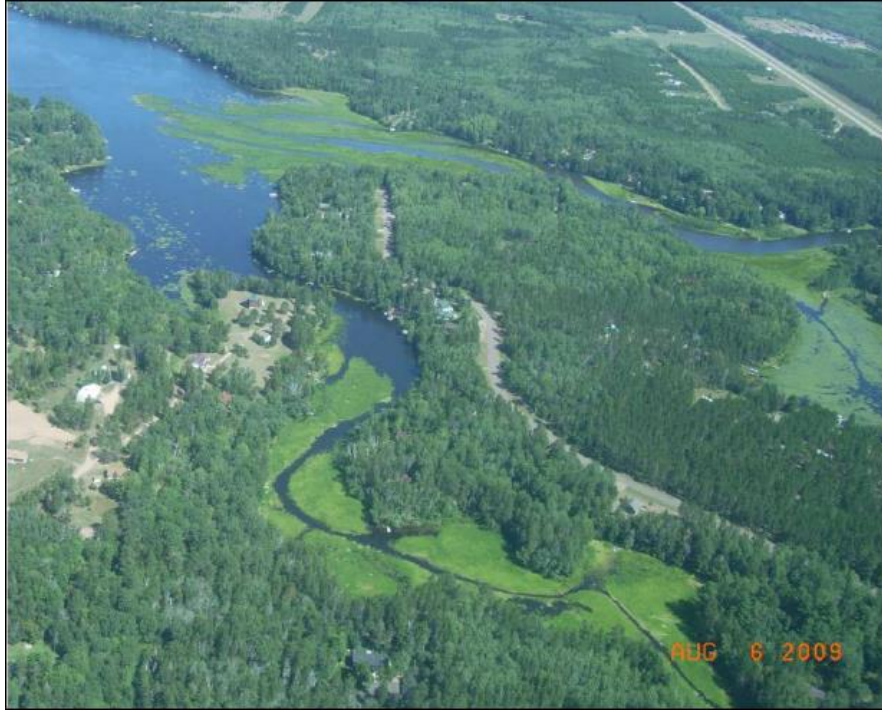
Figure 19: Wild rice in Potato Creek and the east basin of Trego Lake in 2009 (GLIFWC)

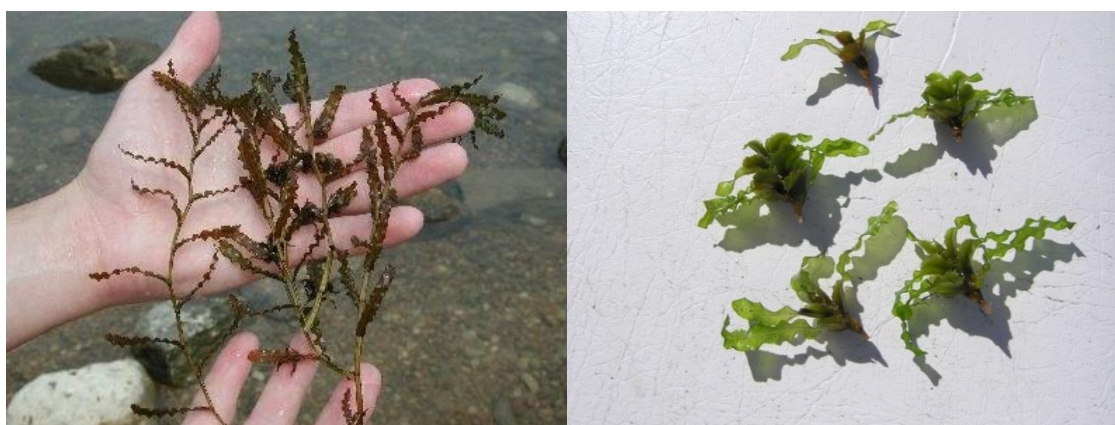
Figure 20: CLP Plants and Turions

Curly-leaf pondweed (CLP) is an invasive aquatic perennial that is native to Eurasia, Africa, and Australia (Figure 20). The leaves are reddish-green, oblong, and about 3 inches long, with distinct wavy edges that are finely toothed. The stem of the plant is flat, reddish-brown and grows from 1 to 3 feet long. CLP is an annual with new plants growing from burr-like winter buds called turions (Figure 20) deposited on the lake bottom when the water is cool, even under the ice in winter. It is one of the first nuisance aquatic plants to emerge in the spring, growing rapidly as sunlight becomes more available. Dense mats of early growth vegetation often interfere with or out-compete native aquatic plant growth that begins a little later when water temperatures rise. At peak growth, mats of CLP at and just under the surface can interfere with aquatic recreation. CLP usually completes its annual life cycle in June depositing new turions on the bottom of the lake. By early July the plant dies, dropping to the bottom to decompose, releasing nutrients back into the water as it does so. Large-scale die-offs may result in a critical loss of dissolved oxygen. Floating mats of dead and dying CLP can inundate shallow water areas and foul shorelines and beaches. In the fall, when water temperature begins to cool, turions start to sprout again.

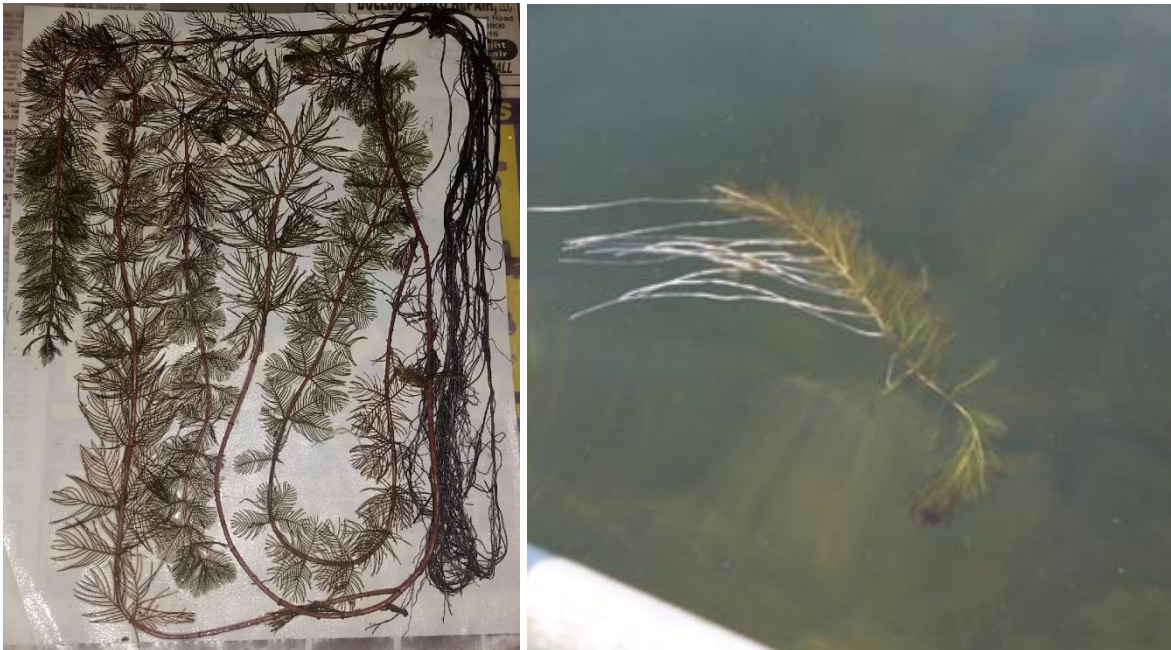
Figure 23: EWM plant and a floating fragment with new roots

EWM (Figure 23) is a submersed aquatic plant native to Europe, Asia, and northern Africa. It is the only non-native milfoil in Wisconsin. Like the native milfoils, the Eurasian variety has slender stems whorled by submersed feathery leaves and tiny flowers produced above the water surface. The leaves are threadlike, typically uniform in diameter, and

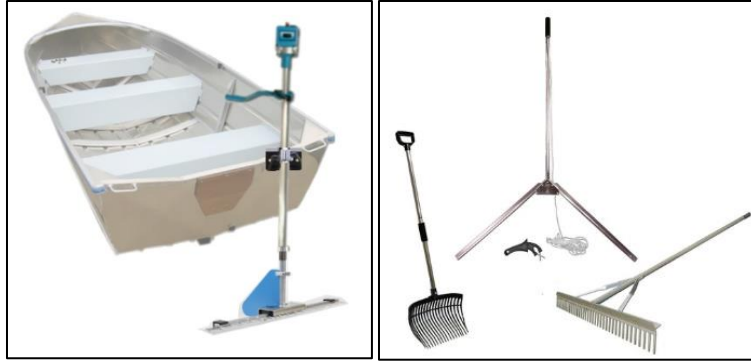
Figure 34: Aquatic Mower & Weedshear Weed Cutter (weedersdigest.com)

There are a wide range of small-scale mechanical harvesting techniques, most of which involve the use of boat mounted rakes, scythes, and electric cutters. As with all mechanical harvesting, removing the cut plants is required. Commercial rakes and cutters (Figure 34) range in prices from \$200 for rakes to around \$3000 for electric cutters with a wide range of sizes and capacities. Using a weed rake or cutter that is run by human power is allowed without a permit, but the use of any device that includes a motor, gas or electric, would require a permit. Dragging a bed spring or bar behind a boat, tractor or any other motorized vehicle to remove vegetation is also illegal without a permit. Incidental plant disruption by normal boat traffic is not considered mechanical management and is a legal method of management. Active use of an area is often one of the best ways for riparian owners to gain navigation relief near their docks. Most aquatic plants won't grow well in an area actively used for boating and swimming. It should be noted that purposefully navigating a boat to clear large areas is not only potentially illegal it can also re-suspend sediments, encourage aquatic invasive species growth, and cause ecological disruptions.

Small-scale harvesting could be used effectively to manage CLP and nuisance native vegetation in certain areas of Trego Lake. For a small investment to purchase a boat mounted type weed cutter and some volunteer time, the areas of greatest impact to navigation could be improved.

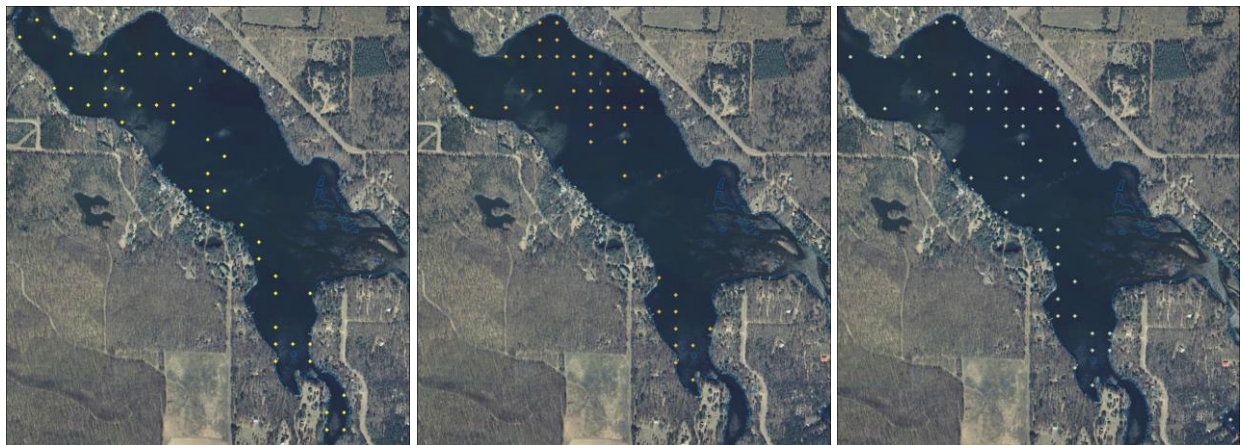
Figure 37: 2020 water celery distribution (left), coontail distribution (center), and flat-stem pondweed distribution (right)

Several other native plant species are dominant in the east basin and Potato Creek area of Trego Lake once CLP completes its life cycle. Larger, rooted plants including water celery and flat-stem pondweed, and coontail - a large suspended plant, form moderate to dense beds of vegetation in the mid to late summer throughout Trego Lake, but particularly in the east basin and Potato Creek inlet (Figure 37). The density of plants in these areas may appear worse than it is due to very abundant small floating plants including the duckweeds and watermeal that tend to get caught in the surface mats of the larger plant species (Figure 38). During mid to late summer harvesting it is these few plants that are removed most frequently and in abundance.

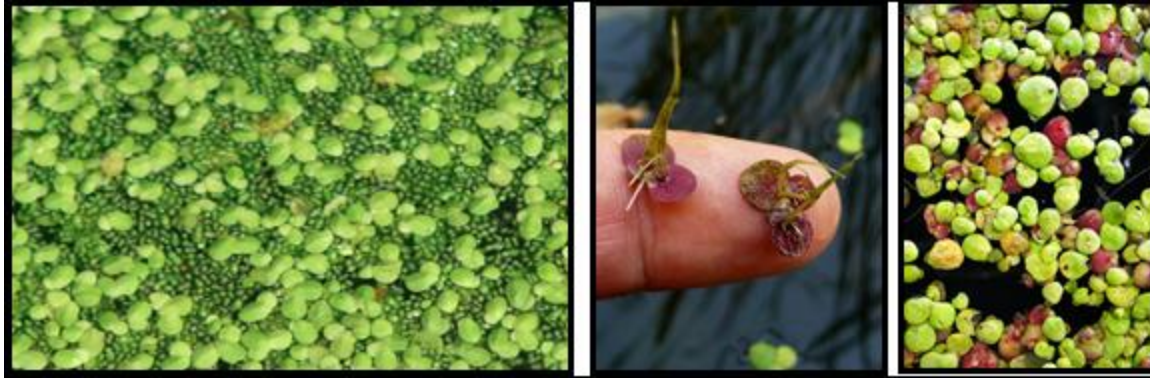
Figure 38: *Lemna minor* (small duckweed) and *Wolfia Columbiana* (watermeal) (left), and *Spirodela polyrhiza* (large duckweed) (right) (ERS)
