**Eurasian Water-milfoil (*Myriophyllum spicatum*)
August Bed Mapping Survey
Minong Flowage - (WBIC: 2692900)
Washburn and Douglas Counties, Wisconsin**

Minong Flowage Association, Lake Education and Planning Services, LLC
and the Wisconsin Department of Natural Resources

Endangered Resource Services, LLC
Matthew S. Berg, Research Biologist
St. Croix Falls, Wisconsin
August 14, 2019

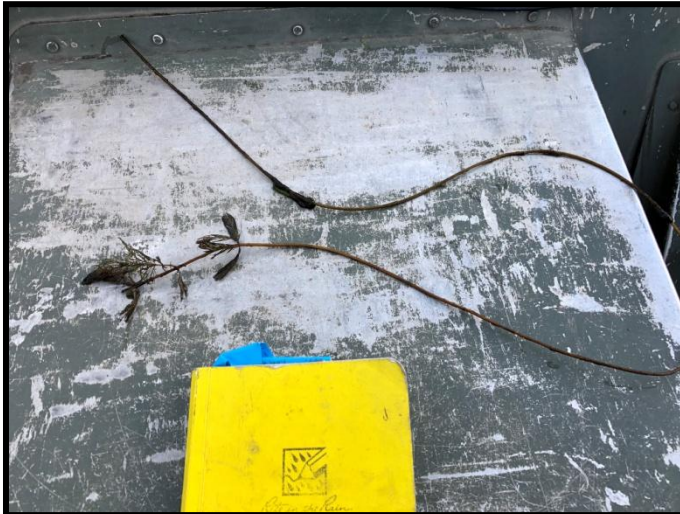
EWM in the Totagatic Inlet – blackened stems with only a few live leaflets 8/14/19

Bed 19 – For unknown reasons, we were unable to find EWM in the majority of this formerly large bed. Those plants we did find were sickly looking, almost black, showed no recent growth, and appeared to be just clinging to life with only a few leaflets near the surface (see cover page of this report).

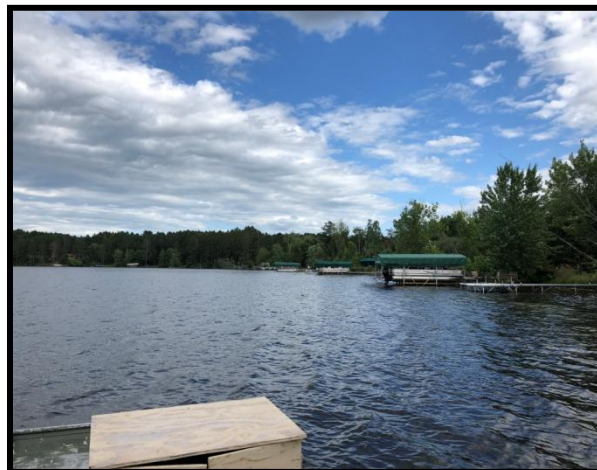
Open water along the south shoreline of Serenity Bay

Bed 16 – EWM was absent from the majority of the south shoreline of Serenity Bay. On the south end of the main bed in the center of the bay, plants were much more scattered than in 2018, and we notice a general retreat towards shallow water. Even among the stumps where EWM has often formed a solid canopied mat in the past, most areas had only patchy plants and native species were noticeably more common.
