**Curly-leaf Pondweed (*Potamogeton crispus*) and  
Eurasian Water-milfoil (*Myriophyllum spicatum*)  
Pre/Post Herbicide and Fall EWM Bed Mapping Surveys  
Big Trade Lake – WBIC: 2638700  
Burnett County, Wisconsin**

Endangered Resource Services, LLC  
Matthew S. Berg, Research Biologist  
St. Croix Falls, Wisconsin  
May 22, June 25, and October 22-25, 2018

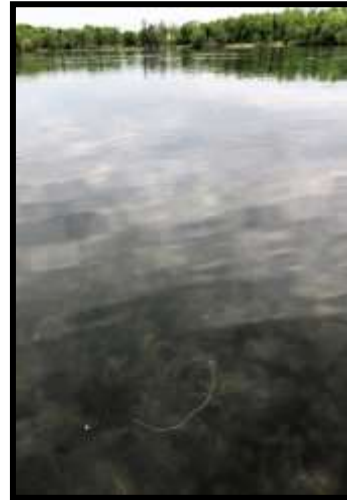
Canopied EWM on Big Trade (5/22/18)

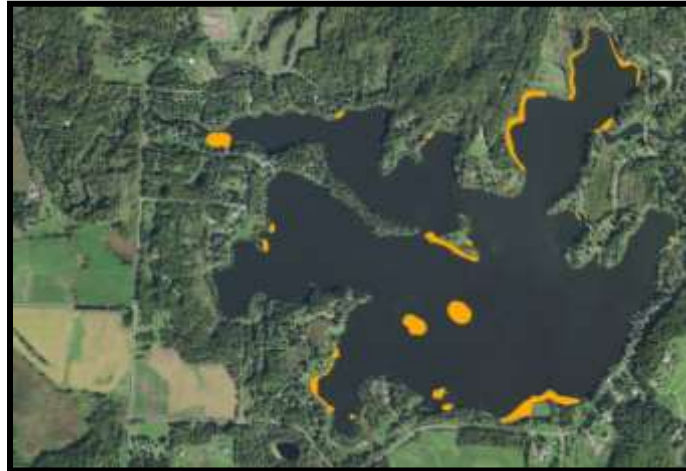
**Figure 1: 2018 EWM Treatment Areas**

In 2018, the RTLIA – under the direction of Dave Blumer (Lake Education and Planning Services, LLC - LEAPS) – applied for and was awarded a WDNR Aquatic Invasive Species control grant (ACEI21618) to help cover the costs associated with management. These funds were used to chemically treat 23 areas totaling 13.34 acres (4.08% of the lake's surface area) for EWM only (Figure 1). On May 22<sup>nd</sup>, we conducted a pretreatment survey to gather baseline data from these areas and to allow LEAPS/RTLIA to finalize treatment plans. After the May 30<sup>th</sup> herbicide application, we completed a June 25<sup>th</sup> posttreatment survey to evaluate the effectiveness of the treatment. We also conducted an October 22-25<sup>th</sup> EWM bed mapping survey to determine where control might be considered in 2019. This report is the summary analysis of these three field surveys.
