**Curly-leaf Pondweed (*Potamogeton crispus*) and
Eurasian Water-milfoil (*Myriophyllum spicatum*)
Pre/Post Herbicide and Fall EWM Bed Mapping Surveys
Little Trade Lake – WBIC: 2639300
Burnett County, Wisconsin**

Endangered Resource Services, LLC
Matthew S. Berg, Research Biologist
St. Croix Falls, Wisconsin
May 19, June 25, and October 17, 2018

INTRODUCTION:

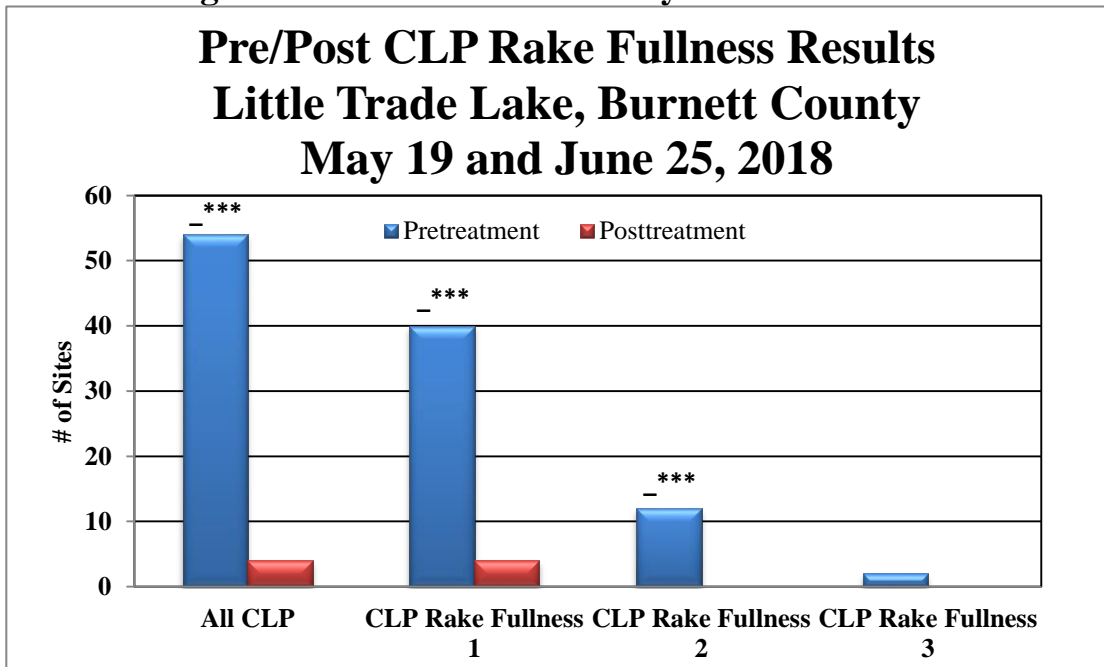
Figure 9: Pre/Post Changes in CLP Rake Fullness

We found Curly-leaf pondweed at 54 of 128 sites during the pretreatment survey (42.2% coverage) (Figure 8). Of these, two had a rake fullness rating of 3, 12 rated a 2, and the remaining 40 were a 1. This produced a mean rake fullness of 1.30 and suggested that 10.9% of the proposed treatment areas had a significant infestation (rake fullness 2 and 3). During the posttreatment survey, we found CLP at just four points (3.2% coverage) all of which rated a 1. **Our results demonstrated a highly significant decline in total CLP as well as rake fullness 2 and 1** (Figure 9) (Appendix V).

Significant differences = * $p < 0.05$, ** $p < 0.01$, *** $p < 0.001$

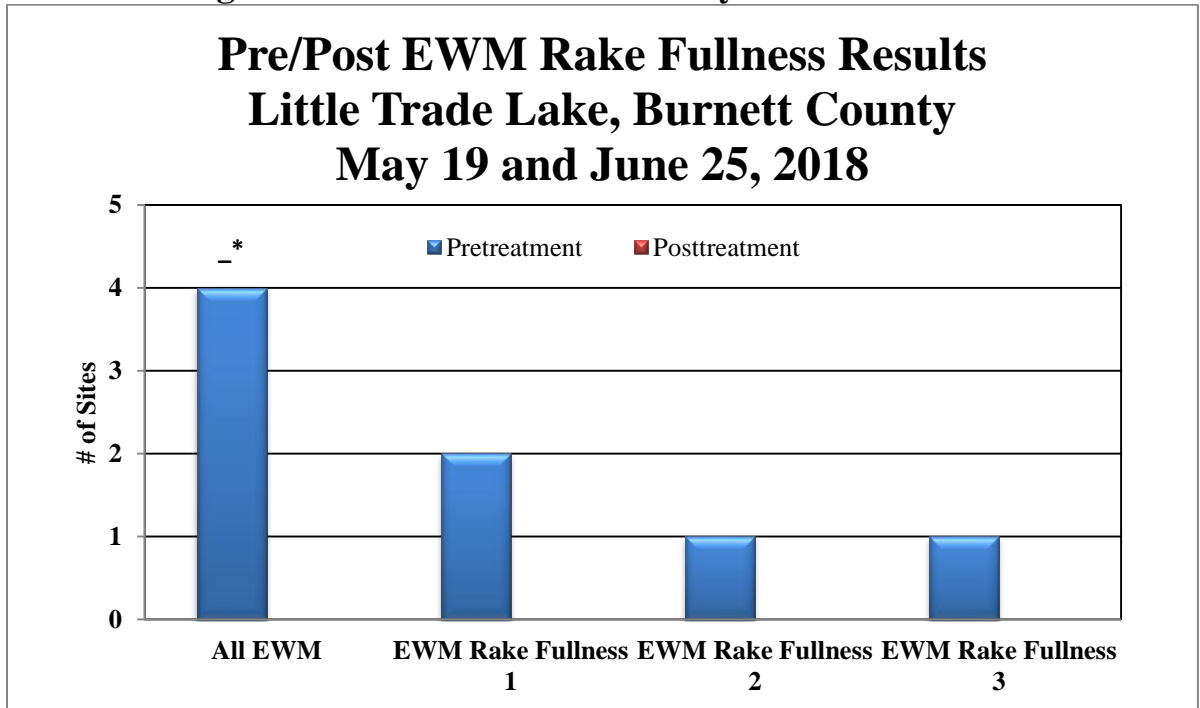
Figure 11: Pre/Post Changes in EWM Rake Fullness

Eurasian water-milfoil was present at four of 128 points (3.1% coverage) during the pretreatment survey (Figure 10). We rated one point a 3, one a 2, and two a 1. This extrapolated to 1.6% of the proposed treatment areas having a significant infestation (rake fullness 2 and 3) and produced a mean rake fullness of 1.75. During the posttreatment survey, we didn't see any evidence of EWM at or between any survey points. **This overall reduction was statistically significant for only total EWM** (Figure 11) (Appendix V).

Significant differences = * $p < 0.05$, ** $p < 0.01$, *** $p < 0.001$

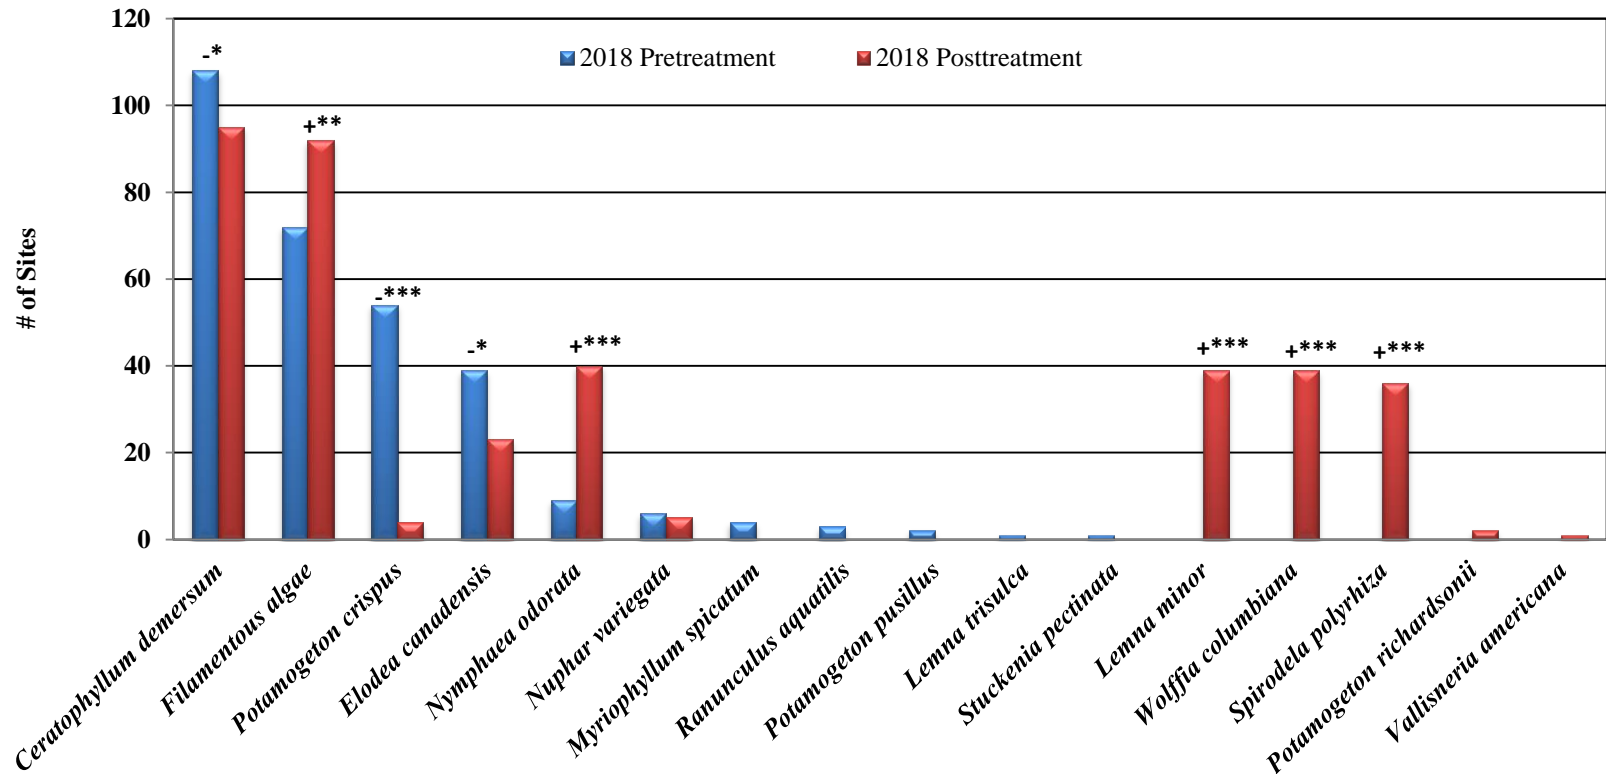
Figure 14: Pre/Post Macrophyte Changes

Pre/Post Differences for All Species Little Trade Lake, Burnett County May 19 and June 25, 2018

Significant differences = * $p < 0.05$, ** $p < 0.01$, *** $p < 0.001$

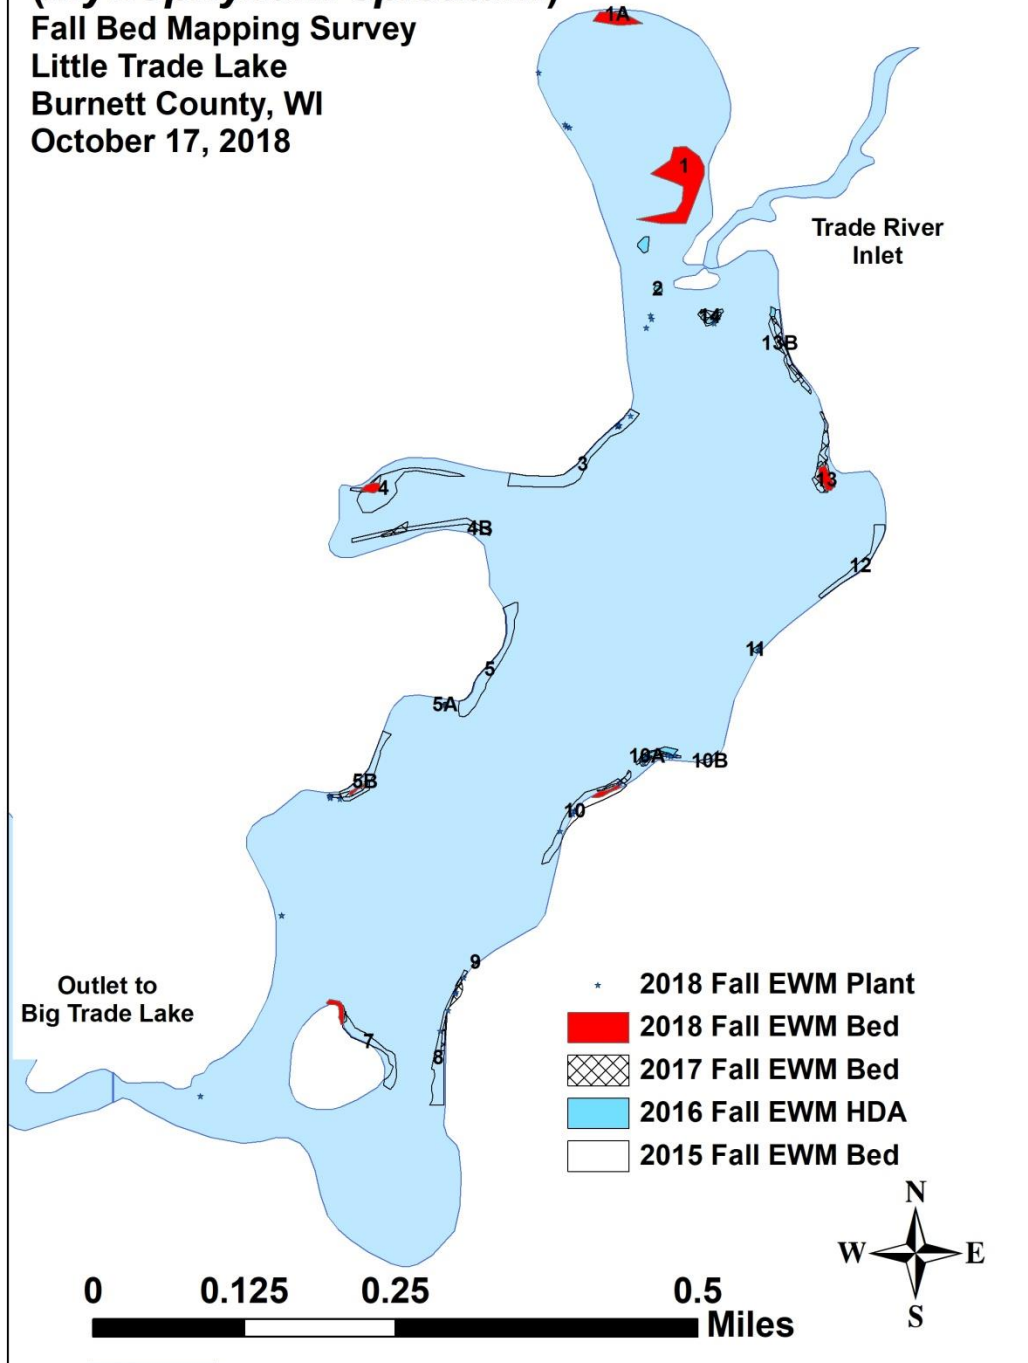
Fall Bed Mapping Survey
Little Trade Lake
Burnett County, WI
October 17, 2018

On October 17th, 2018, we mapped seven Eurasian water-milfoil beds totaling 1.40 acres or 1.11% of the lake's total surface area (Table 5). Outside of these areas, we marked 44 additional EWM plants (Figure 3) (Appendix VIII). This total was an increase of 0.31 acres (+28.44%) from the 14 small beds totaling 1.09 acres (0.87% coverage) mapped in 2017, and it was also higher than the 0.34 acre (0.27% coverage) we mapped in 2016; however, it was still well below the recent peak of 4.23 acres (3.36% coverage) mapped in fall 2015.

Beds 1 and 2 – The north bay has historically been one of the worst places on the lake, and, after a year without management, we found the area contained nearly continuous Eurasian water-milfoil towers that were actively fragmenting in water up to 5ft deep. Although the majority of increase in acreage on the lake occurred in this area, most of the “bed” was still technically better described as a high density area.

Bed 1A – In 2017, this bed was little more than a tiny super cluster of plants. Following a dramatic expansion, regular EWM clusters were now present along almost a quarter of the northern shoreline of the north bay. These plants were still somewhat fragmented, but they were merging into microbeds rather than being just isolated towers as we saw in the past.

Bed 3 – Five plants were found in Bed 3 just southwest of the point on the western shoreline at the entrance to the north bay.

Beds 4 and 4B – The treatment was highly successful at knocking EWM back throughout the majority of the western midlake bay. Unfortunately, we found a few dozen large plants had already formed a small canopied mat and were recolonizing the northwest corner of Bed 4 just off the end of a resident’s dock. Several of them showed evidence of being prop-clipped, and this likely explained the rapid expansion north of the largest plants.

Beds 5 and 5A – We didn’t see any EWM in the area formerly covered by Bed 5; however, we rake removed two plants in bed 5A.

Bed 5B – In this area, we found a small dense canopied microbed with 10-15 well-established plants that were expanding near the end of a resident’s dock.

Bed 6 – Two single-stemmed EWM plants were found and removed from this area.

Bed 7 – A canopied mat again occurred on the northwest end of the island in <2.5ft of water near shore. This trouble spot might be an ideal candidate for manual removal.

Beds 8 and 9 – We found a total of five large towers along this narrow littoral shoreline.

Beds 10 and 10A – These two areas again had scattered individual plants, and there was a microbed on the northeast end of Bed 10. This area continues to have a significant amount of Northern water-milfoil (*Myriophyllum sibiricum*) mixed in with the EWM.

Beds 10B, 11, 12 – We rake removed the only two EWM plants found along the northeast shoreline.

Beds 13 and 13B – On the northeast point, Bed 13 was again the worst area on the lake. EWM formed a near mat of canopied plants at the core before declining on the periphery and disappearing altogether in the area formerly covering Bed 13B.

Bed 14 – We found four near-canopied plants on the sandbar near the river inlet.
