**Curly-leaf Pondweed (*Potamogeton crispus*) and Eurasian Water-milfoil (*Myriophyllum spicatum*)
Pre/Post Herbicide and Fall EWM Bed Mapping Surveys
Long Trade Lake – WBIC: 2640500
Polk County, Wisconsin**

Endangered Resource Services, LLC
Matthew S. Berg, Research Biologist
St. Croix Falls, Wisconsin
May 19, June 25, and October 15, 2018

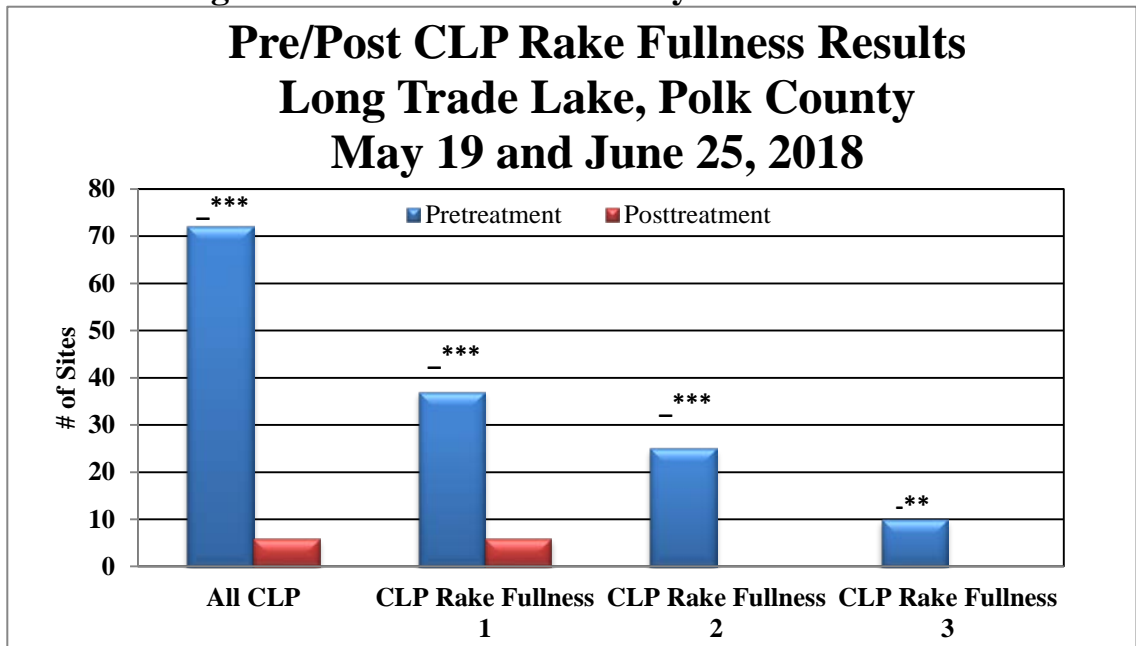
Figure 9: Pre/Post Changes in CLP Rake Fullness

We found Curly-leaf pondweed at 72 of 115 sites during the pretreatment survey (62.6% coverage) (Figure 8). Of these, ten had a rake fullness rating of 3, 25 rated a 2, and the remaining 37 were a 1. This produced a mean rake fullness of 1.63 and suggested that 30.4% of the treatment area had a significant infestation (rake fullness 2 and 3). During the posttreatment survey, we found CLP at just six points (5.2%) all of which rated a 1. **Our results demonstrated a highly significant decline in total CLP as well as rake fullness 2 and 1; and a moderately significant decline in rake fullness 3** (Figure 9) (Appendix V).

Significant differences = * $p < 0.05$, ** $p < 0.01$, *** $p < 0.001$

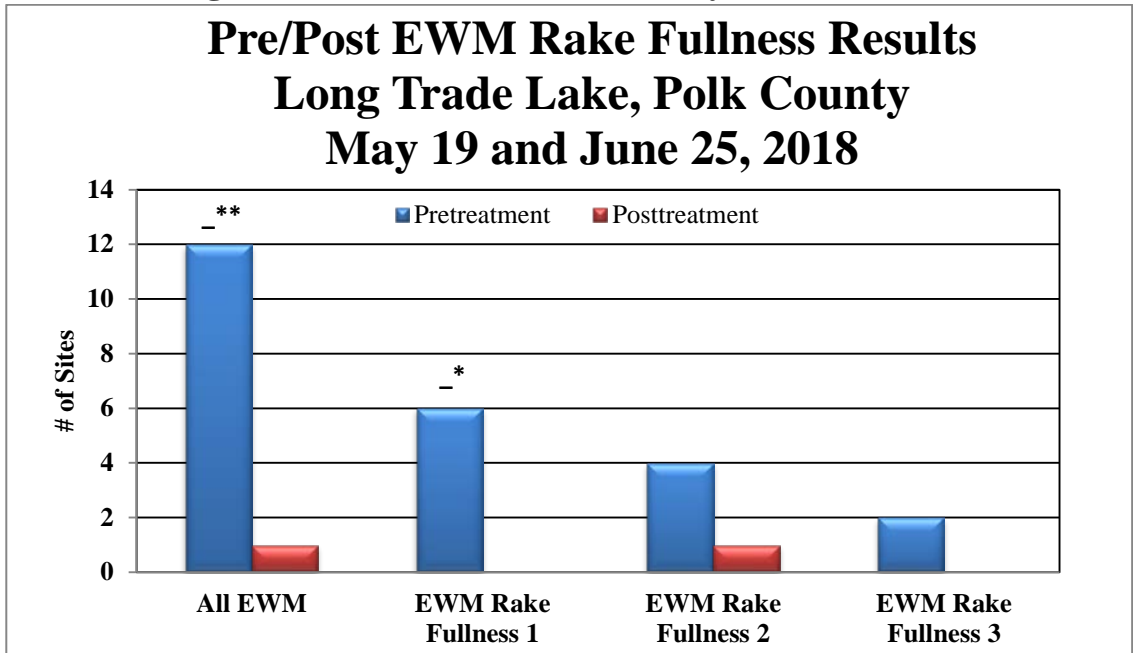
Figure 11: Pre/Post Changes in EWM Rake Fullness

Eurasian water-milfoil was present at 12 of 115 points (10.4% coverage) during the pretreatment survey. We rated two points a 3, four a 2, and six a 1. This produced a mean rake fullness of 1.67 and extrapolated to 5.2% of the treatment area having a significant infestation (rake fullness 2 and 3). During the posttreatment survey, we found EWM at a single point (0.9%) although it was a sizable tower that we rated a 2 prior to rake removing it (Figure 10). This overall reduction was moderately significant for total EWM, and significant for rake fullness 1 (Figure 11) (Appendix V).

Significant differences = * $p < 0.05$, ** $p < 0.01$, *** $p < 0.001$

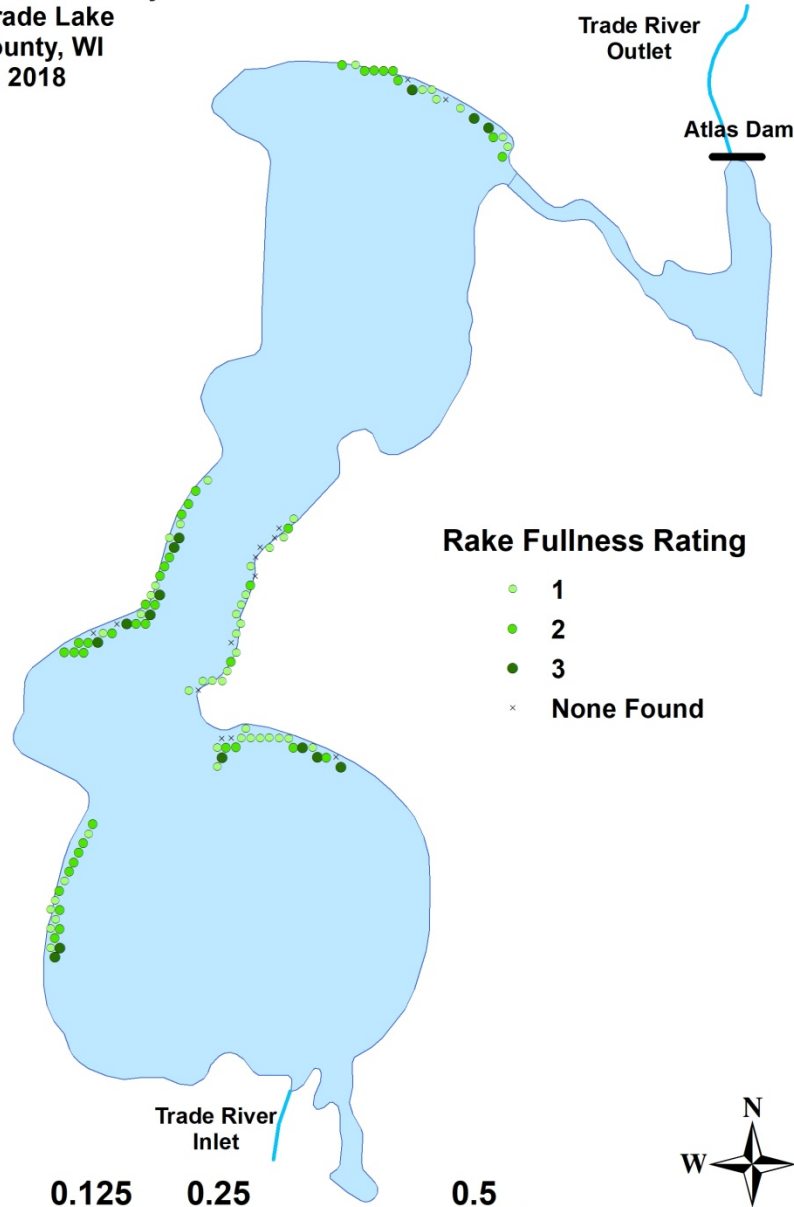
Pretreatment Survey
Long Trade Lake
Polk County, WI
May 19, 2018

Total Rake Fullness

Rake Fullness Rating

- 1
- 2
- 3
- × None Found

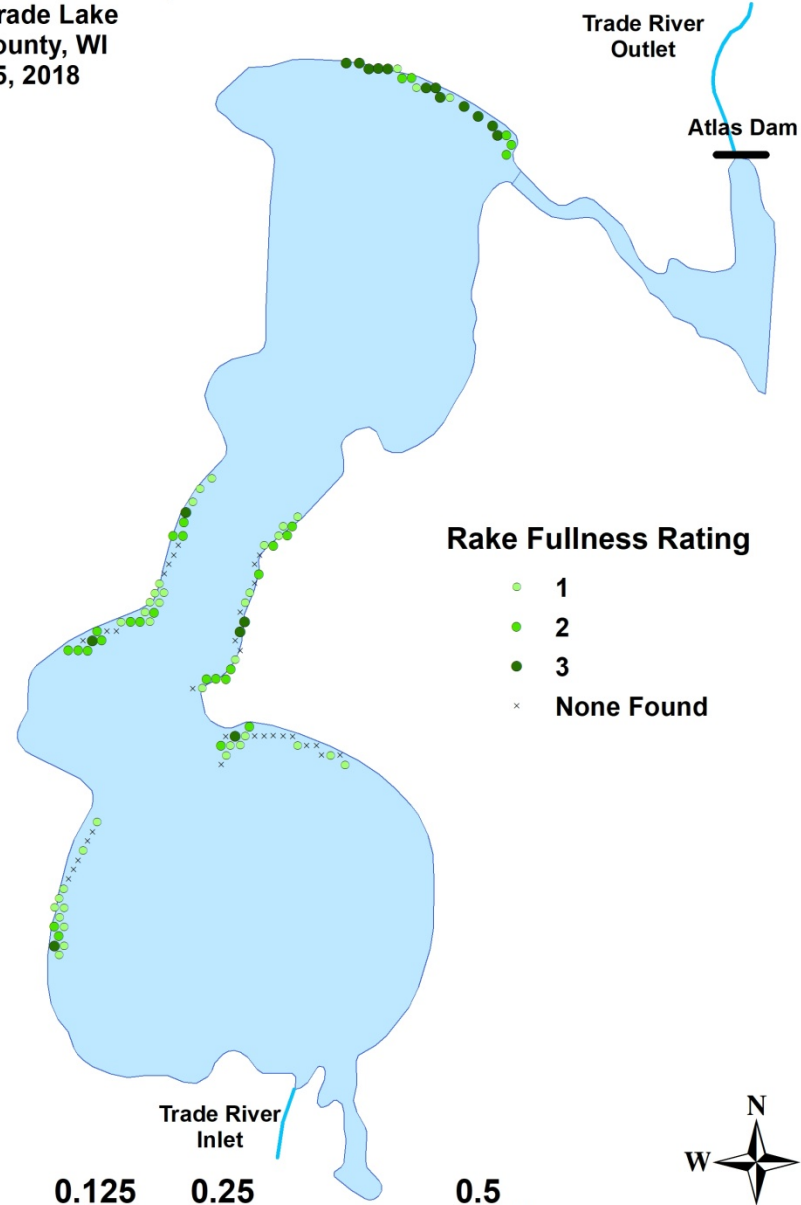
Posttreatment Survey
Long Trade Lake
Polk County, WI
June 25, 2018

Total Rake Fullness

Rake Fullness Rating

- 1
- 2
- 3
- × None Found

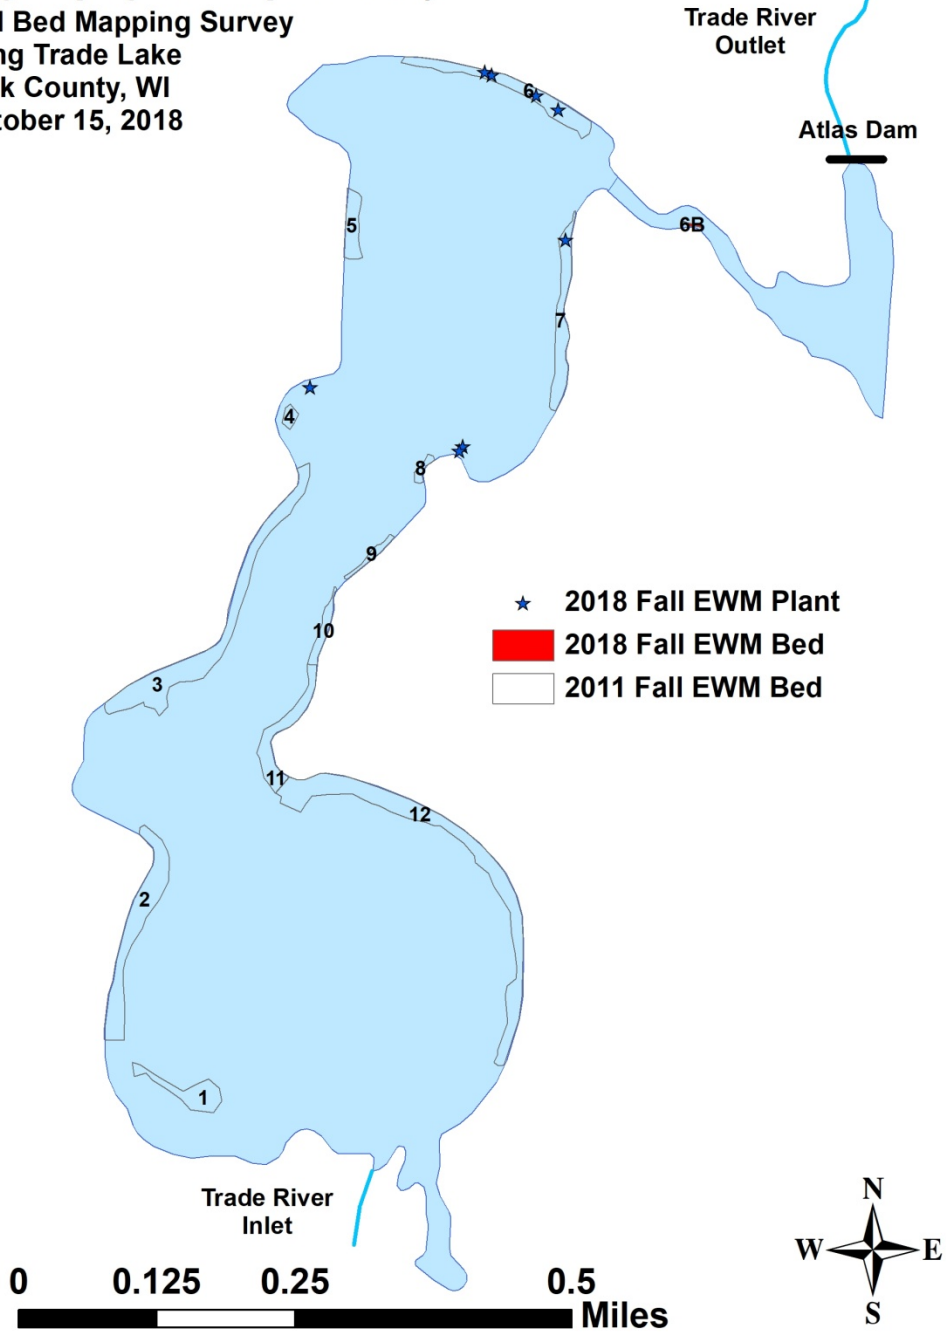
Fall Bed Mapping Survey
Long Trade Lake
Polk County, WI
October 15, 2018

Eurasian water-milfoil (*Myriophyllum spicatum*)

During the October 15th survey, we found that Eurasian water-milfoil was almost undetectable as we located and rake removed just eight plants throughout the main lake. The only bed present occurred in the outlet channel, had fewer than 100 plants, and covered just 0.02 acre (Bed 6B) (Figure 15) (Appendix VIII). This represented a 98% decline in acreage from the fall 2017 survey (Table 5).

Bed 6B and Mill Pond – A small bed had regrown in the shallow area just before the old bridge. This spot seems to naturally filter out fragments as it's always the first place in the outlet channel to reestablish. Other than this, we saw no evidence of EWM in the rest of the outlet or the Mill Pond suggesting residual herbicide flowing downstream was enough to knock plants out in these areas.
