**Eurasian Water-milfoil (*Myriophyllum spicatum*)
Pre/Post Herbicide and EWM Bed Mapping Surveys
Round Lake – WBIC: 2640100
Burnett County, Wisconsin**

Project Initiated by: Round-Trade Lakes Improvement Association Inc.,
Lake Education and Planning Services, LLC, and the
Wisconsin Department of Natural Resources (Grant ACEI21618)

Endangered Resource Services, LLC
Matthew S. Berg, Research Biologist
St. Croix Falls, Wisconsin
May 14, June 18, and August 29, 2020

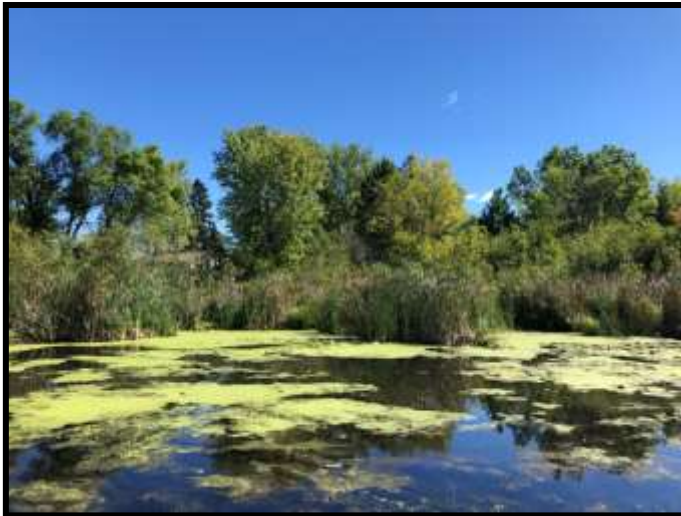
Purple loosestrife and Hybrid cattail in the Trade River Inlet (8/29/20)

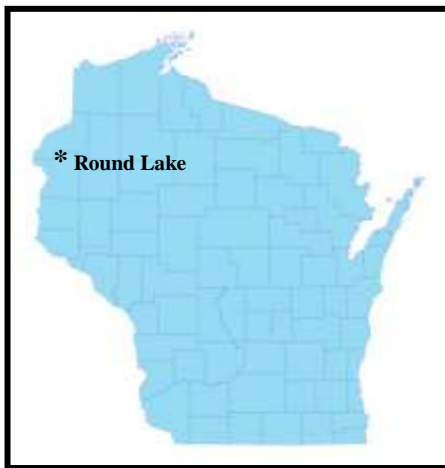
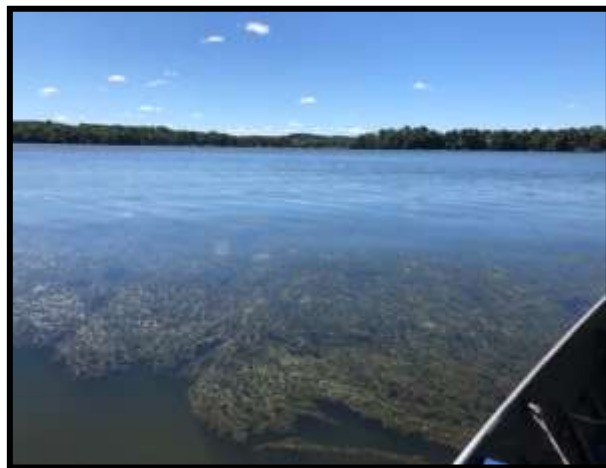
Canopied Eurasian water-milfoil bed at the lake outlet (8/29/20)

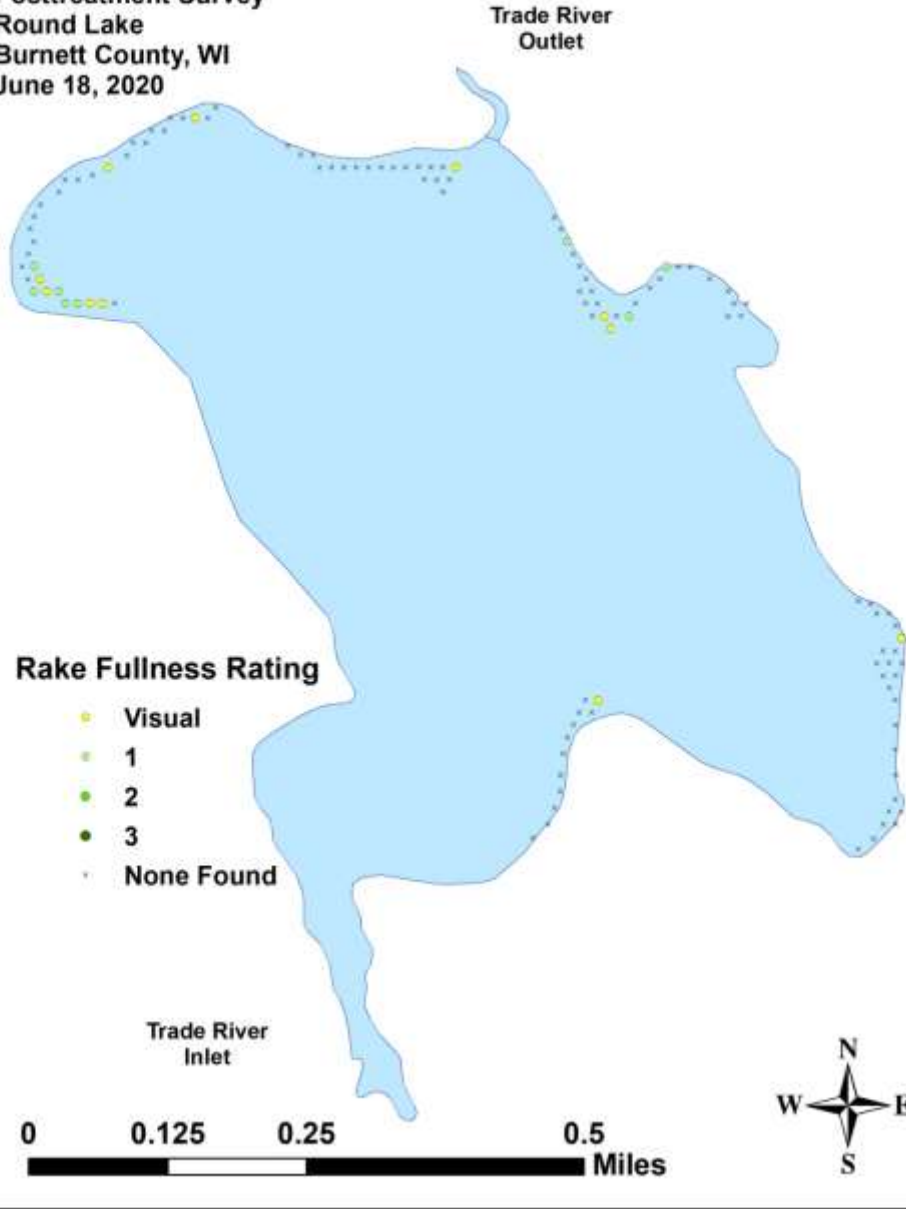
Exotic Species
Posttreatment Survey
Round Lake
Burnett County, WI
June 18, 2020

Curly-leaf pondweed (*Potamogeton crispus*)

We didn't find Curly-leaf pondweed at any point during the pretreatment survey, and, consequently, the treatment in Area 6 was cancelled (Figure 8). During the posttreatment survey, CLP was present at eight points (7.0% coverage) all of which rated a 1. We also noted 11 visual sightings. **Our results indicated a moderately significant increase ($p=0.004$) in total distribution and rake fullness 1; and a highly significant increase ($p<0.001$) in visual sightings** (Figure 9). Despite these increases, CLP was seldom more than a few canopied plants, and we didn't see any areas where it was bed forming or likely a significant impairment to navigation (Appendix V).

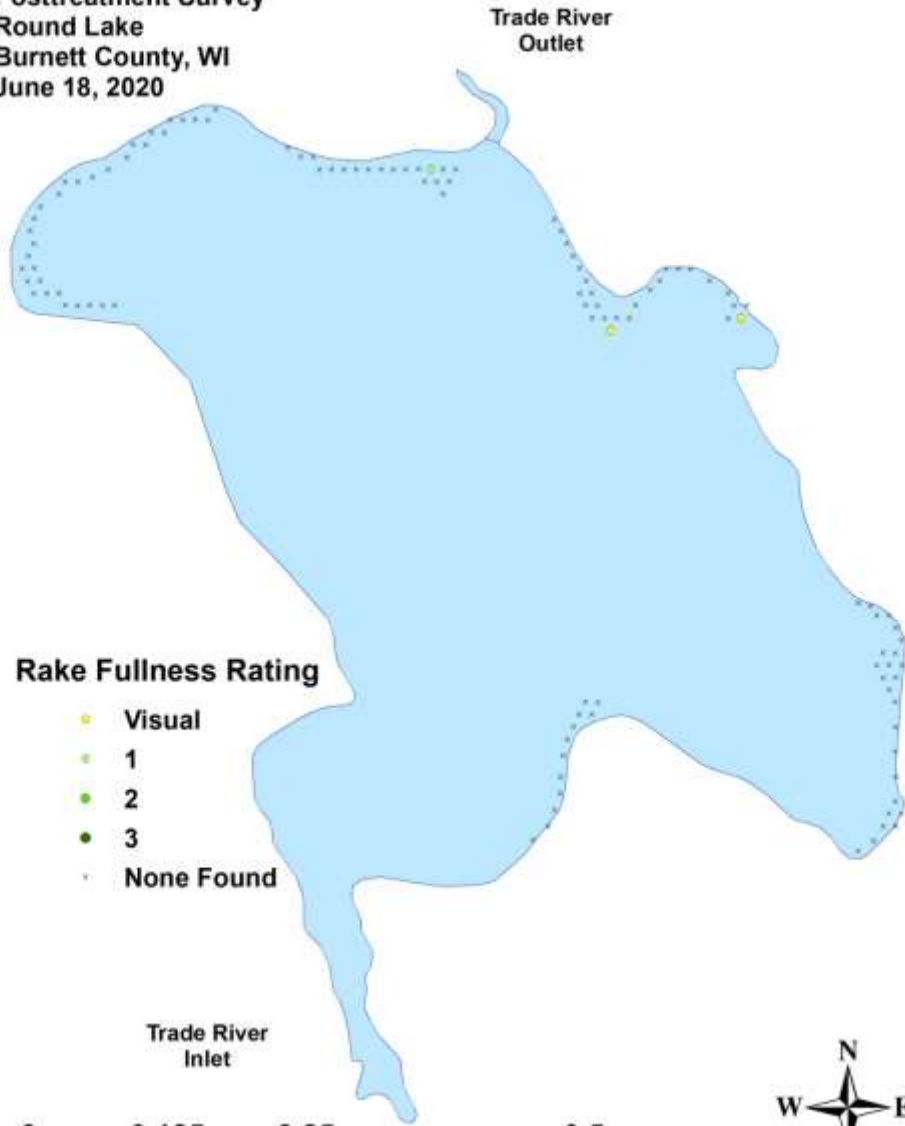
Exotic Species
Posttreatment Survey
Round Lake
Burnett County, WI
June 18, 2020

Eurasian water-milfoil (*Myriophyllum spicatum*)

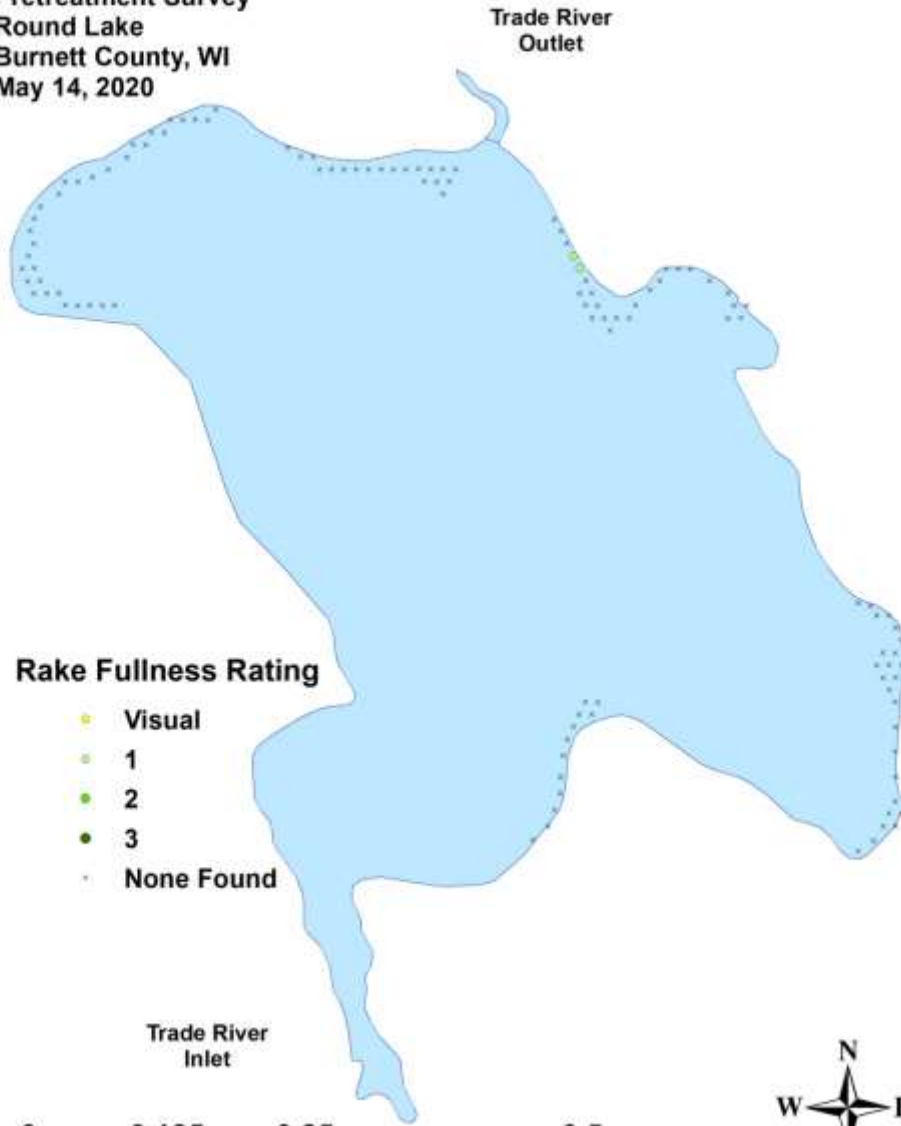
Coefficient of Conservatism = 6
Pretreatment Survey
Round Lake
Burnett County, WI
May 14, 2020

Water star-grass (*Heteranthera dubia*)

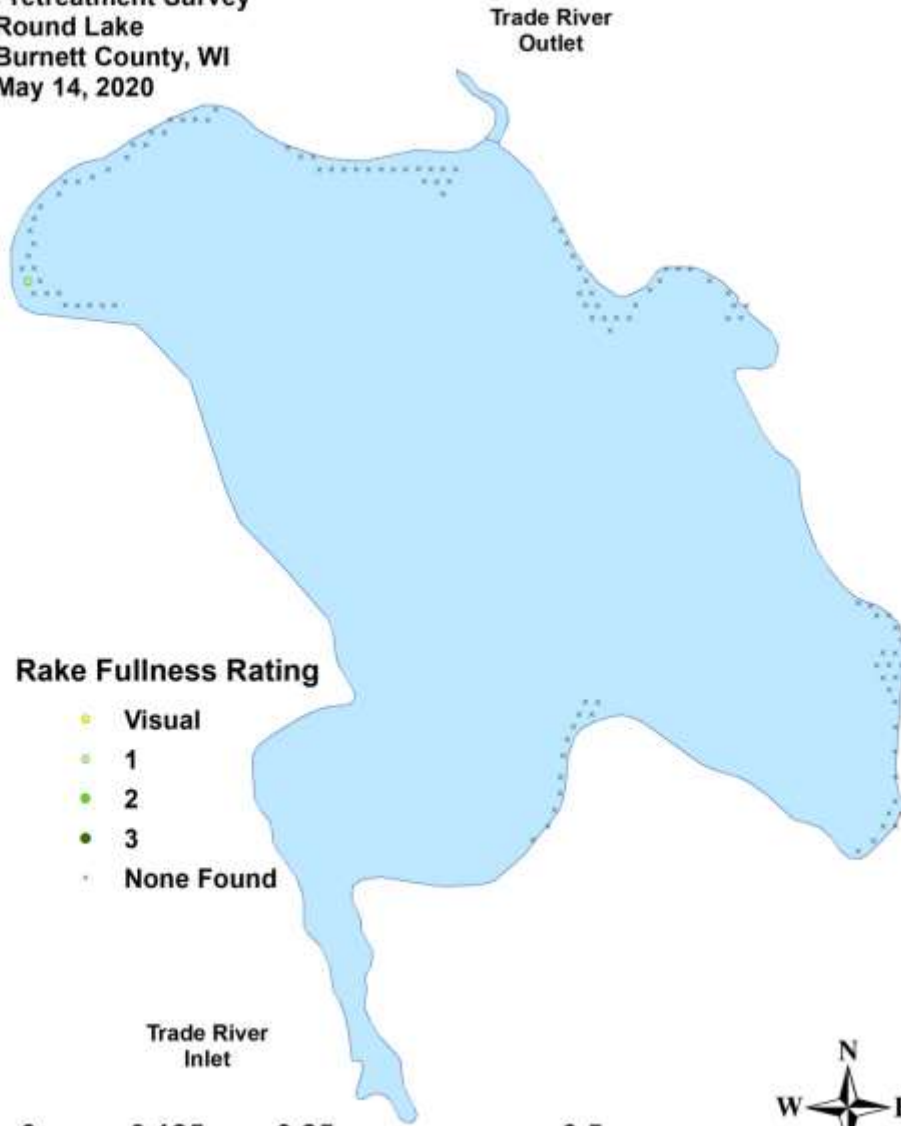
Coefficient of Conservatism = 6
Pretreatment Survey
Round Lake
Burnett County, WI
May 14, 2020

White water lily (*Nymphaea odorata*)

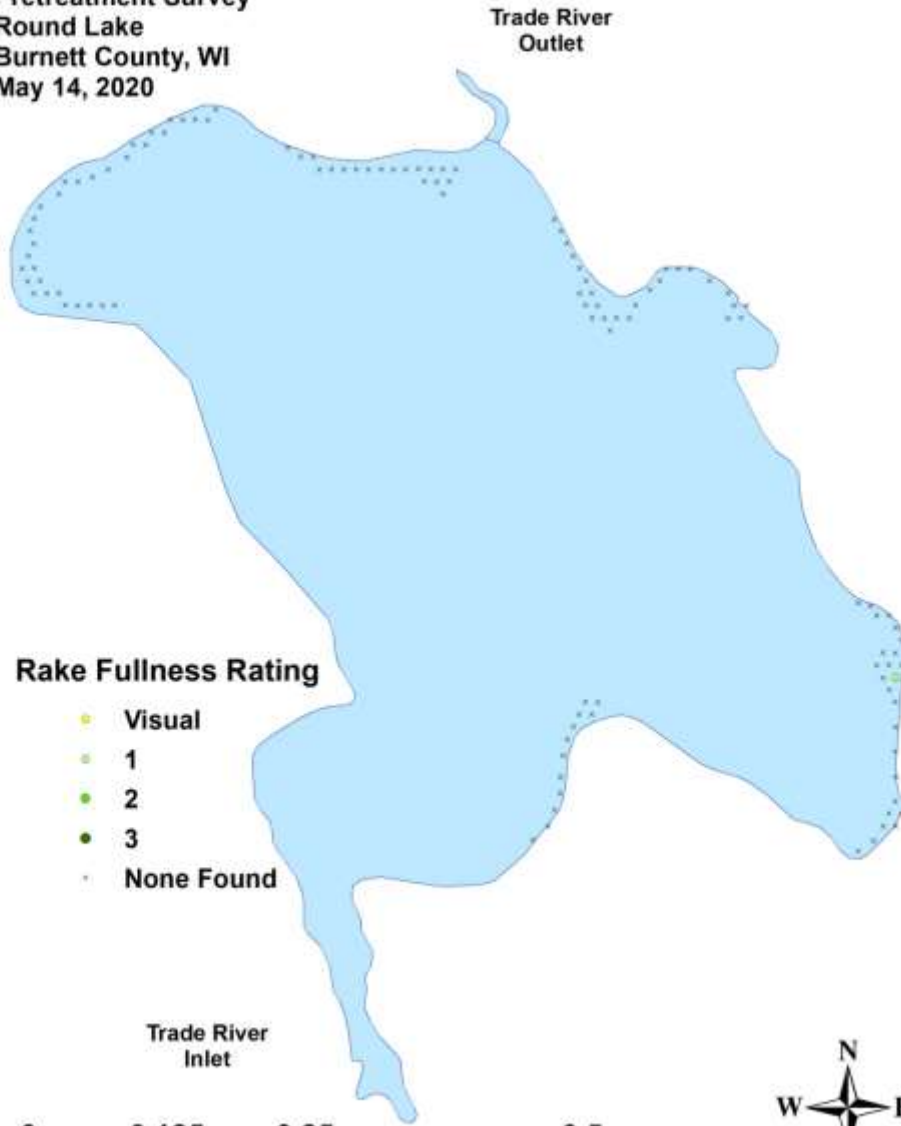
Coefficient of Conservatism = 5
Pretreatment Survey
Round Lake
Burnett County, WI
May 14, 2020

Clasping-leaf pondweed (*Potamogeton richardsonii*)

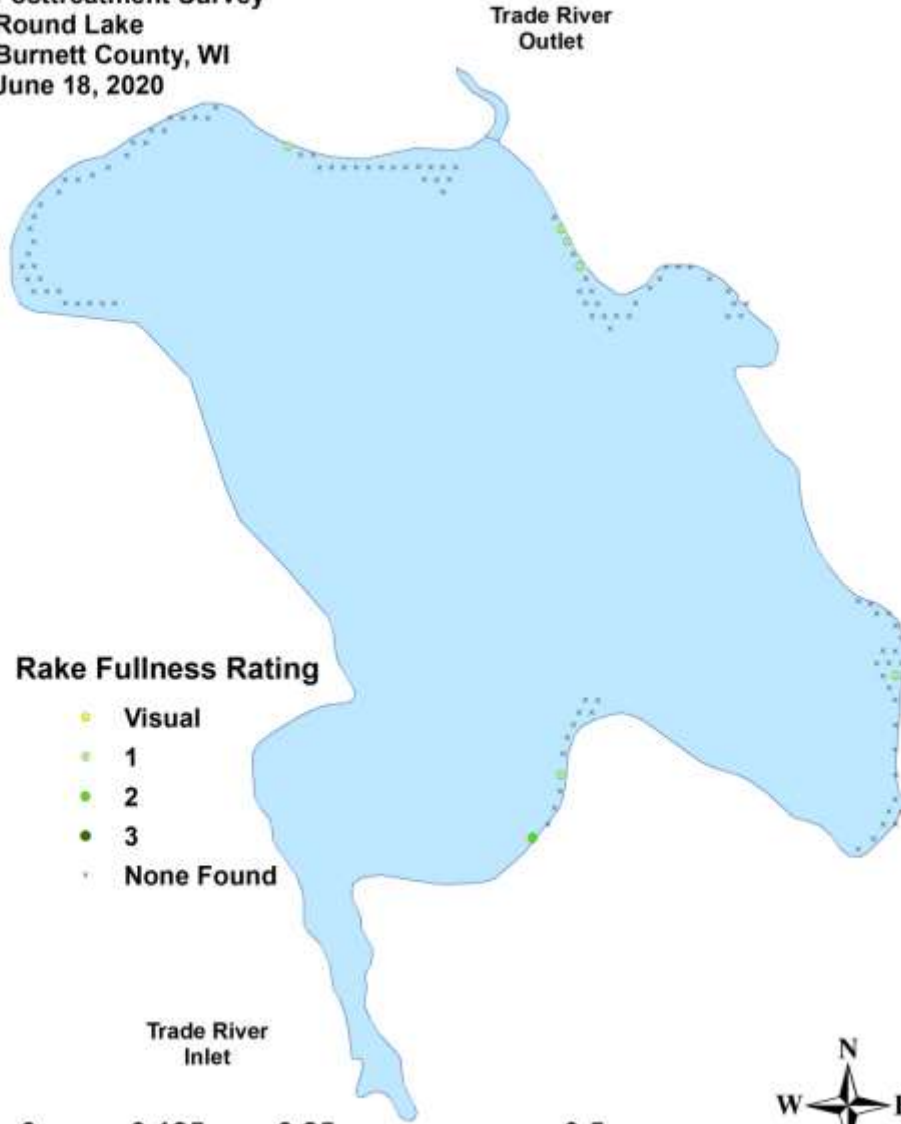
Coefficient of Conservatism = 6
Posttreatment Survey
Round Lake
Burnett County, WI
June 18, 2020

Water star-grass (*Heteranthera dubia*)

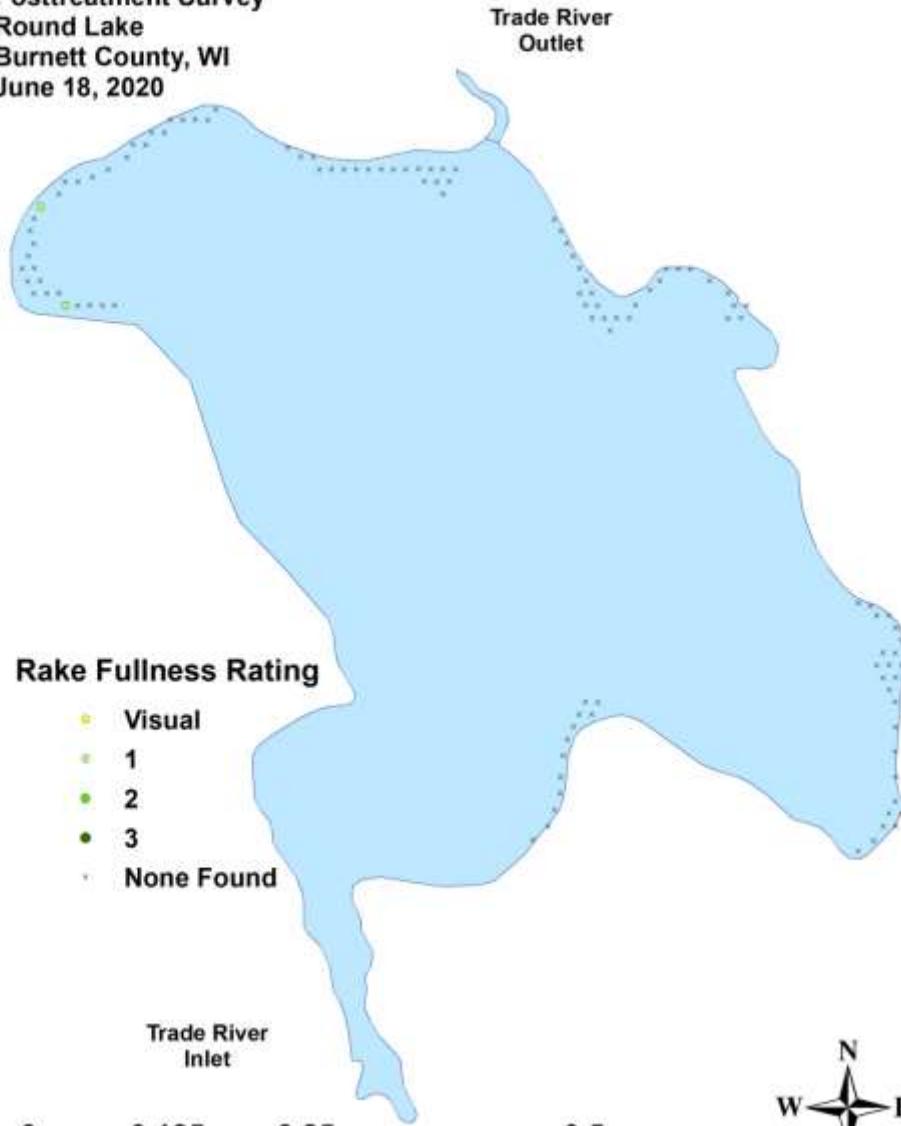
Coefficient of Conservatism = 6
Posttreatment Survey
Round Lake
Burnett County, WI
June 18, 2020

**Slender naiad
(*Najas flexilis*)**

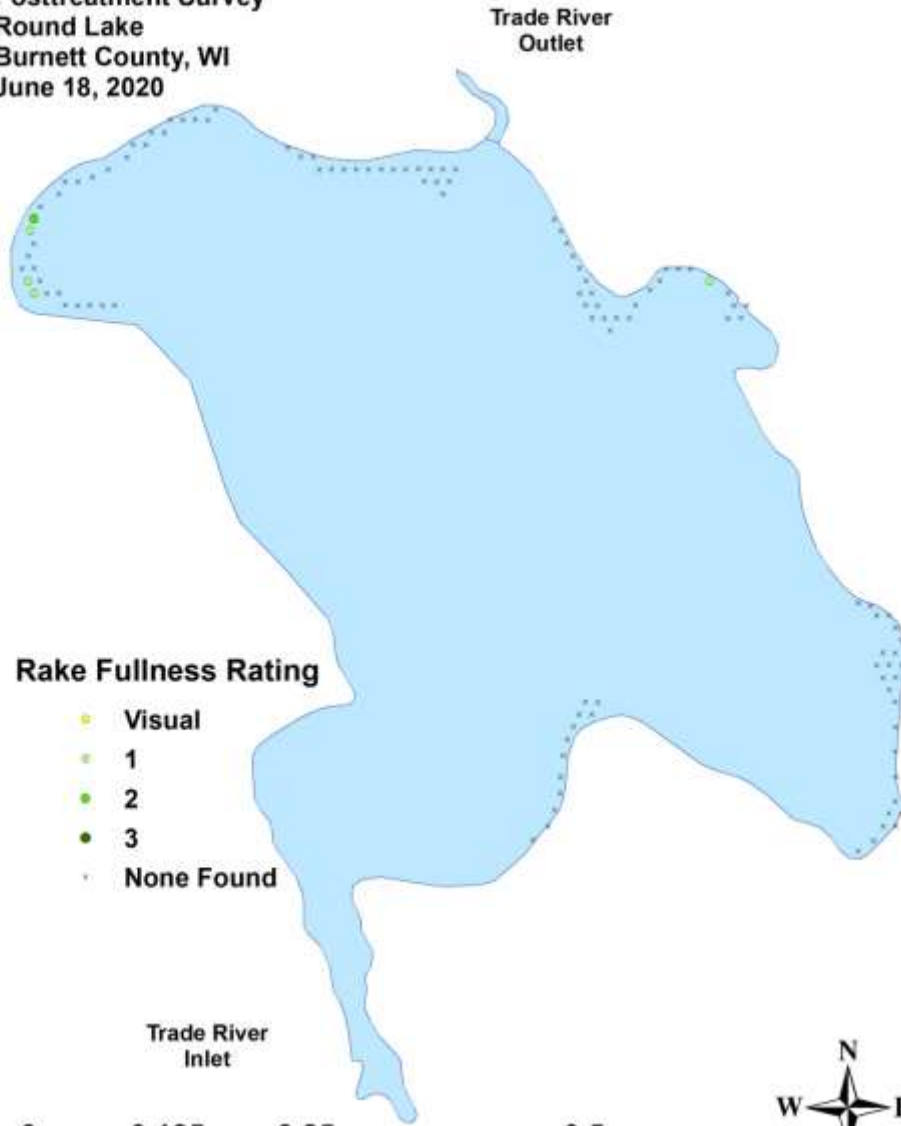
Coefficient of Conservatism = 6
Posttreatment Survey
Round Lake
Burnett County, WI
June 18, 2020

**White water lily
(*Nymphaea odorata*)**

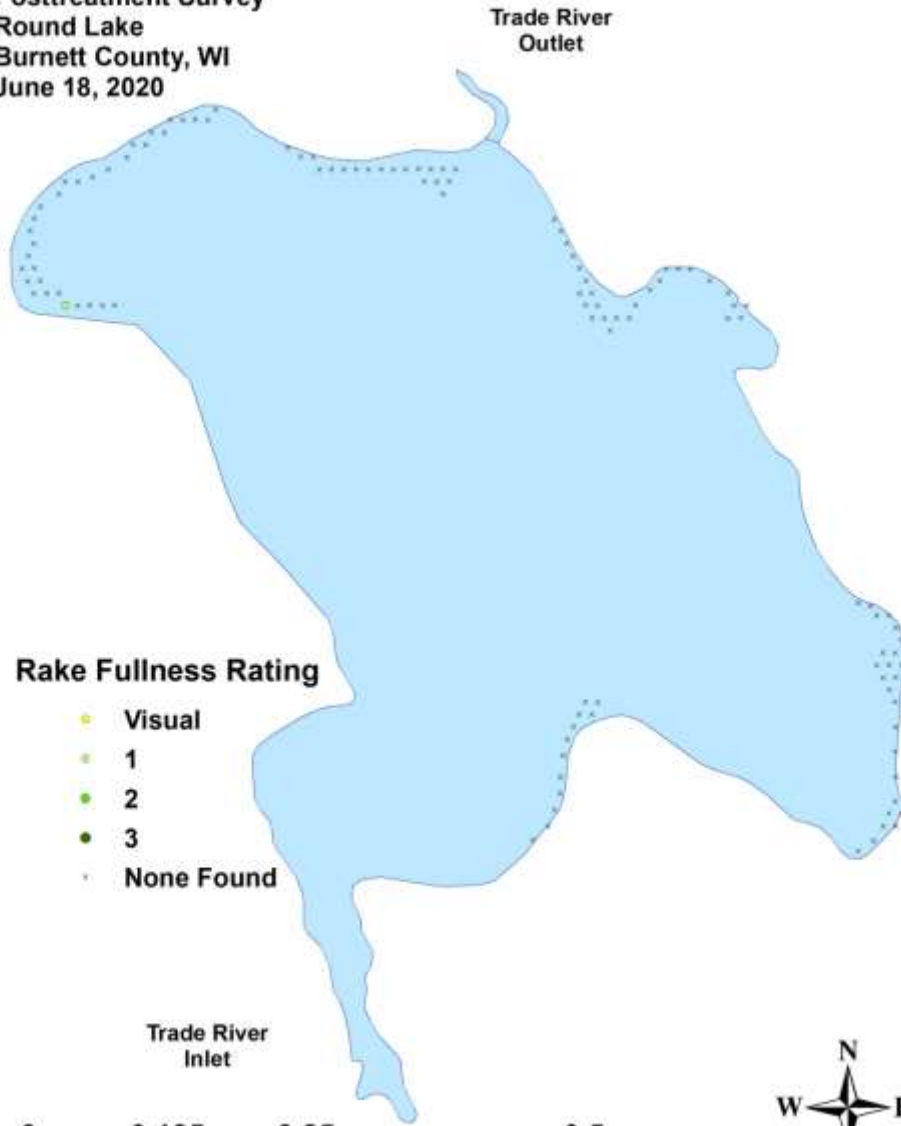
Coefficient of Conservatism = 6
Posttreatment Survey
Round Lake
Burnett County, WI
June 18, 2020

Leafy pondweed (*Potamogeton foliosus*)

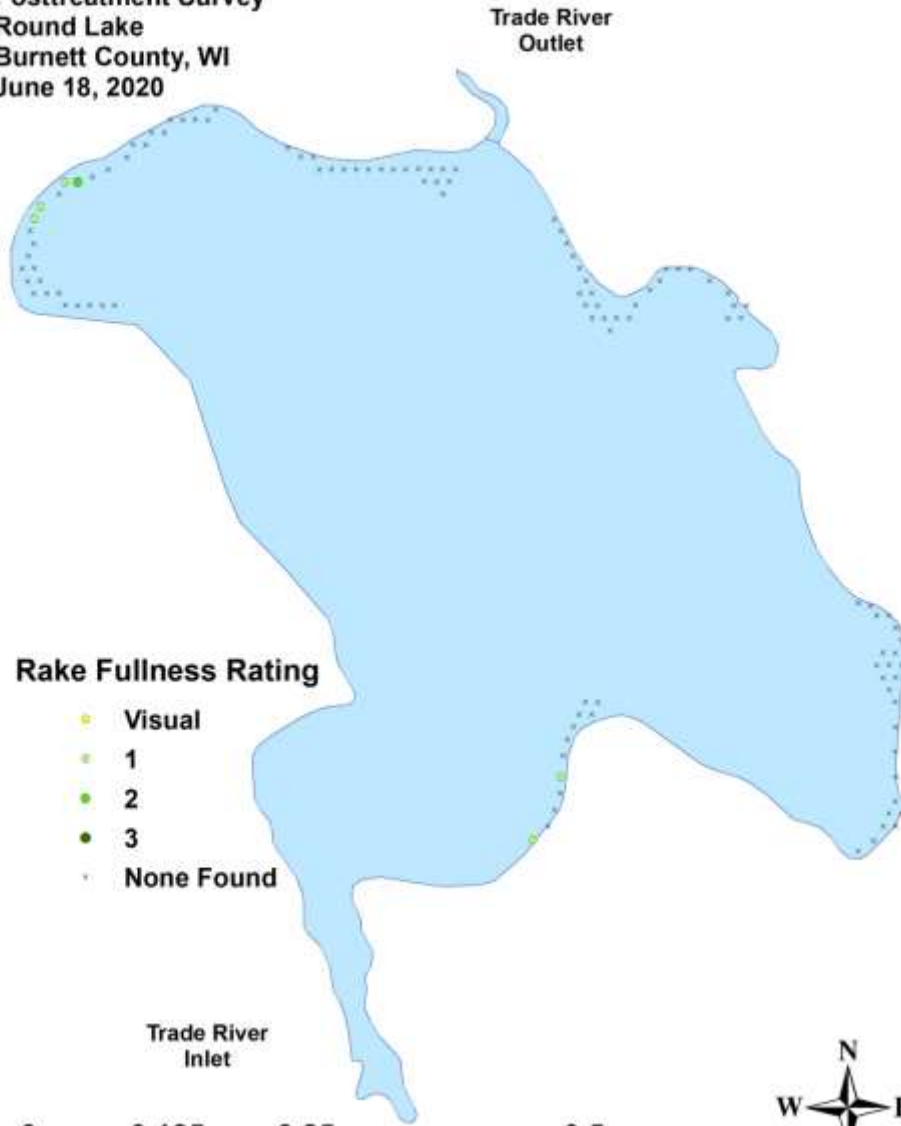
Coefficient of Conservatism = 7
Posttreatment Survey
Round Lake
Burnett County, WI
June 18, 2020

Long-leaf pondweed (*Potamogeton nodosus*)

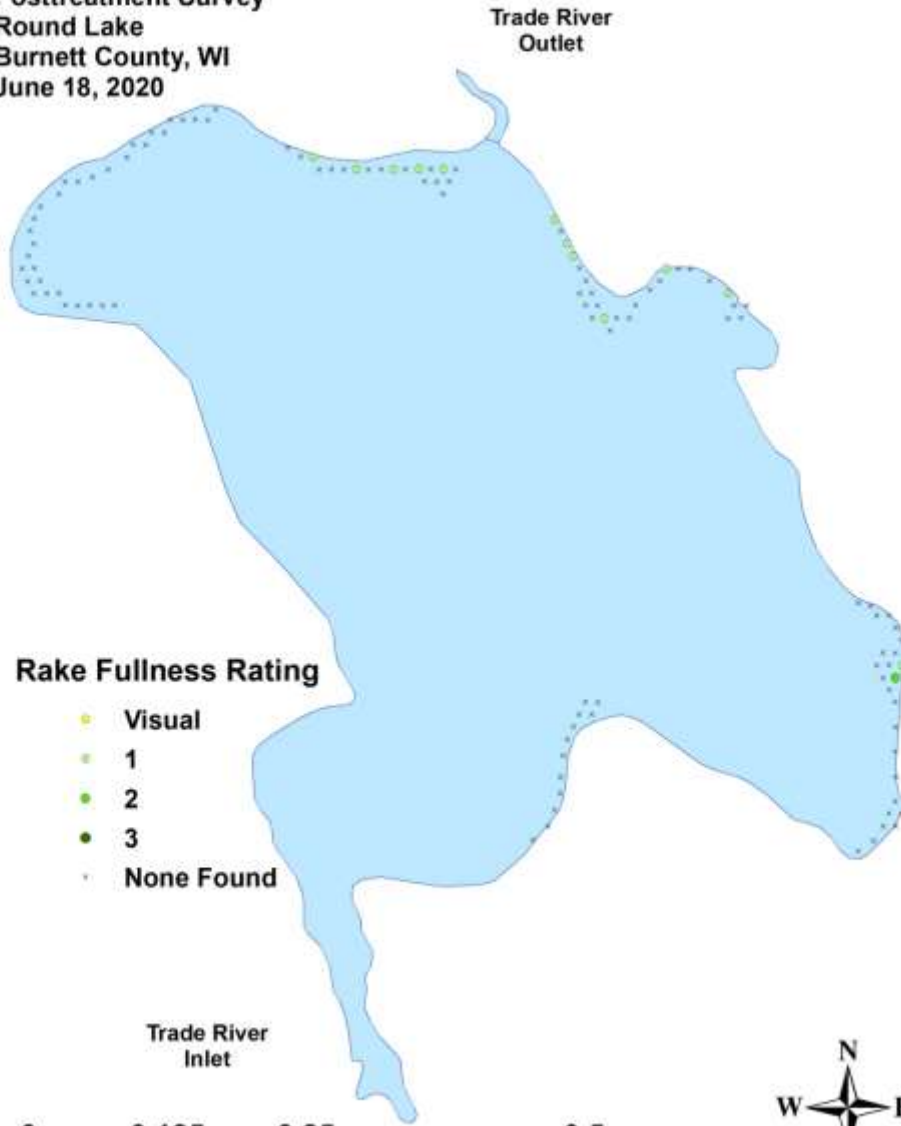
Coefficient of Conservatism = 6
Posttreatment Survey
Round Lake
Burnett County, WI
June 18, 2020

Wild celery
(*Vallisneria americana*)

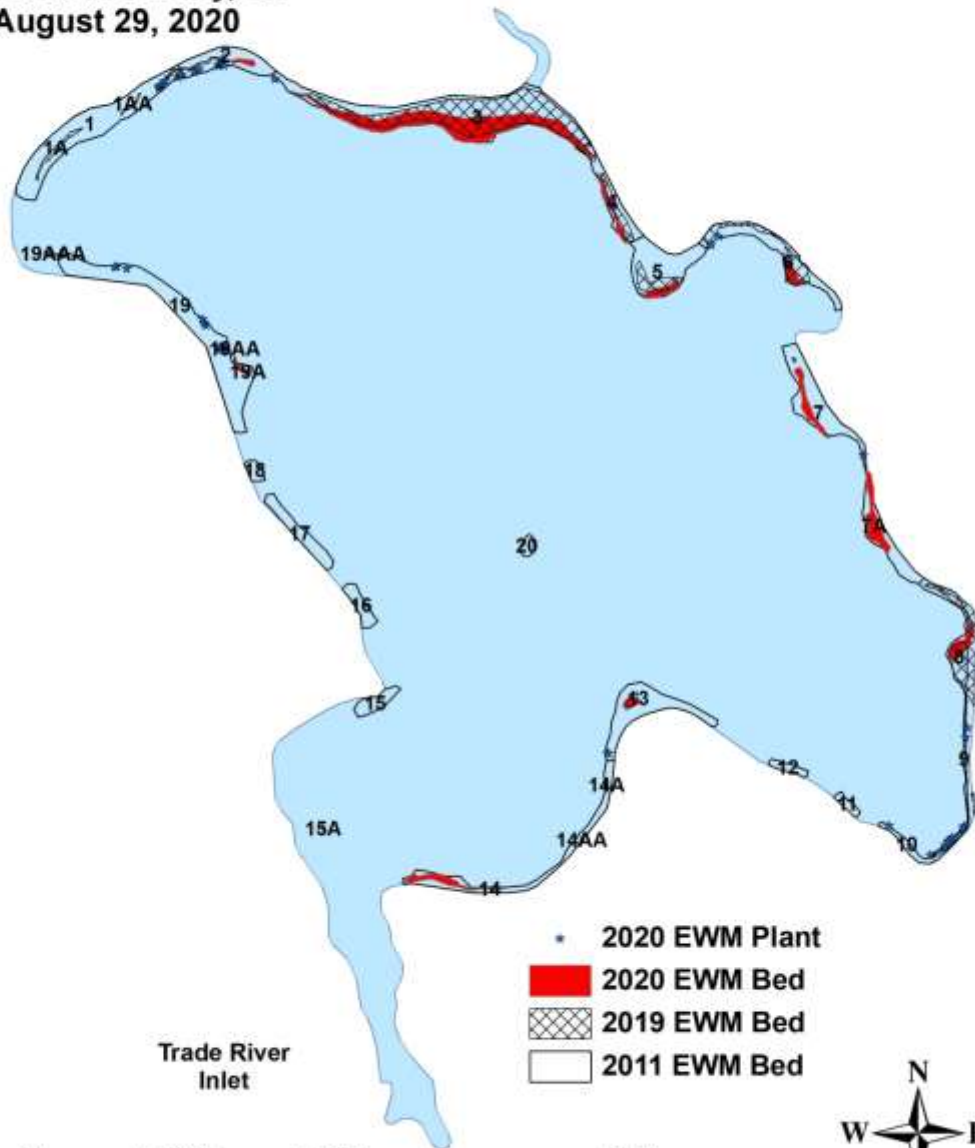
EWM Bed Mapping Survey
Round Lake
Burnett County, WI
August 29, 2020

Eurasian water-milfoil (*Myriophyllum spicatum*)

During the August survey, we located and mapped 12 areas ranging in size from 0.01 acre (Bed 15A) to 1.67 acres (Bed 3) (Figure 15) (Appendix VIII). Collectively, these beds covered 2.95 acres (1.42% of the lake's surface area) (Table 5). This was a decrease of 1.65 acres (-35.87%) from the 7 areas covering 4.60 acres (2.21% of the lake's surface area) we mapped in 2019, but it was still more than the seven areas totaling 2.18 acres (1.05% coverage) found in 2018 and the 15 beds totaling 2.76 acres (1.28% coverage) in 2017. However, it was lower than the recent high of 7.57 acres (3.64% coverage) mapped in 2016 (Table 6). Outside these beds, EWM was relatively uncommon and scattered as we marked a total of 43 additional plants throughout the rest of the lake.
