**Eurasian Water-milfoil (*Myriophyllum spicatum*)  
Meandering Littoral Zone Survey  
Horseshoe Lake (WBIC: 2470000)  
Washburn County, Wisconsin**

Endangered Resource Services, LLC  
Matthew S. Berg, Research Biologist  
St. Croix Falls, Wisconsin  
September 22, 2019

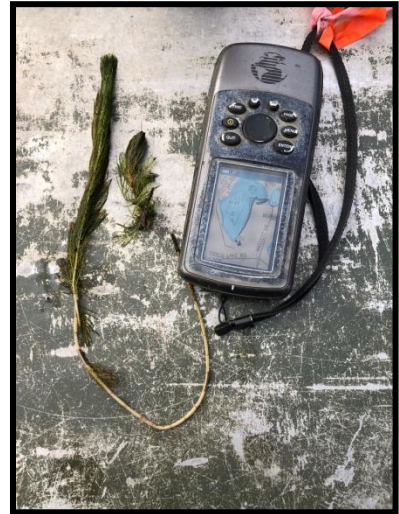
Small rooted EWM plant raked out of "nook" 9/28/19

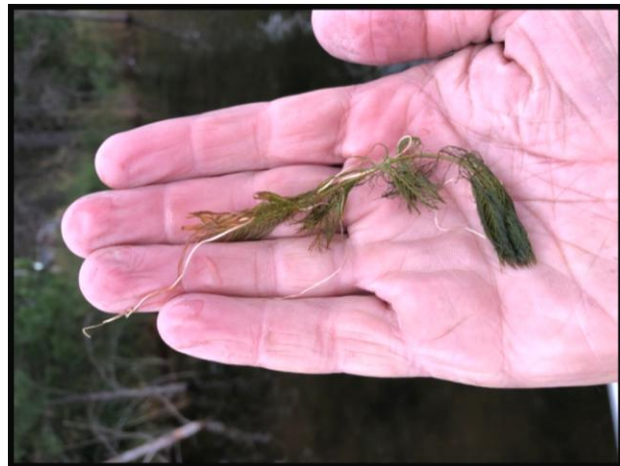
EWM fragment found on the north shoreline of the west basin 9/28/19

Although it is possible the fragments found on the north end of the west basin drifted out of the “nook” bay, it seems more likely there is an as of yet undiscovered bed somewhere in deeper water. Hopefully the planned point-intercept survey in July of 2020 will locate any such bed. However, an earlier search might be warranted if clarity improves in the spring; especially if treating any newly discovered bed in 2020 is desired. Ultimately, the HLPOA, LEAPS, and the Wisconsin Department of Natural Resources will have to decide on a course of action. In the meantime, lake residents should remain on the lookout for any signs of EWM. If they discover a plant they even suspect may be EWM, we strongly encourage them to **immediately** contact Matthew Berg, ERS, LLC Research Biologist at 715-338-7502 and/or Alex Smith/Pamela Toshner, Regional Lakes Management Coordinators in the Spooner DNR office at 715-635-4073 for identification confirmation. If possible, a specimen, a jpg, and the accompanying GPS coordinates of the location should be included. Texting pictures from a smartphone is actually ideal as it give immediate feedback. Likewise, we are happy to identify ANY plant a lake resident finds that they may want identified.
