# Eurasian water-milfoil (*Myriophyllum spicatum*) Pre/Posttreatment and Meandering Shoreline Surveys Horseshoe Lake (WBIC: 2470000) Washburn County, Wisconsin

Endangered Resource Services, LLC  
Matthew S. Berg, Research Biologist  
St. Croix Falls, Wisconsin  
May 22, July 7, and September 5, 2021

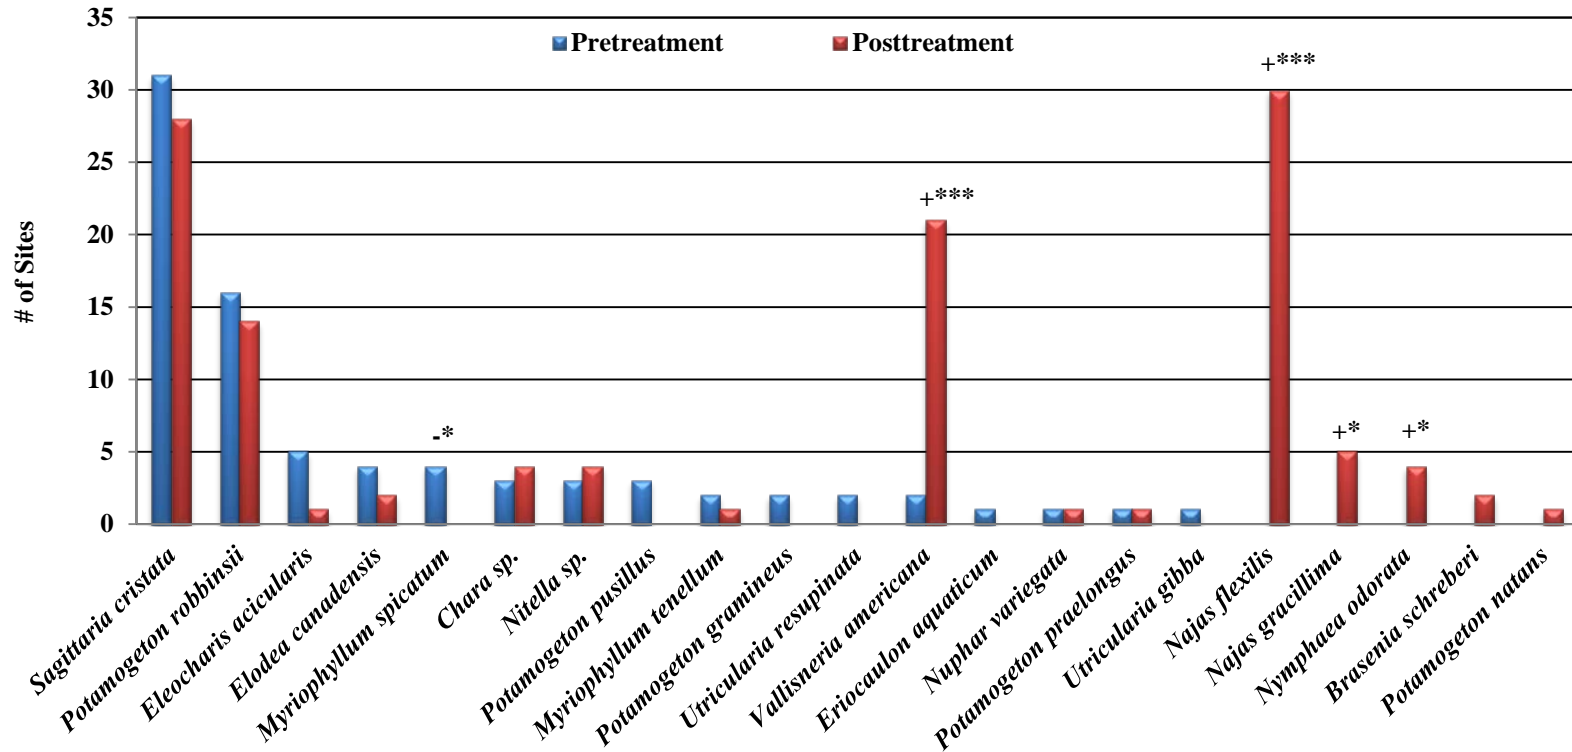
**Figure 12: Pre/Posttreatment Macrophyte Changes**

Eurasian water-milfoil was the only species that showed a significant decline in distribution posttreatment. Conversely, Slender naiad (*Najas flexilis*) and Wild celery (*Vallisneria spiralis*), two late-growing species that were just germinating during the pretreatment survey, each enjoyed highly significant expansions ( $p < 0.001$ ) to become the most common and third most common species posttreatment. Northern naiad (*Najas gracillima*) and White water lily (*Nymphaea odorata*) also demonstrated significant increases ( $p = 0.02/p = 0.04$ ) in distribution (Figure 12) (Maps for all native species from the pre and posttreatment surveys can be found in Appendixes VI and VII).

Significant differences = \*  $p < 0.05$ , \*\*  $p < 0.01$ , \*\*\*  $p < 0.001$

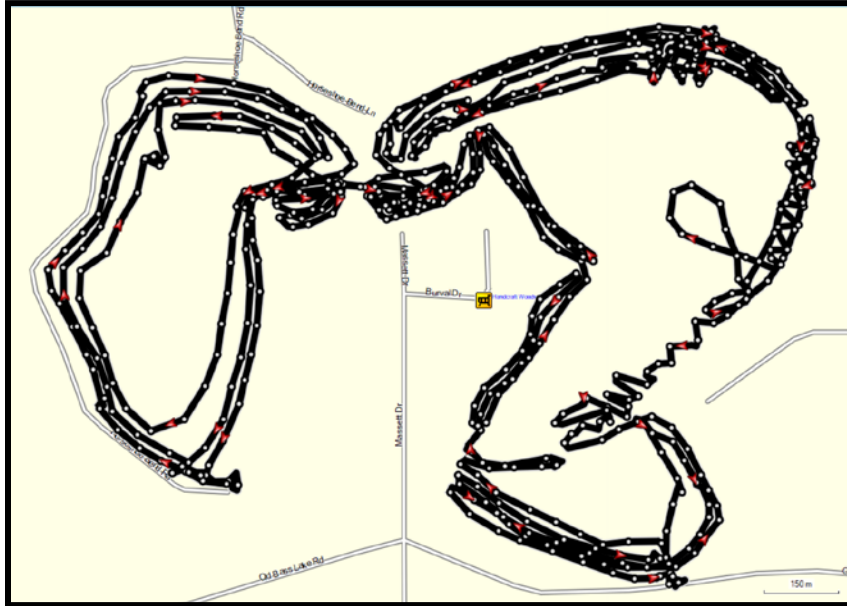
**Figure 13: September 5, 2021 Shoreline Survey Tracks**

On September 5<sup>th</sup>, we returned to the lake to look for evidence of surviving EWM. Water clarity continued to be good, and, with calm conditions, we could see down approximately 10ft. We covered transects totaling 24.3km (15.1 miles) (Figure 13).

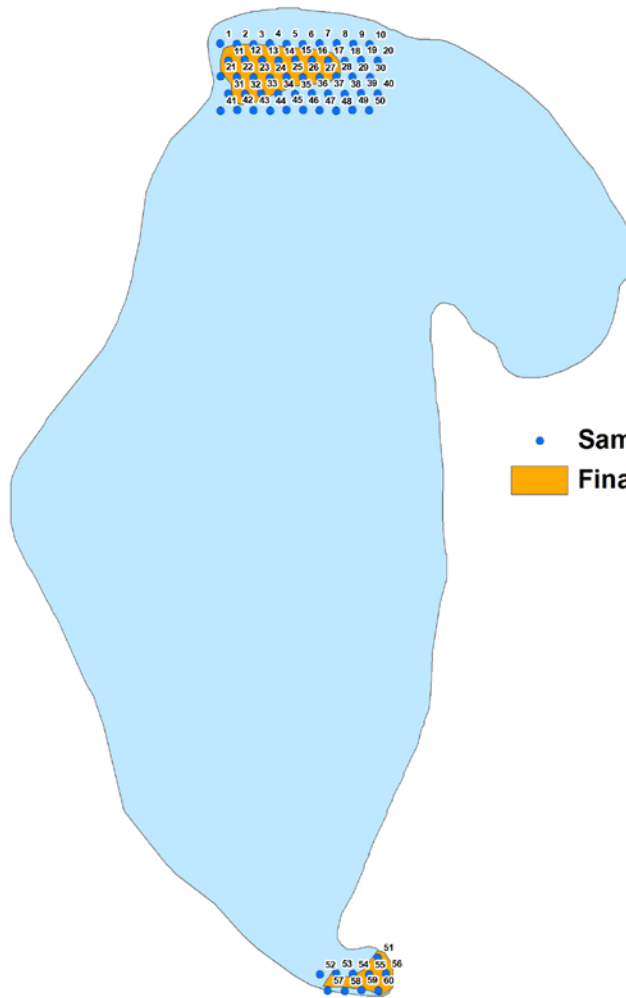
May 22 and July 7, 2021

- Sample Point
- Final Treatment Area

Initial expectations were to treat two areas covering 1.16 acres (0.66% of the lake’s surface area). After the pretreatment survey found Eurasian water-milfoil in each area, it was decided to maintain the treatment as originally planned (Figure 3) (Appendix I).
