Warm-water Point-intercept Macrophyte Survey Kirby Lake - WBIC: 1858200 Barron County, Wisconsin

Endangered Resource Services, LLC
Matthew S. Berg, Research Biologist
St. Croix Falls, Wisconsin
July 26, 2020

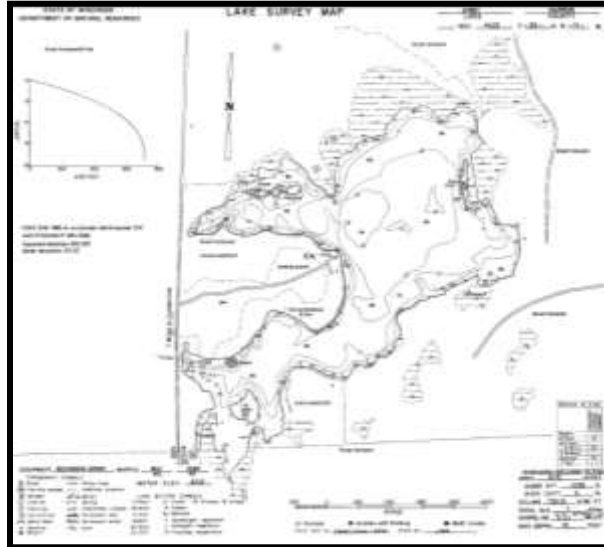
Figure 1: Kirby Lake Bathymetric Map

Kirby Lake (WBIC 1858200) is a 98 acre seepage lake in northwestern Barron County, Wisconsin in the Town of Maple Plain (T36N R14W S14/23). It reaches a maximum depth of 19ft on the west side of the central basin and has an average depth of approximately 8ft (WDNR 2020). The lake is mesotrophic bordering on eutrophic in nature with Secchi readings from 1992-2020 ranging from 4-8ft and averaging 6.3ft (WDNR 2020). Kirby Lake's tannic-stained water produced a littoral zone that extended to 13.0ft during the July 2020 survey. The bottom substrate is predominately muck with scattered sand and rock along the shoreline (Figure 1).

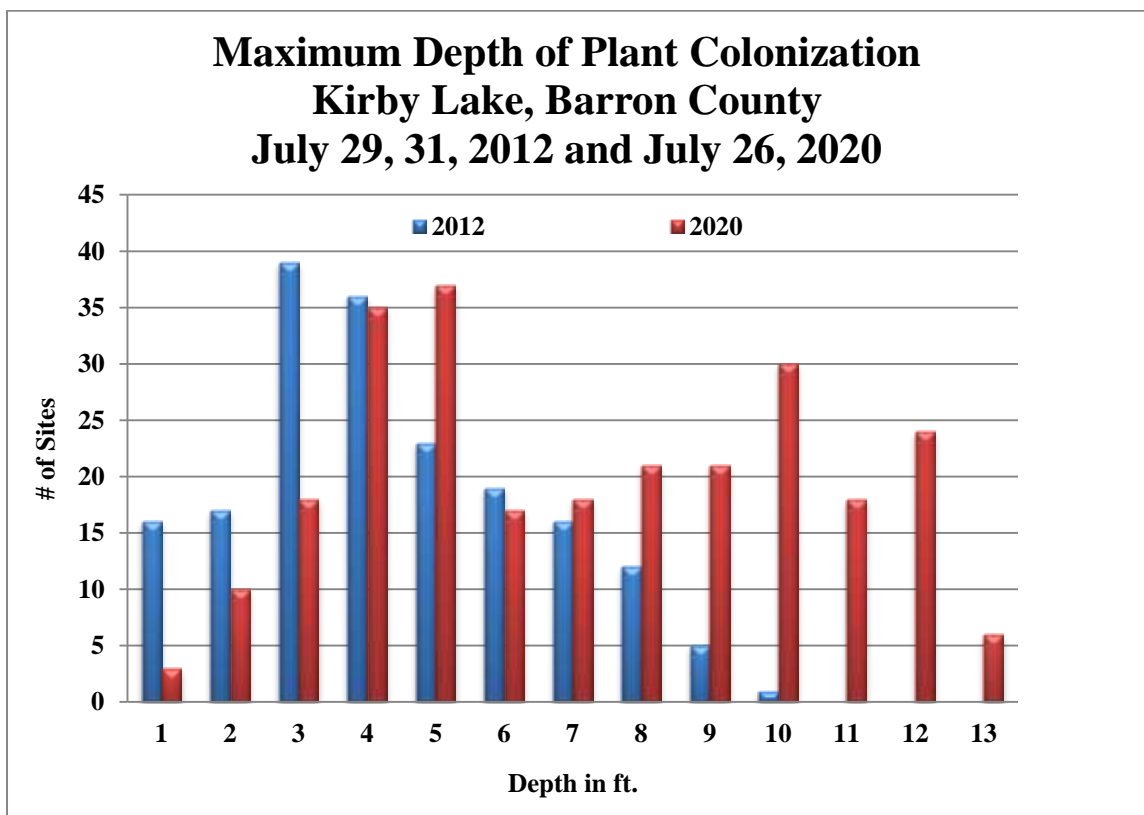
Figure 5: 2012 and 2020 Plant Colonization Depth Chart

Plant growth in 2020 was slightly skewed to deep water as the mean depth of 7.0ft was more than the median depth of 6.8ft. This was similar to 2012 when we also found plant growth was slightly skewed to deep water (4.2ft mean/4.0ft median). These results were unexpected as rising water levels usually results in a narrowing of the littoral zone. It may be that the sustained increases in clarity documented by Secchi disc volunteers over the past three years allowed greater light penetration which resulted in this deepwater expansion (Figure 5).
