Eurasian water-milfoil (*Myriophyllum spicatum*) Spring and Fall Bed Mapping Surveys and Manual Removal Locations Lower Vermillion Lake – WBIC: 2098200 Barron County, Wisconsin

2021 Fall EWM Bed Mapping Survey

Endangered Resource Services, LLC
Matthew S. Berg, Research Biologist
St. Croix Falls, Wisconsin
May 29 and September 26, 2021

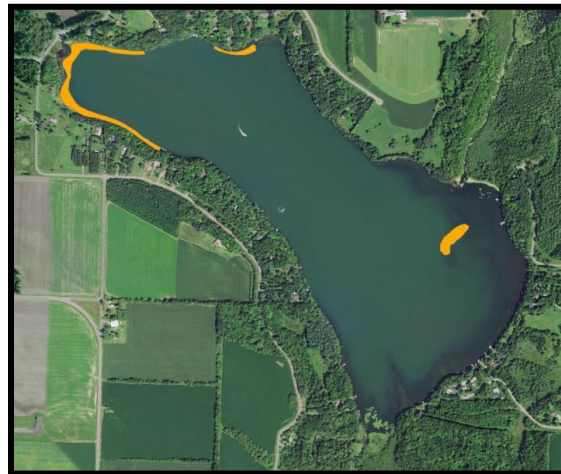
Figure 1: Aerial Photo of 2020 EWM/CLP Treatment Areas

In 2008, the Wisconsin Department of Natural Resources (WDNR) confirmed the presence of Eurasian water-milfoil (EWM) (*Myriophyllum spicatum*) in Lower Vermillion Lake, and the Vermillion Lakes Association (VLA) has been actively working to control this exotic invasive species ever since. Following the 2019 fall EWM bed mapping survey that found scattered patches of EWM throughout the northwest bays near the boat landing and in the east bay, the VLA, under the direction of D. Blumer - Lake Education and Planning Services, LLC (LEAPS) and in accordance with their WDNR approved Aquatic Plant Management Plan, decided to chemically treat three areas totaling approximately 5.13 acres (2.39% of the lake's total surface area) in 2020 (Figure 1). Several of these areas were simultaneously treated for Curly-leaf pondweed (CLP) (*Potamogeton crispus*) – another exotic invasive plant species that is locally abundant early in the growing season.

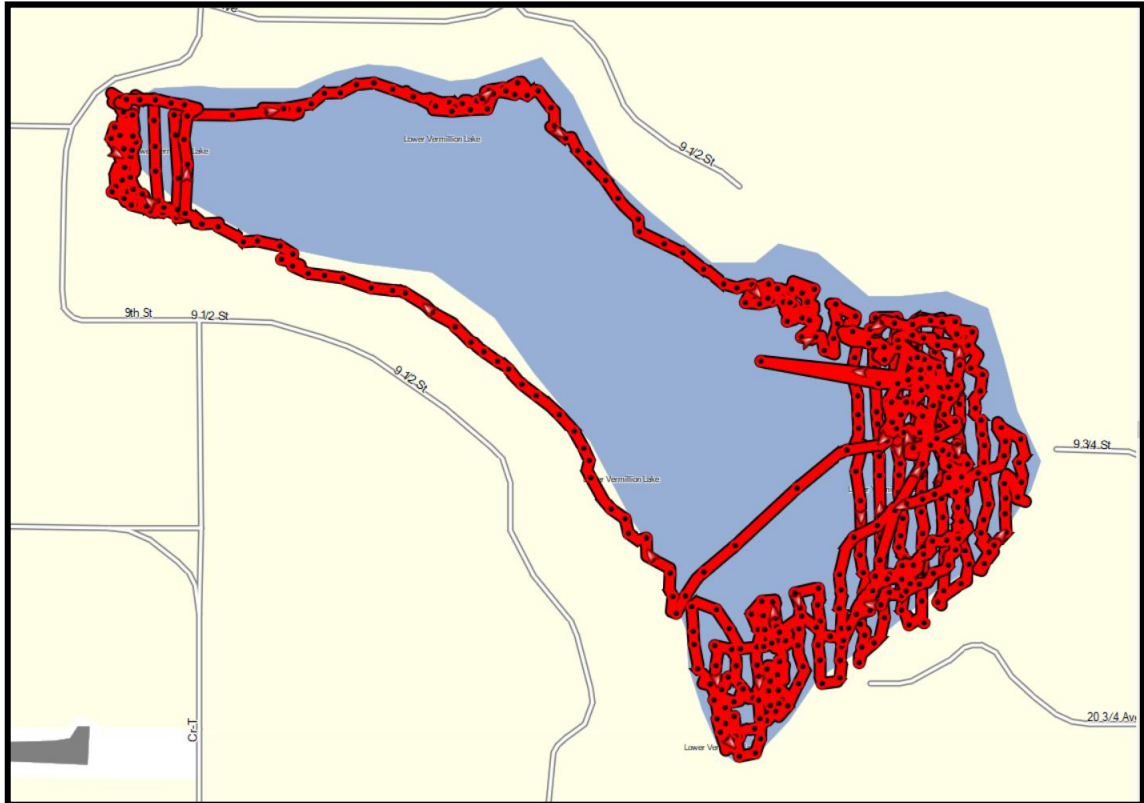
Figure 3: May 29, 2021 Littoral Zone Survey Transects

On May 29th, while simultaneously conducting an early-season point-intercept survey for Curly-leaf pondweed and Eurasian water-milfoil, we searched for EWM throughout the lake's visible littoral zone. Collectively, we searched transects totaling 21.0km (13.0 miles) spending extra time in the 2020 treatment areas, looking at all areas that previously supported EWM beds, and searching in the northeast and northwest bays where fragments from elsewhere would likely be blown by the prevailing winds (Figure 3).

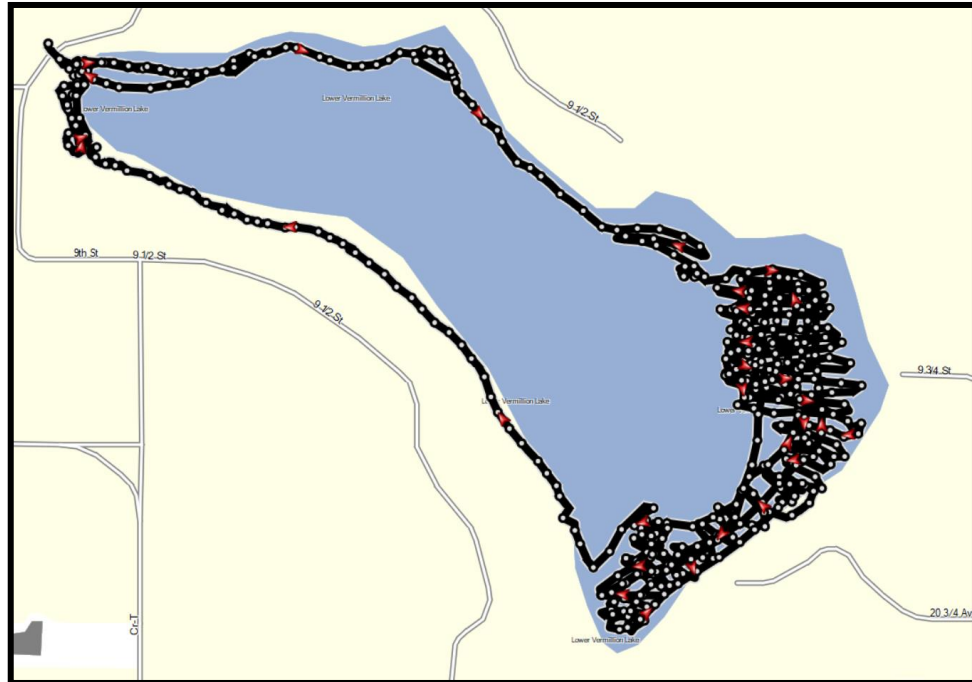
Figure 6: September 26, 2021 Littoral Zone Survey Transects

On September 26th, we returned to the lake and searched 19.3 kilometers (12.0 miles) of transects within the lake’s littoral zone (Figure 6). Clarity was very poor due to a significant algal bloom that limited visibility to 3-4ft. Collectively, we mapped ten small beds that totaled 0.72 acre (Figure 7) (Table 2). This was a significant increase from our 2019 fall survey when we found no beds and removed 21 isolated plants. It was also more than double our 2017 survey when we mapped six microbeds that totaled 0.31 acre (Table 2) (Appendix III). Despite these increases, EWM continues to occupy a low percentage of the lake as the 2021 fall total suggested that just 0.33% of the lake had EWM present.

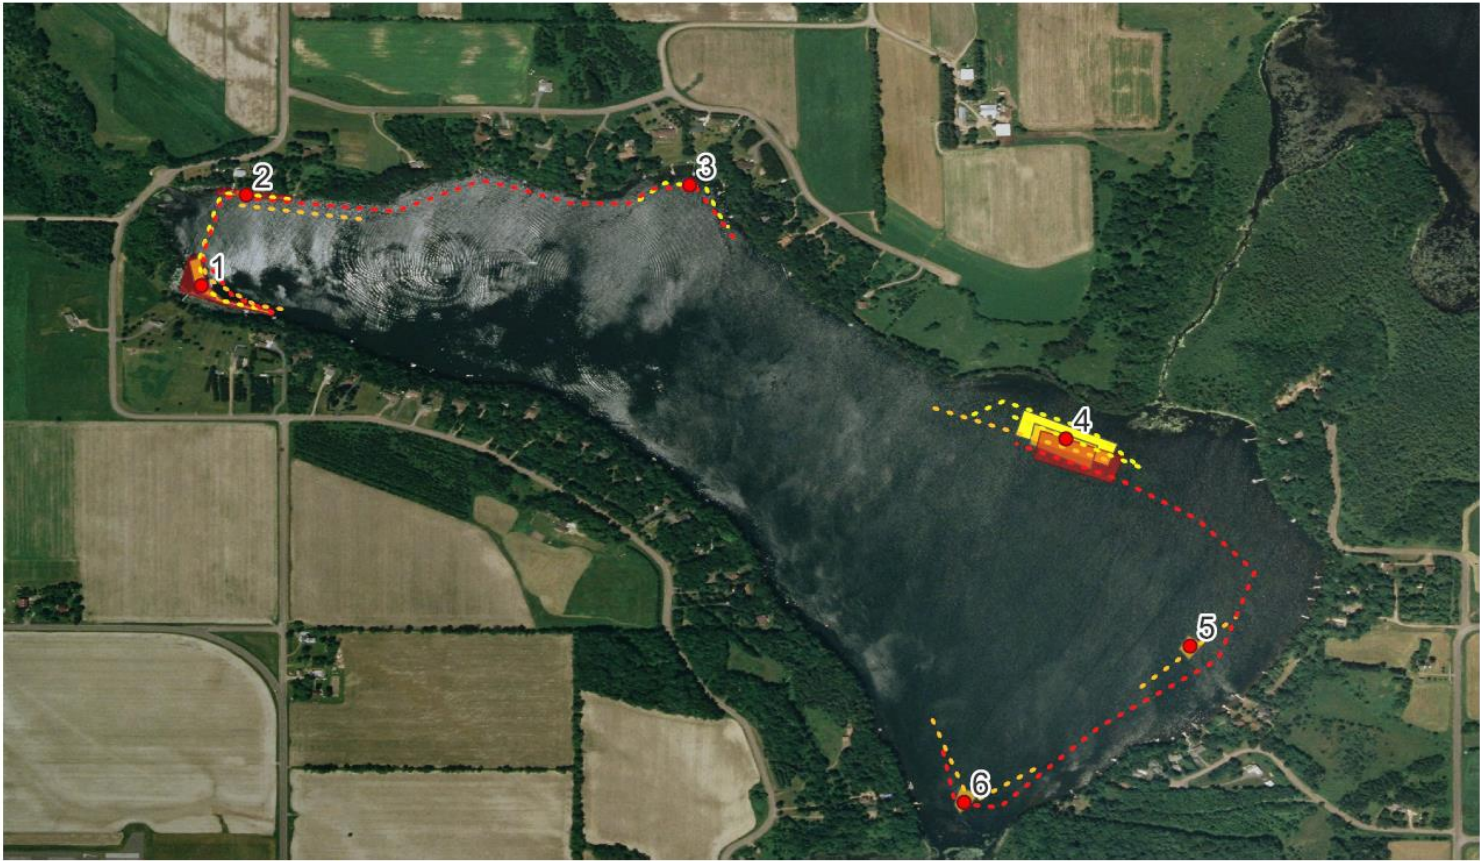
Lower Vermillion 2021 EWM Dive Removal

- 8-14-2021 Visual Search
- 7-1-2021 Visual Search
- 6-9-2021 Visual Search
- 8-14-2021 Dive Removal
- 7-1-2021 Dive Removal
- 6-9-2021 Dive Removal

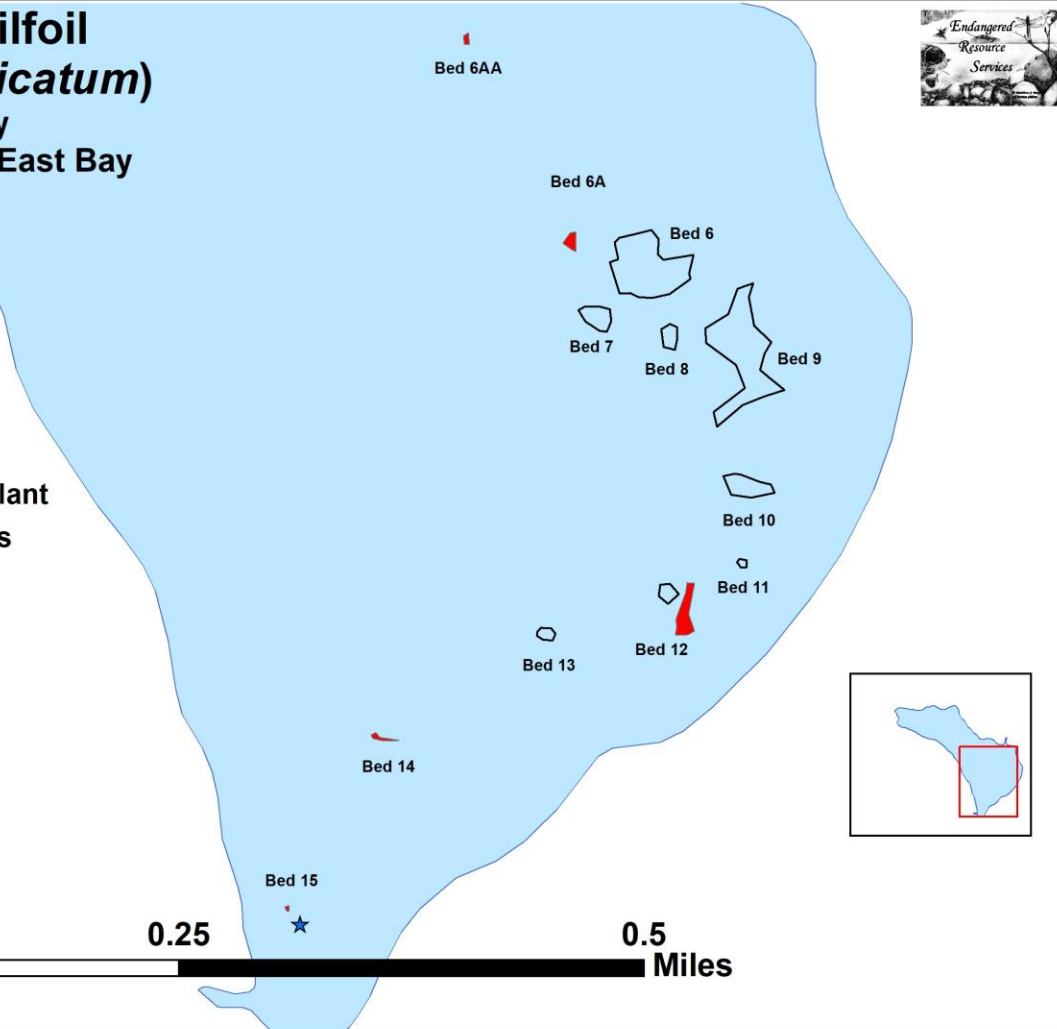
Eurasian water-milfoil
(*Myriophyllum spicatum*)
Fall Bed Mapping Survey
Lower Vermillion Lake - East Bay
Barron County, WI
September 26, 2021

- ★ 2021 Single EWM Plant
- 2021 Fall EWM Beds
- 2012 Fall EWM Bed
