**Curly-leaf Pondweed (*Potamogeton crispus*) and
Eurasian Water-milfoil (*Myriophyllum spicatum*)
Pre/Post Herbicide and EWM Bed Mapping Surveys
Long Trade Lake – WBIC: 2640500
Polk County, Wisconsin**

Surveys Conducted by and Report Prepared by:
Endangered Resource Services, LLC
Matthew S. Berg, Research Biologist
St. Croix Falls, Wisconsin
May 12, June 18, and August 29, 2020

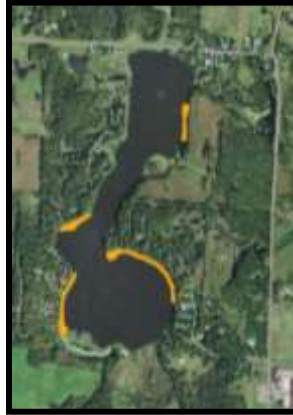
Figure 1: 2020 CLP Treatment Areas

The RTLIA – under the direction of Dave Blumer (Lake Education and Planning Services, LLC - LEAPS) – applied for and was awarded a WDNR Aquatic Invasive Species control grant (ACEI21618) to help cover the costs associated with management. In 2020, these funds were used to chemically treat 8.69 acres (5.79% of the lake’s surface area) for CLP and/or EWM (Figure 1). On May 12th, we conducted a pretreatment survey to gather baseline data from the proposed treatment areas and to allow LEAPS/RTLIA to finalize treatment plans. After the May 19th CLP treatment and the May 22nd EWM treatment, we completed a June 18th posttreatment survey to evaluate the effectiveness of the herbicide application. We also conducted an August 29th EWM bed mapping survey to determine where control might be considered in 2021. This report is the summary analysis of these three field surveys.

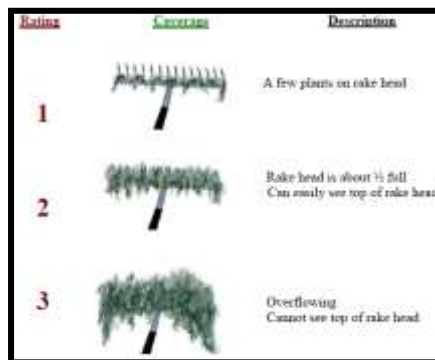
Figure 2: Rake Fullness Ratings

During the surveys, we located each point using a handheld mapping GPS unit (Garmin 76CSx) and used a rake to sample an approximately 2.5ft section of the bottom. All plants on the rake were assigned a rake fullness value of 1-3 as an estimation of abundance, and a total rake fullness for all species was also recorded (Figure 2). Visual sightings of EWM and CLP were noted if they occurred within 6ft of the point; however, visuals of other species were not recorded as they do not figure into the pre/posttreatment calculation. In addition to plant data, we recorded the lake depth using a metered pole and the substrate (bottom) type when we could see it or reliably determine it with the rake.

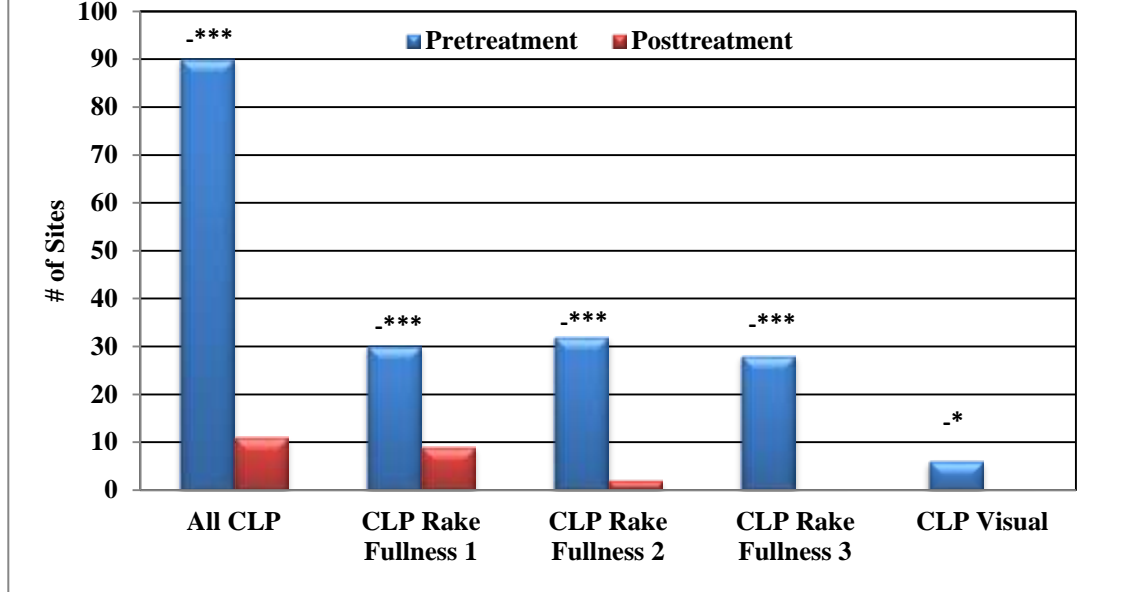
Figure 9: Pre/Post Changes in CLP Rake Fullness

During the posttreatment survey, we found CLP at 11 points (9.6% coverage) (Figure 8). Of these, none rated a 3, two were a 2, and nine were a 1 for a mean rake fullness of 1.18. The two nuisance points suggested that just 1.7% of the beds still had a significant CLP infestation posttreatment. **Our results demonstrated a highly significant decline ($p<0.001$) in total CLP density, distribution, and rake fullness 3, 2, and 1; and a significant decline ($p=0.01$) in visual sightings (Figure 9).**

Significant differences = * $p < 0.05$, ** $p < 0.01$, *** $p < 0.001$

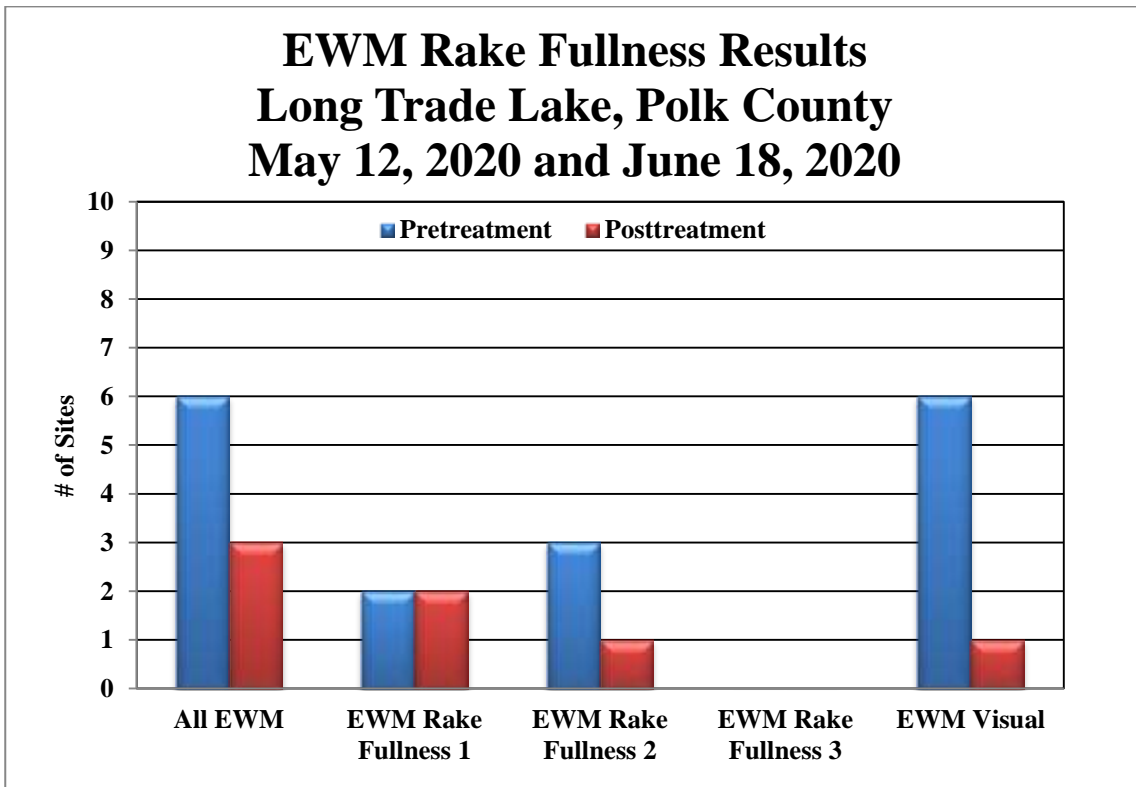
Figure 11: Pre/Post Changes in EWM Rake Fullness

During the posttreatment survey, we found EWM at three points (2.6% coverage) with one additional visual sighting (Figure 10). None rated a 3, one was a 2, and two were a 1 for a mean rake fullness of 1.33. The single nuisance point suggested 0.9% of the beds still had a significant EWM infestation posttreatment. **Due to the low number of detections, none of these changes were statistically significant, although the decline in visual sightings was nearly significant ($p=0.05$)** (Figure 11).

Significant differences = * $p < 0.05$, ** $p < 0.01$, *** $p < 0.001$
