**Eurasian Water-milfoil (*Myriophyllum spicatum*)
Summer Rake Removal and
Fall Rake Removal and Bed Mapping Surveys
Red Lake - WBIC: 2492100
Douglas County, Wisconsin**

Endangered Resource Services, LLC
Matthew S. Berg, Research Biologist
St. Croix Falls, Wisconsin
August 2 and October 6, 2018

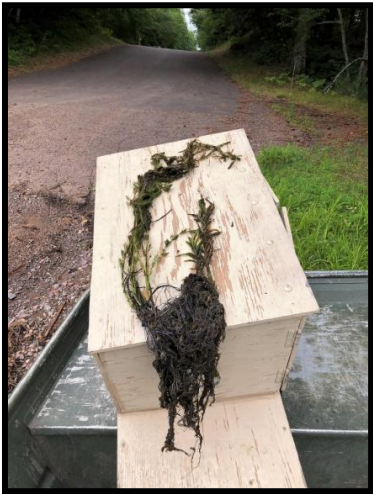
Large EWM plant found 8/2/18

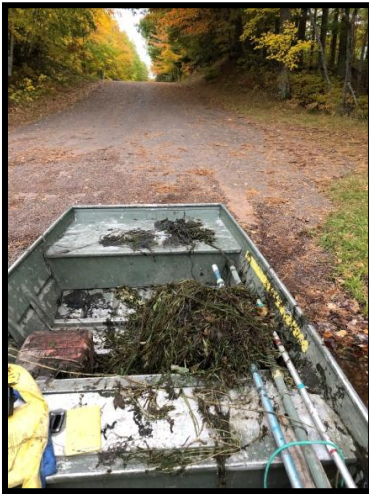
EWM raked out of lake 10/6/18

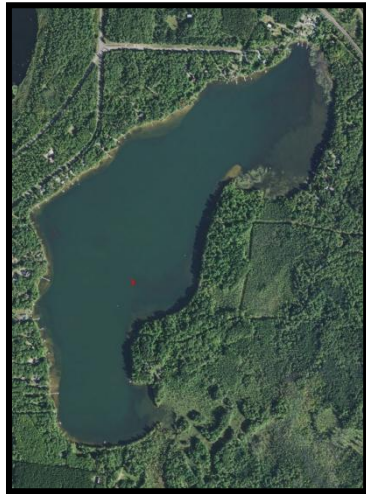
EWM Beds on Red Lake 10/6/18

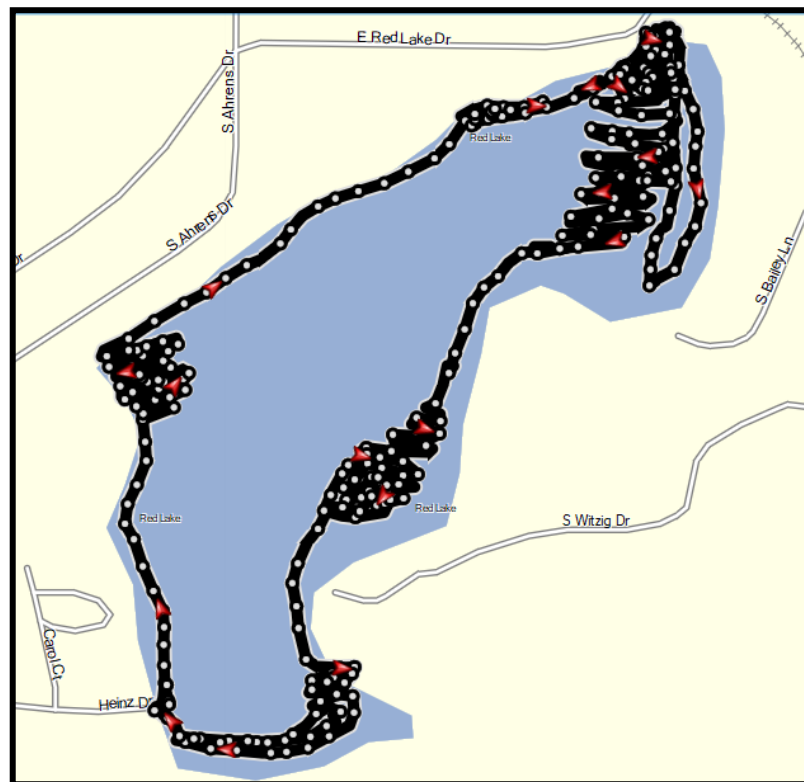
Figure 3: August 2018 Littoral Zone EWM Survey Transects

On August 2nd, we surveyed transects covering 16.2km (10.1 miles) spending extra time in the treatment area and along the northeast shore where we have found scattered plants but not beds in past surveys (Figure 3). Unfortunately, the forecasted sunny conditions for the day never materialized so, although we had calm winds and fair to good water clarity, we were only able to see 7-8ft down into the water column. We did **NOT** find any evidence of Eurasian water-milfoil within the treatment area during this initial survey, and raking at the core of the area didn't produce any surviving plants either. However, we did find and remove a total of 30 plants in the northeast bay with 25 of those occurring around the Red Lake Resort docks. This was similar to Dave Blumer's (LEAPS) survey that occurred during the week of July 9th. At that time, he and his assistant also failed to find any EWM in the treatment area, but reported they removed approximately 30 plants from around the docks at the resort.

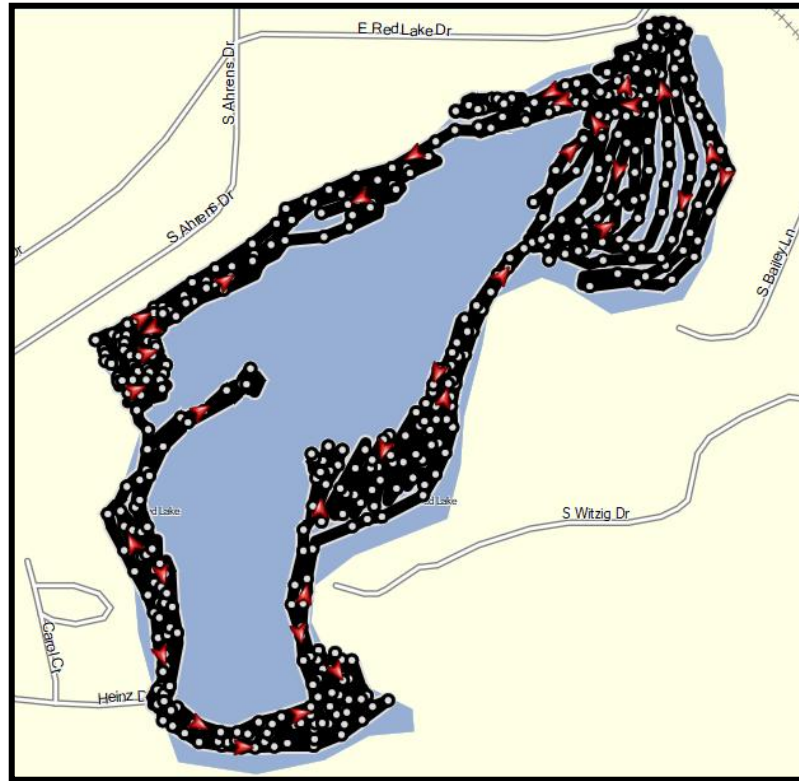
Figure 4: October 2018 Littoral Zone EWM Survey Transects

During the October 6th survey, the winds were calm but it was again overcast for most of the day. Because of this, we could only see the bottom clearly in 5-7ft meaning short EWM plants in deep water may have gone unnoticed. These less than ideal conditions forced us to significantly tightened our transects in an attempt to not miss plants. In total, we searched 32.7km (20.3 miles) – over twice the distance covered in August (Figure 4).

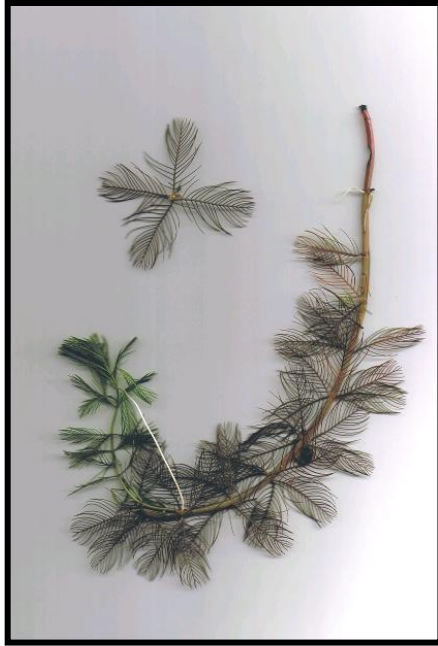
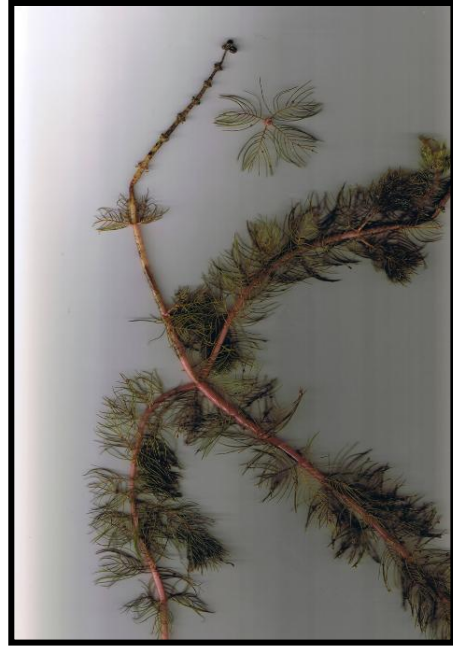
Figure 7: EWM and Northern Water-milfoil Identification (Berg 2007)

Residents should know that Red Lake has a significant amount of the very similar looking Northern water-milfoil – a valuable native plant that provides important fish habitat and is likely to be heavily impacted by any future chemical treatments. NWM is widely distributed throughout the lake's rooted littoral zone, but does best over sandy and organic muck often just inshore from EWM in 6-8ft of water. Despite its superficial resemblance to EWM, Northern water-milfoil can be told apart by its leaflets numbering <24 that are usually held rigidly at 90 degree angles off the stem when out of water. Conversely, EWM normally has >26 leaflets that fall limp against the stem when out of water (Figure 7). EWM also tends to have a bright red growth tip on the top of the plant whereas NWM has a bright lime green growth tip. NWM on Red Lake is often mixed with other plants, is seldom bed-forming, and rarely canopies on the surface; whereas EWM was often found in nearly monotypic beds that excluded most native species and canopied even in deep water. In the fall, NWM also forms winter buds on the tips of shoots whereas EWM has none. These buds were readily visible during the fall survey (Figure 8).

Eurasian water-milfoil

Northern water-milfoil

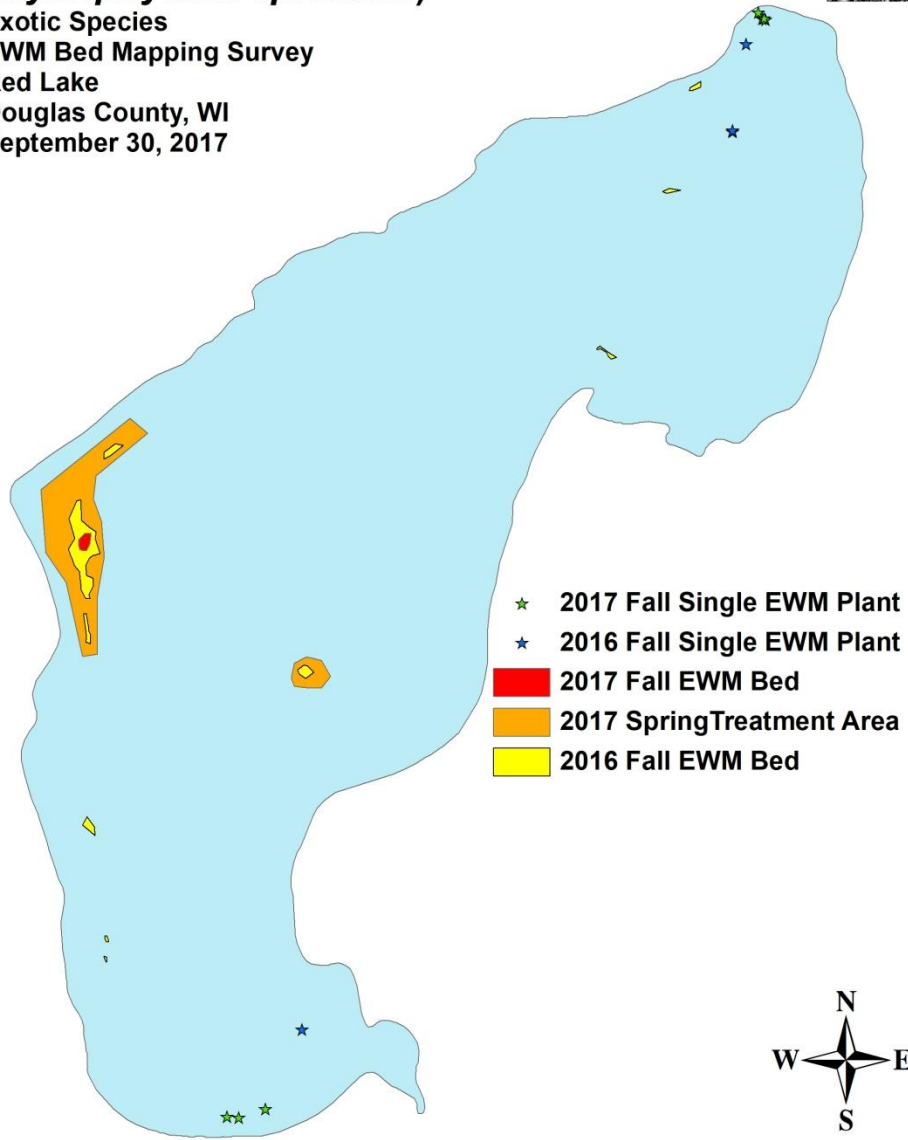
Appendix II: Fall 2017 and 2018 Eurasian Water-milfoil Bed Maps

Exotic Species
EWM Bed Mapping Survey
Red Lake
Douglas County, WI
September 30, 2017

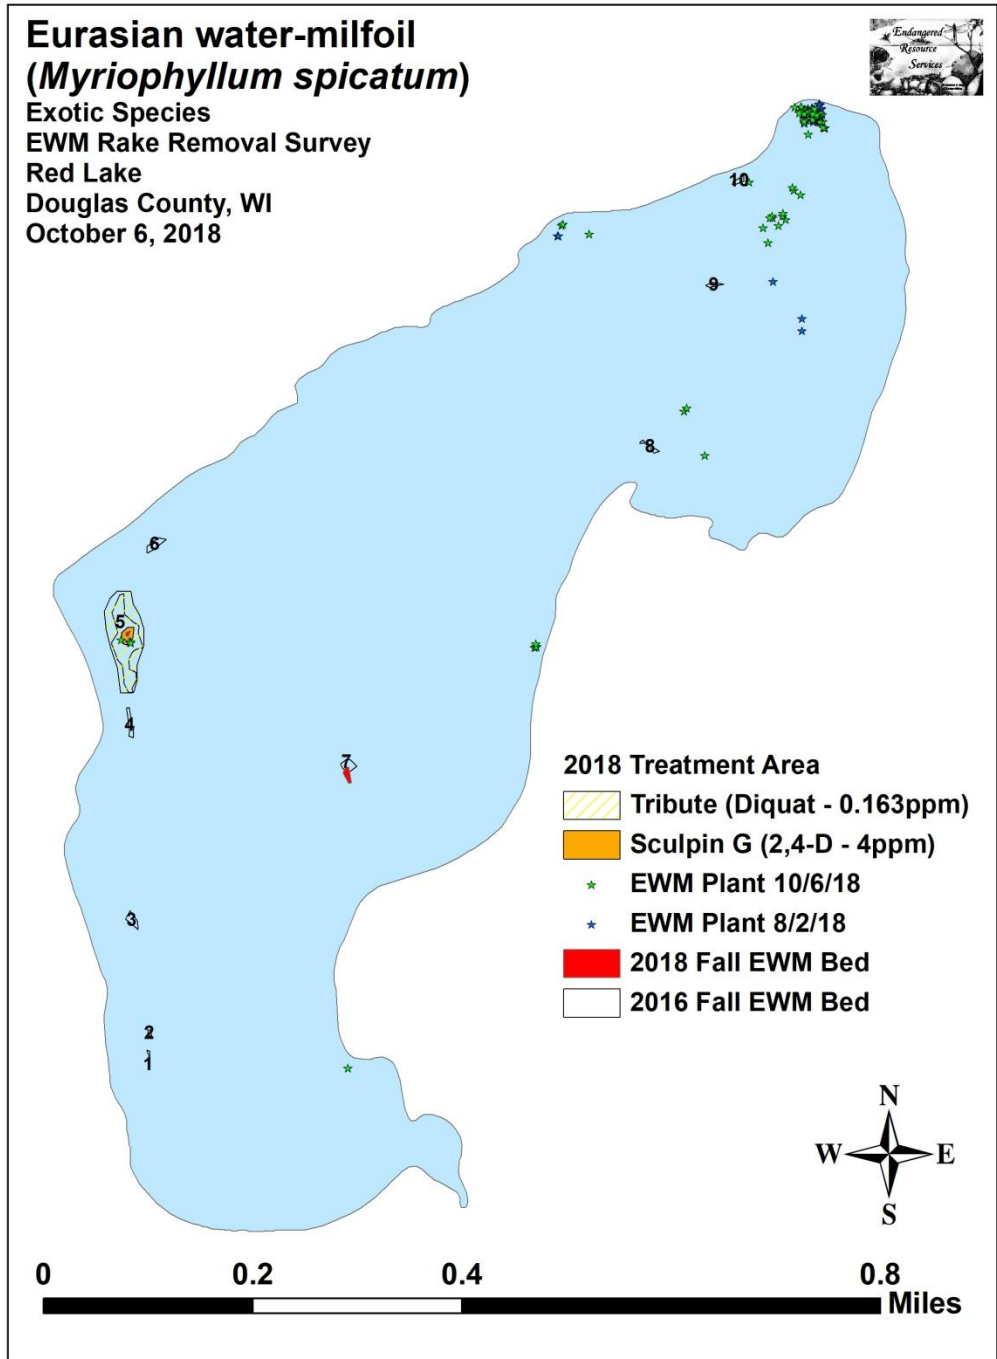
Exotic Species
EWM Rake Removal Survey
Red Lake
Douglas County, WI
October 6, 2018
