Warm-water Point-intercept Macrophyte and Fall Eurasian Water-milfoil Bed Mapping Surveys Red Lake - WBIC: 2492100 Douglas County, Wisconsin

Surveys Conducted by and Report Prepared by:

Endangered Resource Services, LLC
Matthew S. Berg, Research Biologist
St. Croix Falls, Wisconsin
July 30 and September 30, 2017

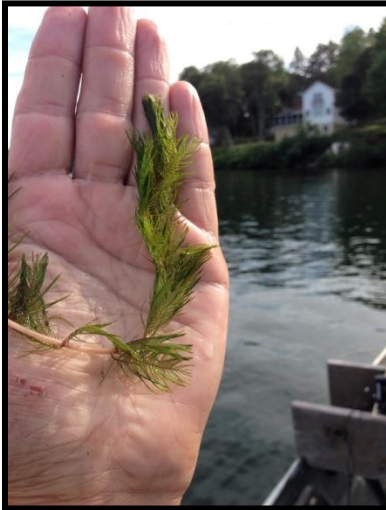
Red Lake Eurasian water-milfoil regrowing from chemically burned root crowns 7/30/17

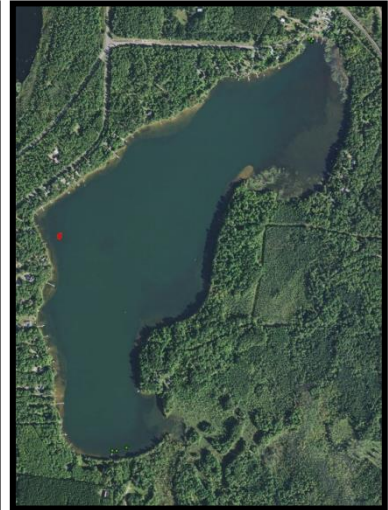
EWM Bed on Red Lake 9/30/17

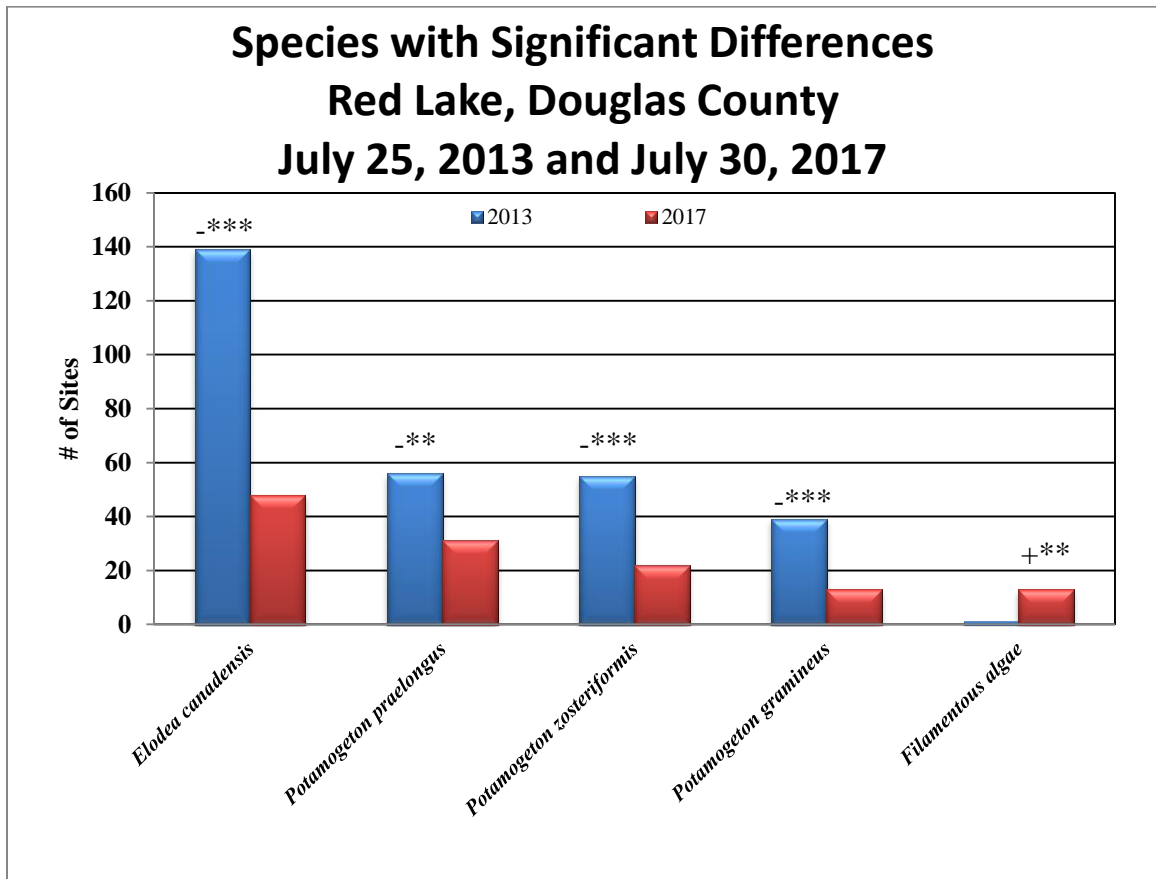
Figure 8: Significant Macrophyte Changes from 2013-2017

Lakewide, five species showed significant changes in distribution from 2013 to 2017. Common waterweed, Flat-stem pondweed, and Variable pondweed suffered highly significant declines; and White-stem pondweed experienced a moderately significant decline. Conversely, filamentous algae saw a highly significant increase (Figure 8).

Significant differences = * $p < .05$, ** $p < .01$, *** $p < .001$

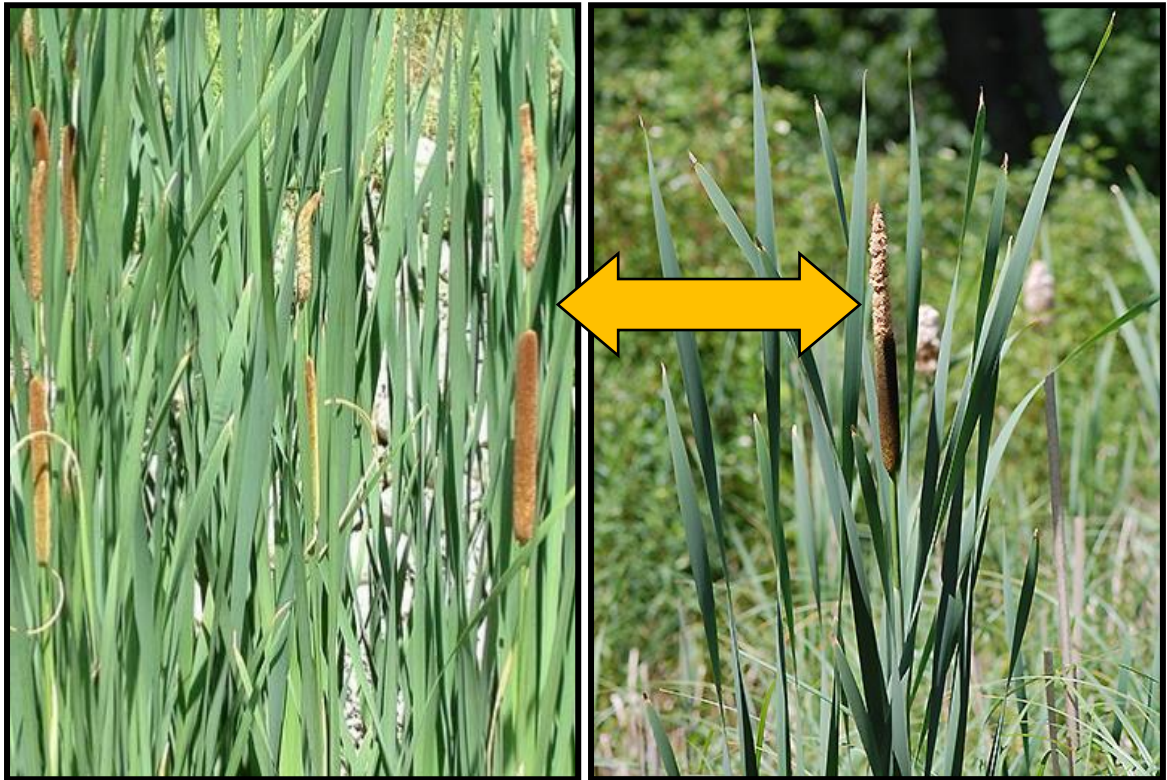
Figure 16: Exotic Hybrid and Native Broad-leaved Cattail Identification

Other than EWM, we saw no evidence of Curly-leaf pondweed (*Potamogeton crispus*), Purple loosestrife (*Lythrum salicaria*), Reed canary grass (*Phalaris arundinacea*), or any other exotic plant species on Red Lake. The small stand of Narrow-leaved cattail (*Typha angustifolia*) we found in the northwest corner bay on the western shoreline during the original 2013 survey was not present in 2017. Native to southern but not northern Wisconsin, this species is potentially invasive in that it often excludes the native Broad-leaved cattail from places where the two are found together. Besides having narrower leaves, the exotics can be told from our native cattails by having a relatively narrower and longer “hotdog-shaped” tan female cattail flower whereas our native species tends to produce a fatter and shorter “bratwurst-shaped” dark chocolate colored female flower. Narrow-leaved cattail and its hybrids also have a male flower that is separated from the female flower by a thin green stem while the native Broad-leaved cattail has its male and female flowers connected (Figure 16). As the lake offers little of the organic muck shoreline habitat that cattails prefer, it seems unlikely that either species will become invasive on Red Lake. However, if residents find cattails growing along their shoreline and determine them to be exotic, they may want to consider removing them (For more information on a sampling of aquatic exotic invasive plant species, see Appendix VIII).

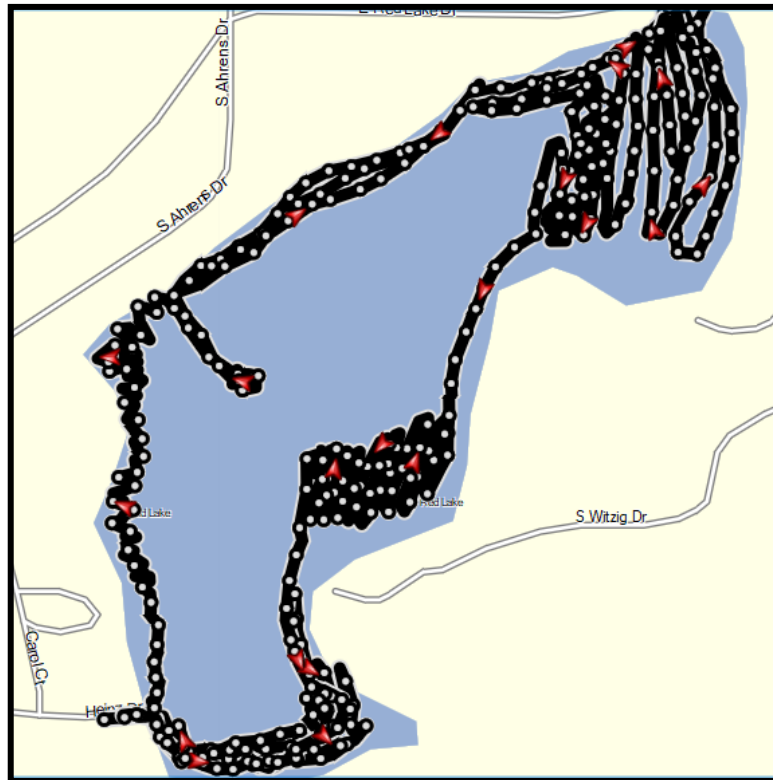
Figure 17: 2017 Fall EWM Bed Mapping Survey Transects

During the fall survey, we had bright overhead sun, and winds were calm or nearly calm making for good to excellent survey condition. Overall clarity, however, was only fair as the water was somewhat “milky”, and we could only see the bottom clearly in 5-7ft meaning short EWM plants in deep water may have gone unnoticed. In total, we searched over 21km (13.1 miles) of transects within Red Lake’s visible littoral zone (Figure 17). Because almost all Eurasian water-milfoil found in 2016 was growing in 8-11ft over sandy muck on the outer edge of the rooted littoral zone, we spent extra time searching in this ecological niche where EWM seems to have a significant competitive advantage and was having the easiest time establishing.

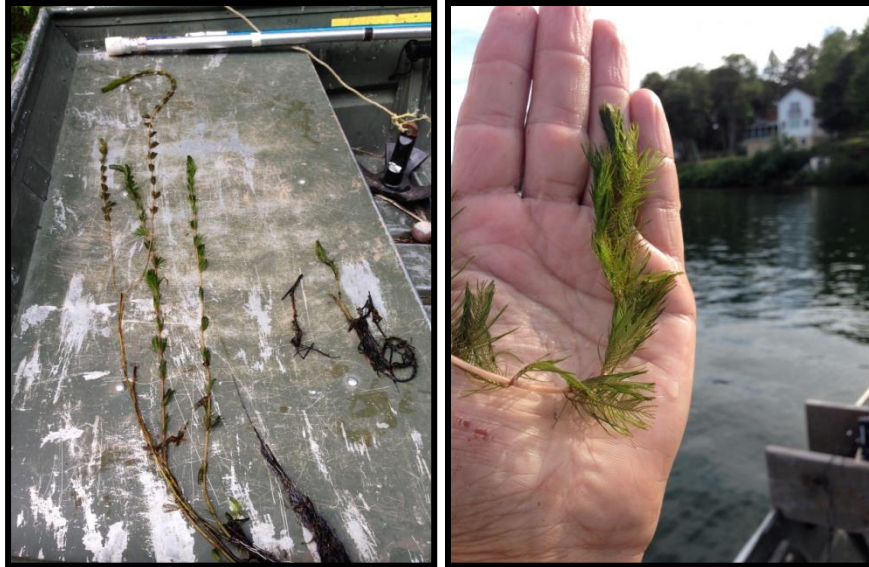
Figure 19: Significant EWM Regrowth from Chemically Burned Roots

Beds 4, 5, and 6 – The areas that were chemically treated with Diquat continued to be EWM free with the exception of the core area where we found surviving plants in July. Plants that ranged from 1-4ft over the summer (Figure 19) were nearing canopy in 8-10ft of water by fall. Although we didn't find any floating fragments, satellite plants were radiating out from the core in all directions as they recolonized areas left barren by the herbicide treatment.

The initial treatment in 2017 appears to have been highly successful at knocking back, but not eliminating EWM within the northwest treatment area. The surviving bed is likely too large for manual removal by SCUBA divers to be an effective control strategy; however, this doesn't mean dive removal shouldn't be considered in other areas of the lake. Although our 2017 fall survey didn't find plants in the narrow littoral areas on the western shoreline where small EWM beds were present in 2016, we believe it is likely there are some surviving plants in these areas. Due to the difficulty in treating small beds adjacent to deep water, we believe these beds, if EWM plants are still present, would make excellent candidates for manual removal; especially if volunteers that are SCUBA certified already exist on the lake.

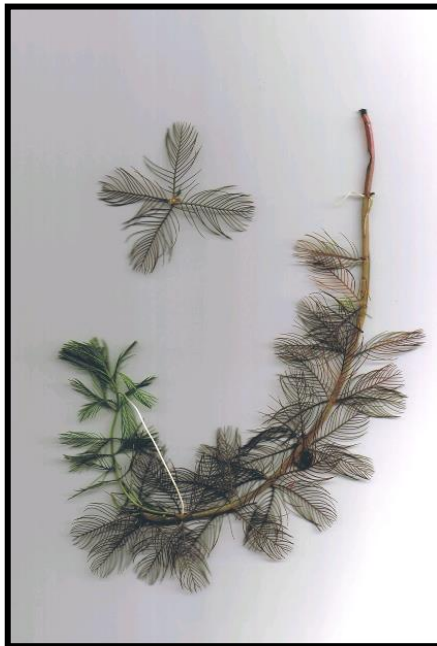
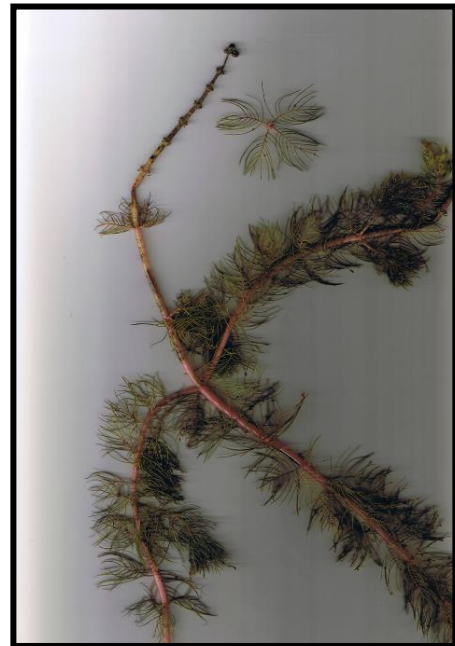
Figure 20: EWM and Northern Water-milfoil Identification (Berg 2007)

Red Lake has a significant amount of the very similar looking Northern water-milfoil – a valuable native plant that provides important fish habitat and is likely to be heavily impacted by any future chemical treatments. NWM is widely distributed throughout the lake’s rooted littoral zone, but does best over sandy and organic muck. Despite its superficial resemblance to EWM, Northern water-milfoil can be told apart by its leaflets numbering <24 that are usually held rigidly at 90 degree angles off the stem when out of water. Conversely, EWM normally has >26 leaflets that fall limp against the stem when out of water (Figure 20). EWM also tends to have a bright red growth tip on the top of the plant whereas NWM has a bright lime green growth tip. NWM on Red Lake is often mixed with other plants, is seldom bed-forming, and rarely canopies on the surface; whereas EWM was often found in nearly monotypic beds that excluded most native species and canopied even in deep water. In the fall, NWM also forms winter buds on the tips of shoots whereas EWM has none. These buds were readily visible during the fall survey (Figure 21).

Eurasian water-milfoil

Northern water-milfoil

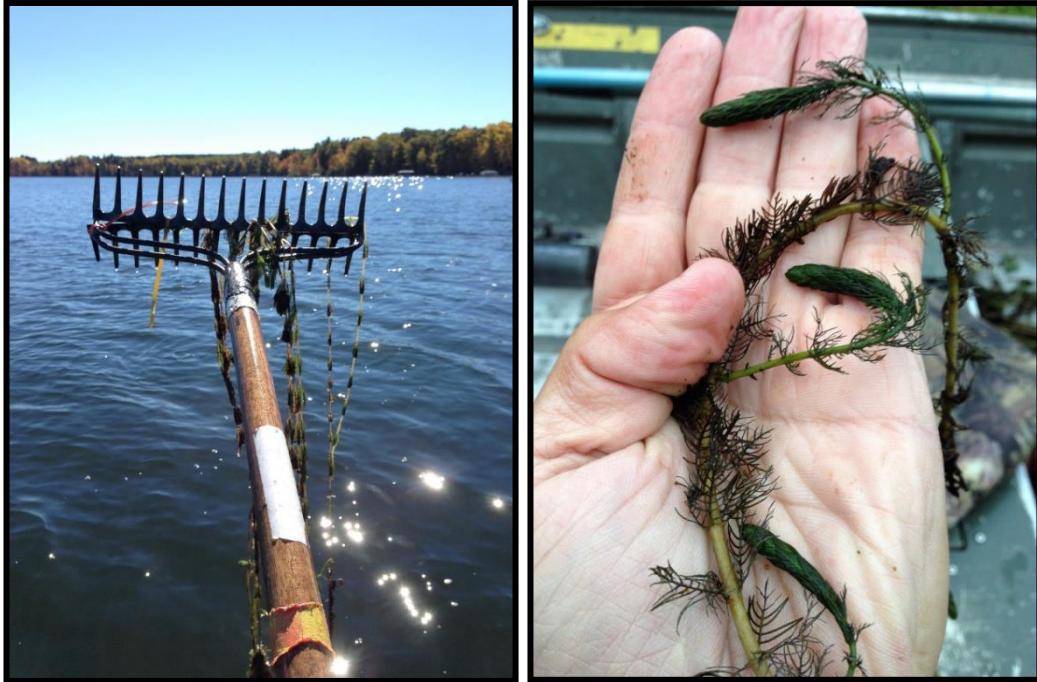
**Figure 21: Limp Nature of EWM Leaflets along Stem –
Stiff Nature of NWM Leaflets along Stem and Overwintering Turions**

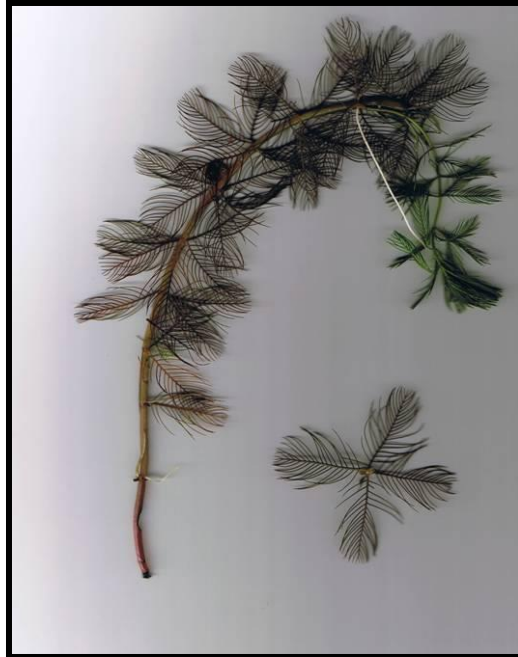
DESCRIPTION: Eurasian Water-milfoil is a submersed aquatic plant native to Europe, Asia, and northern Africa. It is the only non-native milfoil in Wisconsin. Like the native milfoils, the Eurasian variety has slender stems whorled by submersed feathery leaves and tiny flowers produced above the water surface. The flowers are located in the axils of the floral bracts, and are either four-petaled or without petals. The leaves are threadlike, typically uniform in diameter, and aggregated into a submersed terminal spike. The stem thickens below the inflorescence and doubles its width further down, often curving to lie parallel with the water surface. The fruits are four-jointed nut-like bodies. Without flowers or fruits, Eurasian Water-milfoil is nearly impossible to distinguish from Northern Water-milfoil. Eurasian Water-milfoil has 9-21 pairs of leaflets per leaf, while Northern milfoil typically has 7-11 pairs of leaflets. Coontail is often mistaken for the milfoils, but does not have individual leaflets.
