**Eurasian water-milfoil (*Myriophyllum spicatum*)
Pre/Post Herbicide Surveys,
Meandering Littoral Zone Surveys, and Rake Removal
Red Lake (WBIC: 2492100)
Douglas County, Wisconsin**

The Red Lake Association, Lake Education and Planning Services, LLC and the Wisconsin Department of Natural Resources (Grant #AIRR25720)

Endangered Resource Services, LLC
Matthew S. Berg, Research Biologist
St. Croix Falls, Wisconsin
May 22, July 3, and August 30, 2020

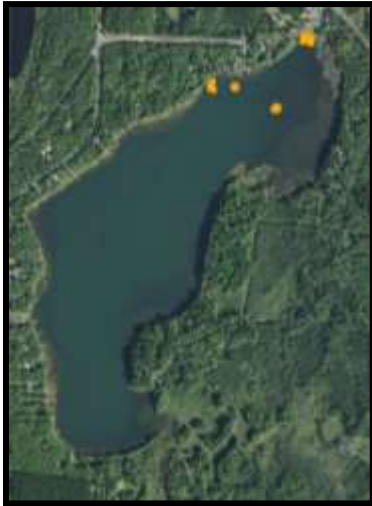
Red Lake 2020 treatment areas

The four proposed treatment areas covered 1.93 acres (0.70% of the lake's surface area) (Figure 3) (Appendix I). Because the May 22nd pretreatment survey found Eurasian water-milfoil was present in each area, the RLA decided to go ahead with the treatment as originally planned.

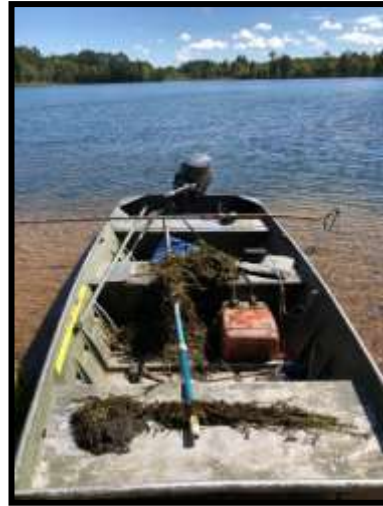
Rake removed EWM 8/30/20

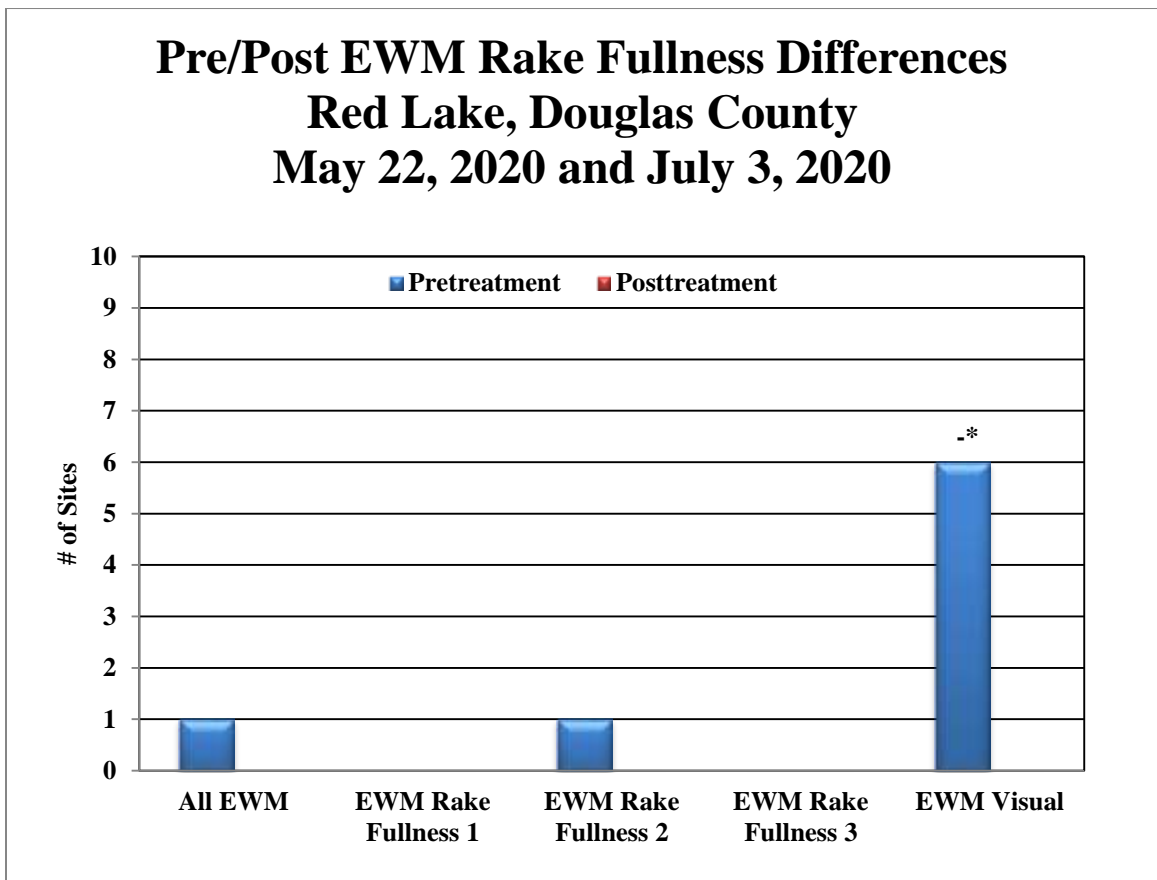
Figure 9: Changes in EWM Rake Fullness

We found Eurasian water-milfoil occurred in scattered clusters within the treatment area. During the pretreatment survey, it was present in the rake at a single point (rake fullness of 2), and we also recorded it as a visual at six points (Figure 8) (Appendix V). Posttreatment, we saw no evidence of EWM anywhere in the treatment areas. Due to the **small number of pretreatment detections, only the decline in visual sightings was significant ($p=0.01$)** (Figure 9).

Significant differences = * $p<0.05$, ** $p<0.01$, *** $p<0.001$

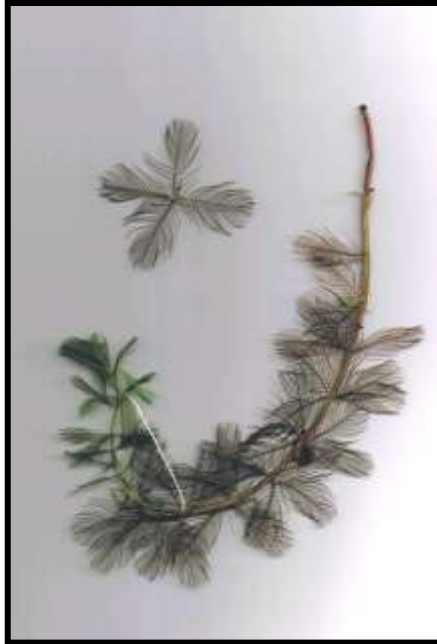
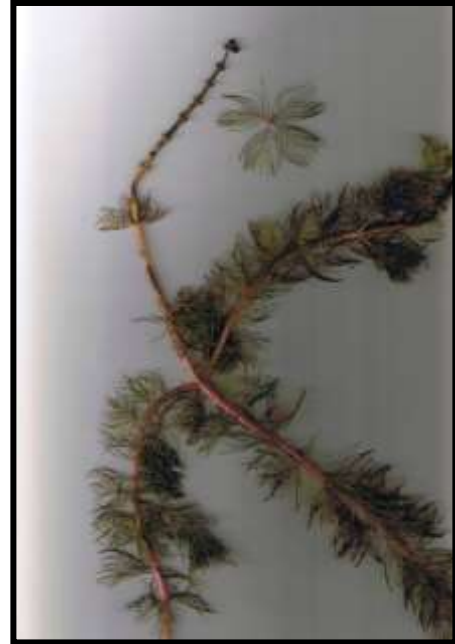
Figure 18: EWM and Northern Water-milfoil Identification (Berg 2007)

Eurasian water-milfoil

Northern water-milfoil

Annual surveys by professionals to locate and, if possible, rake remove Eurasian water-milfoil may be desired in the future to quickly identify and manage newly established beds. Residents on the lake can assist with these efforts by watching the area around their docks for newly established EWM beds. Residents should know that Red Lake has a significant amount of the very similar looking Northern water-milfoil (NWM) – a valuable native plant that provides important fish habitat (Figure 18). NWM is widely distributed throughout the lake's rooted littoral zone, but does best over sandy and organic muck often just inshore from EWM in 6-8ft of water. Despite its superficial resemblance to EWM, NWM can be told apart by its leaflets numbering <24 that are usually held rigidly at 90 degree angles off the stem when out of water. Conversely, EWM normally has >26 leaflets that fall limp against the stem when out of water. EWM also tends to have a bright red growth tip on the top of the plant whereas NWM has a bright lime green growth tip. NWM on Red Lake is often mixed with other plants, is seldom bed-forming, and rarely canopies on the surface; whereas EWM is often found in nearly monotypic beds that exclude most native species, and it frequently canopies even in deep water. In the fall, NWM also forms over wintering turions on the tips of shoots whereas EWM has none. These turions of densely packed leaflets are readily visible on most plants after September 15 (Figure 19).
