2019 Aquatic Plant Survey Report

Lake Redstone Bays

Sauk County, Wisconsin

Arapaho, Cardinal, Chickadee, County F, Eagle,
Hummingbird, Killdeer, Martin-Meadowlark, Oriole, Quail,
Swallow, & Woodpecker

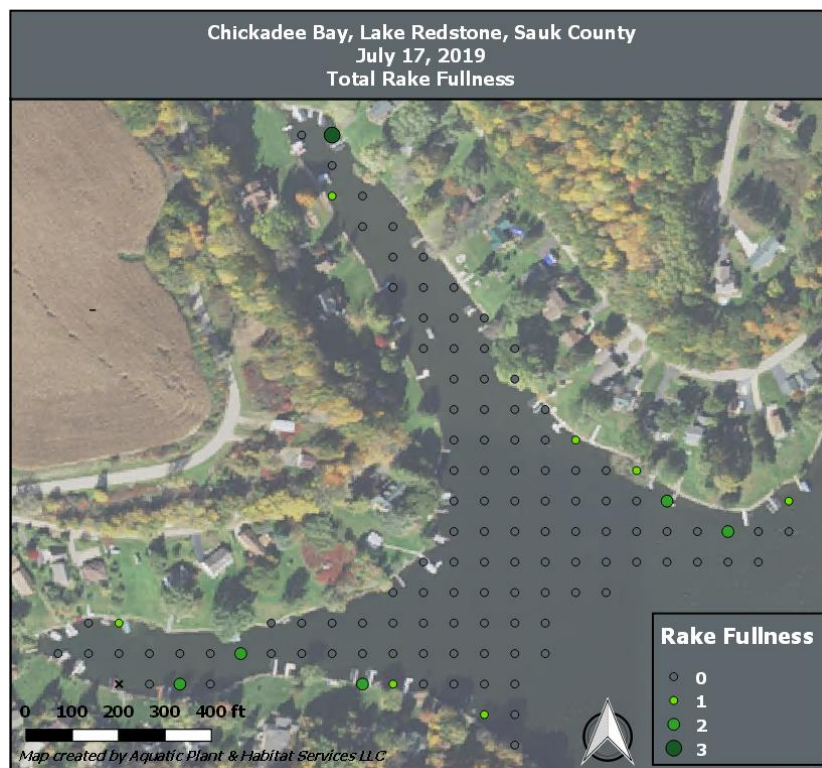
Figure 5 – Chickadee Bay Total Rake Fullness Map

This was the second survey of Chickadee, the first of which occurred in 2015. The south arm of Chickadee Bay was also surveyed 2016 through 2018. Only results from the 2015 and 2019 surveys are listed here. There were 120 points surveyed in Chickadee Bay 50 of which were the same depth or shallower than the maximum rooting depth of 5 feet. Only 13 sites had vegetation present (Table 3). A total of 6 species were found, two of which were “visual only” (maps in Appendix C). EWM and coontail were the most common species found at only 18% and 6% of littoral survey points respectively. Together they accounted for 75% of the total relative frequency, indicating a homogeneous, albeit sparse, plant community in the bay (Table 5). Chi-squared tests of all plant species revealed there were no SS changes between the 2015 and 2019 surveys of the bay. The Simpson Diversity Index for South Chickadee Bay was low at 0.61 on a scale of 0 to 1. The FQI only factors species raked at survey points and does not include visuals or aquatic invasive species. Therefore, only 2 species were included in the calculation, resulting in a floristic quality of 6.4 and average C value of 4.5 (Table 4).

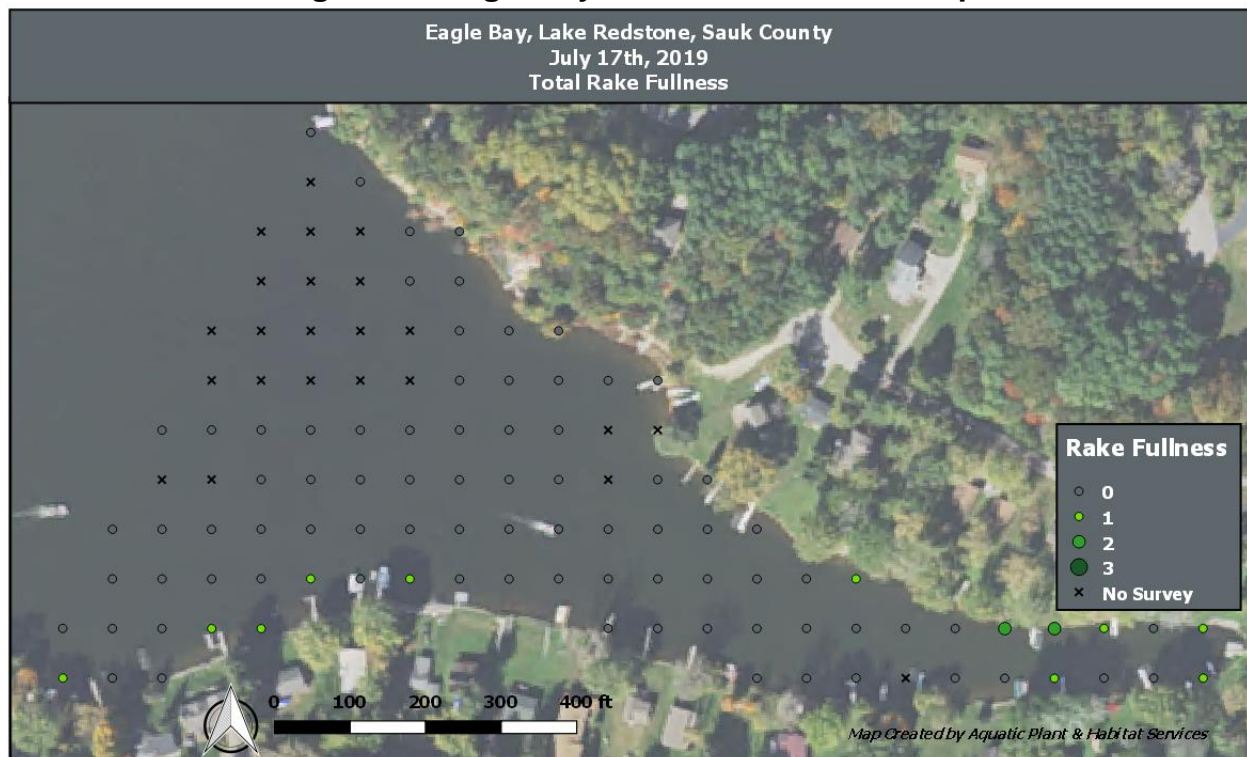
Figure 7 – Eagle Bay Total Rake Fullness Map

This was the fourth survey of Eagle Bay (2014 & 2017-2019). In Eagle Bay, 94 points were surveyed and 36 points were the same depth or shallower than the maximum rooting depth of 5 feet. Twelve of those sites had vegetation (Table 3). A total of 7 species of aquatic plants were found, two of which were “visual only” (maps in Appendix E). Eurasian watermilfoil and white water lily were the most common species found at low littoral frequency of 14% and 8%, respectively. Together they accounted for 57% of the total relative frequency, suggesting the plant community is homogeneous (Table 5). The Simpson Diversity Index was 0.76 on a scale from 0 to 1. The FQI only factors species raked at survey points and does not include visuals or aquatic invasive species. Therefore, 4 species were included in the calculation, yielding a floristic quality of 11 with an average C value of 5.5 (Table 4). Chi-squared tests revealed a statistically significant decrease in coontail when comparing 2014 data to 2019 and when comparing 2018 to 2019 (Appendix M).

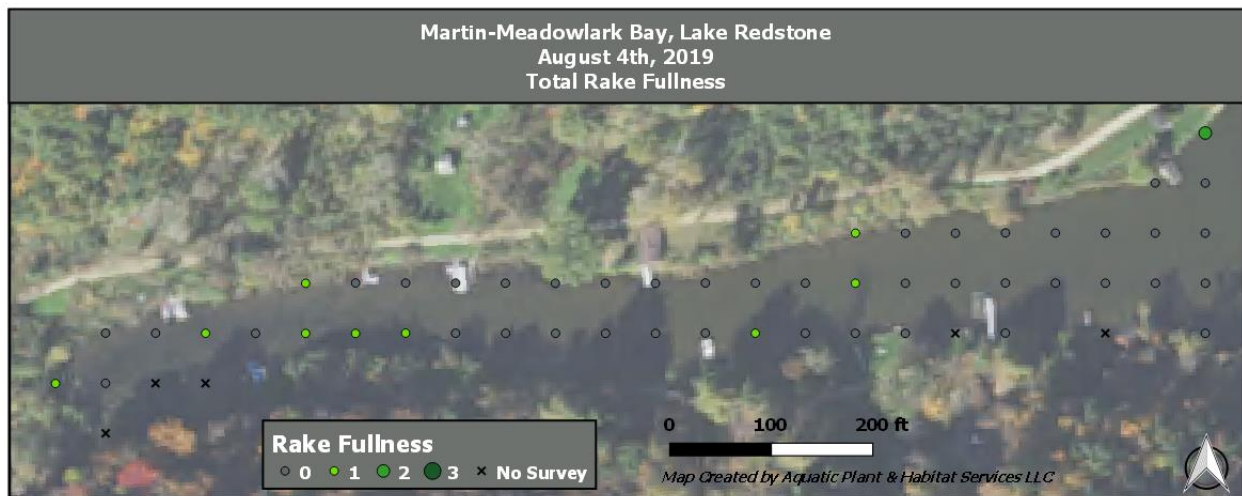
Figure 10 – Martin-Meadowlark Bay Total Rake Fullness Map

This was the sixth consecutive survey of Martin-Meadowlark Bay (2014-2019). Fifty-one points were surveyed and 49 were the same depth or shallower than the maximum rooting depth of 3 feet. Ten of those sites surveyed had vegetation (Table 3). A total of 4 species of aquatic plants were found, one of which was visual only and not counting filamentous algae (Maps in Appendix H). White water lily and small duckweed were the most common species found at 12% and 10% of littoral survey points respectively (42% and 36% in 2017). Together they accounted for 85% of the total relative frequency, indicating a highly homogeneous plant community (Table 6). Chi-squared tests of all plant species revealed a statistically significant (SS) decrease in the occurrence of small duckweed, white water lily, and coontail when comparing 2014 and 2019 data AND when comparing 2018 and 2019 data. There was also a SS decrease in EWM, filamentous algae, and large duckweed in 2019 data when compared to 2014. The Simpson Diversity Index for Martin-Meadowlark Bay was 0.62 on a scale from 0 to 1. The FQI only factors species raked at survey points and does not include visuals or aquatic invasive species. Therefore, only 2 species were included in the calculation, yielding a floristic quality of 7.1 with an average C value of 5 (Table 4).

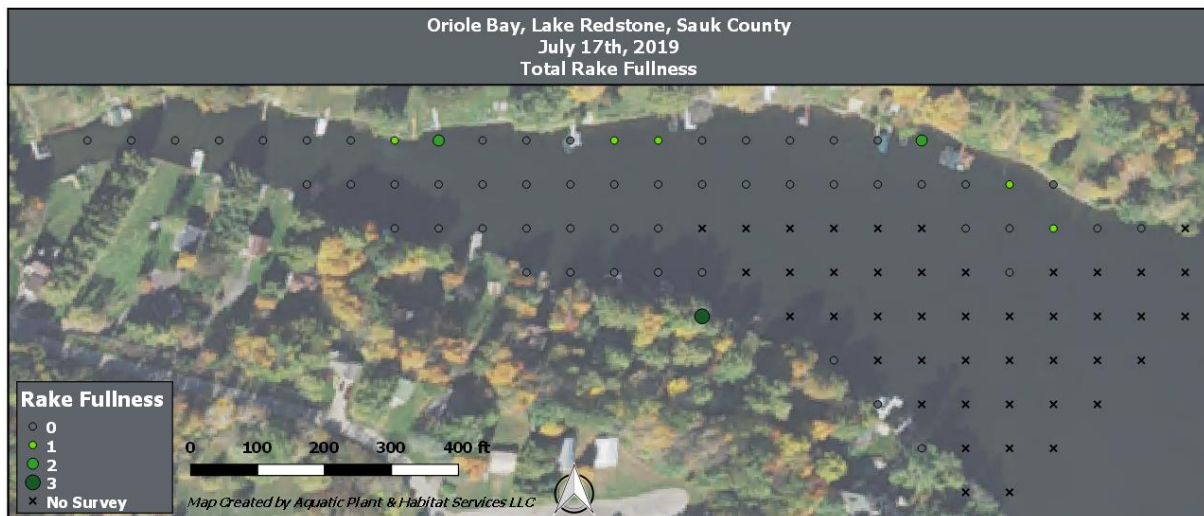
Figure 11 – Oriole Bay Total Rake Fullness Map

This was the fifth consecutive survey of Oriole Bay (2015-2019). A total of 104 predetermined survey waypoints exist in Oriole Bay but about half are consistently deeper than 12 feet. This year there were 60 points actually surveyed with a maximum rooting depth of 5 feet. There were 27 survey points ≤ 5 feet deep and 8 sites had vegetation. A total of 5 species of aquatic plants were found, one of which was “visual only” and not including filamentous algae. Maps of plant species can be found in Appendix I. Coontail was the most common species found at 26% of littoral survey points and accounted for 70% of the total relative frequency, indicating the plant community in Oriole Bay is highly homogeneous (Table 6). Chi-squared tests of all plant species revealed a statistically significant (SS) decrease in coontail, EWM, and slender waterweed when compared to 2015 data. There was also a SS decrease in small pondweed between the 2018 and 2019 data sets (Appendix M). The Simpson Diversity Index for Oriole Bay was 0.48 on a scale from 0 to 1. The FQI does not include aquatic invasive species. Therefore, 3 species were included in the calculation, yielding a floristic quality of 6.9 with an average C value of 4 (Table 4).

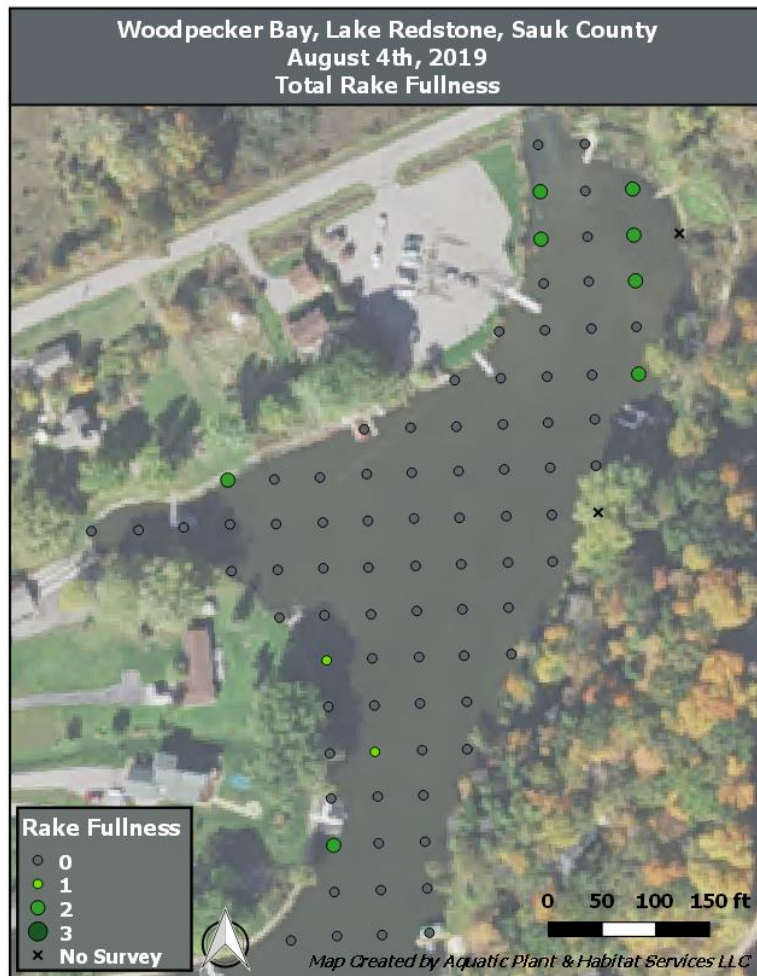
Figure 14 – Woodpecker Bay Total Rake Fullness Map

This was the fourth consecutive aquatic plant survey of Woodpecker Bay (2016-2019). A total of 86 survey waypoints were surveyed, 79 of which were shallower than the maximum rooting depth of 4 feet. Vegetation was present at 10 survey points (Table 3). A total of 6 species of aquatic plants were found, three of which were “visual only”. Maps of plant species can be found in Appendix L. White water lily was the most common species found at 11% of littoral survey points and with a relative frequency of 82% indicates the plant community is highly homogeneous (Table 6). A chi-squared test comparing data from 2016 and 2019 revealed a statistically significant decrease in large duckweed, small duckweed, EWM, filamentous algae, and coontail (Appendix M). There was also a SS decrease in coontail and small duckweed between 2018 and 2019. The Simpson Diversity Index was very low at 0.31 on a scale from 0 to 1. The FQI does not include aquatic invasive species or visual observations. Therefore, 2 species were included in the calculation, yielding a floristic quality of 7.1 with an average C value of 5 (Table 4).

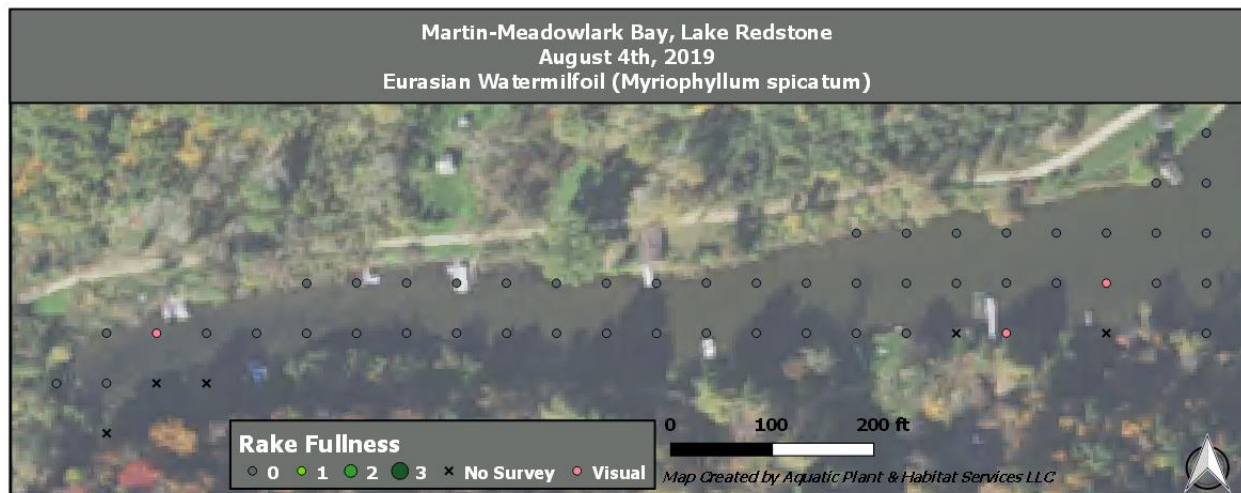
Figure 20 – Martin-Meadowlark Bay Eurasian Watermilfoil Map

EWM was uncommon in the bay with only 3 visual observations. EWM littoral frequency was 0% in 2019, 6% in 2018, 23% in 2017, 22% in 2016, 0% in 2015, and 42% in 2014. Herbicide treatment was done in 2015 to control EWM. There was a significant decrease in EWM in 2019 when compared to 2014.

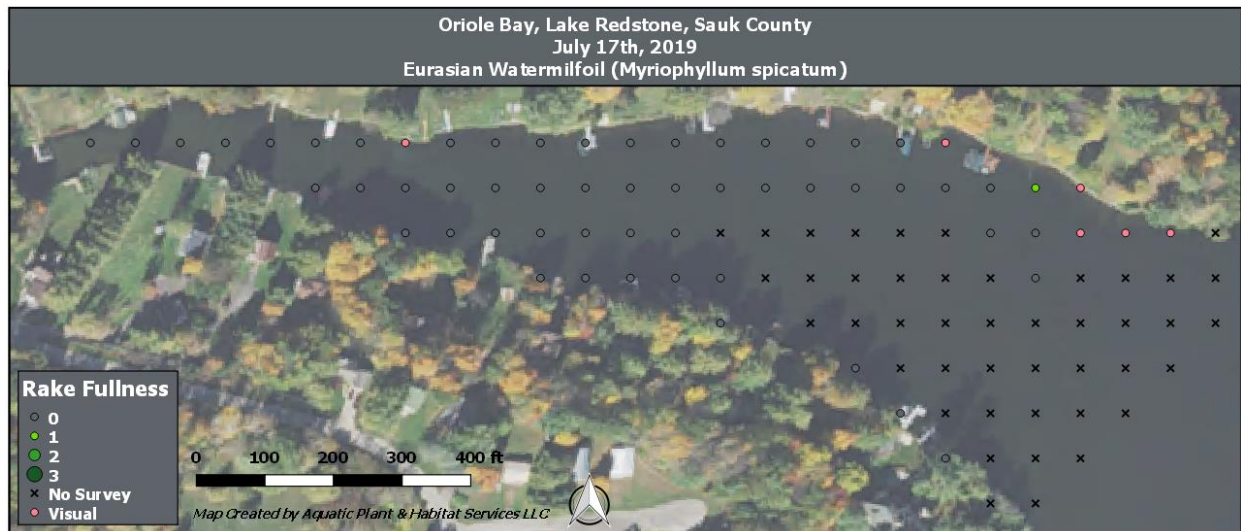
Figure 21 – Oriole Bay Eurasian Watermilfoil Map

EWM was found at only 1 site and visual observation at another 6 points making it a species of low occurrence in 2019, but still the second-most common species because aquatic plant occurrence was low overall. Littoral frequency was 4% in 2019, 6% in 2018, 24% in 2017, 14% in 2016, and 27% in 2015. Herbicide treatment was done in 2016 to control EWM. A chi-squared test of EWM 2019 compared to 2015 revealed a significant decrease in occurrence. There was no significant change in EWM from 2018 to 2019.

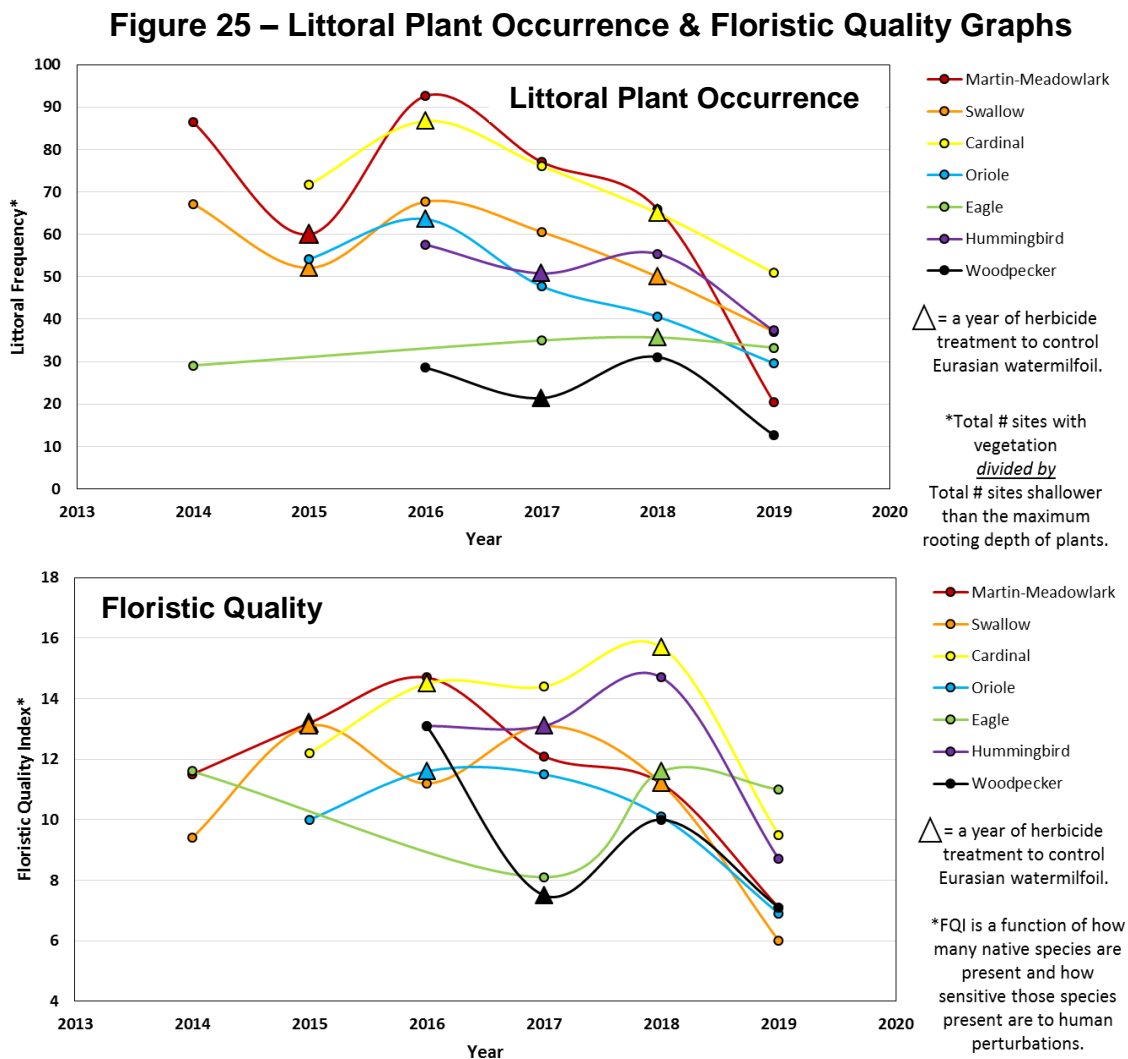
Graphs in Figure 25 illustrate data already listed in Table 3 & Table 4 for bays surveyed for >3 years. One graph charts a function of the total number of sites where plants *do* occur vs. the total number of sites where plants *could* occur, AKA littoral frequency. This function factors in water clarity because it only includes points that are equal to or shallower than the maximum depth of aquatic plants. In theory, if water clarity declines so do the number of points shallower than the maximum depth of plants. This graph shows that littoral frequency was lowest in 2019 compared to all previous years for 6 out of 7 bays⁵. The graph also illustrates a general decline in plant occurrence for 4 bays since 2016. The floristic quality graph charts a function of the number of native species present and how sensitive those species are to human perturbations. This year (2019) marked the lowest floristic quality value for 6 out of 7 bays charted. These trends could be due to environmental factors such as the historic flooding in the area that also likely impacted aquatic plant growth the following year in (2019).

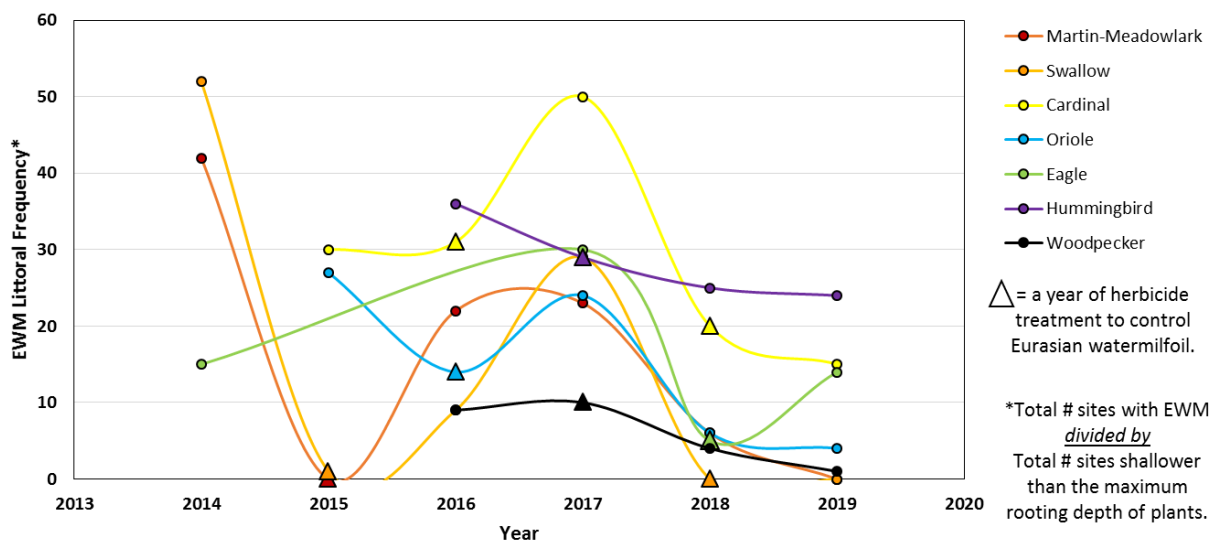
Figure 26 – EWM Littoral Frequency Graph

One way to measure the success of herbicide use is to assess littoral frequency of EWM before and after treatment. Figure 26 illustrates EWM littoral frequency in all bays that were treated with herbicide. Each bay is further discussed below. ***In summary, most herbicide treatments were successful in statistically significant reductions of EWM littoral frequency the summer immediately following spring treatment.*** This is also known as the first season following herbicide treatment, hence could also be summarized by saying that herbicide treatments were successful in SS reductions of EWM for at least one season after herbicide treatment. An entire calendar year following herbicide treatment would be 2 seasons after treatment.

Herbicide treatment in spring of 2016 resulted in NO statistically significant (SS) reduction of EWM when compared to survey results of 2015 and in fact the EWM littoral frequency was highest one year following herbicide treatment in 2017. These findings suggest the herbicide treatment in 2016 was not successful. Herbicide treatment in spring of 2018 resulted in a SS reduction of EWM when compared to survey results of 2017 and littoral frequency continued to decline in 2019. These findings suggest the herbicide treatment in 2018 was successful. However, plant occurrence in most bays in 2018 and 2019 has been lower than previous years. ***In summary, the first herbicide treatments in Cardinal Bay was unsuccessful in reducing littoral frequency of EWM while the second treatment was successful in reducing EWM for 2 seasons (one of which was statistically significant). EWM occurrence has not returned to pre-treatment levels of 2015 & 2017.***

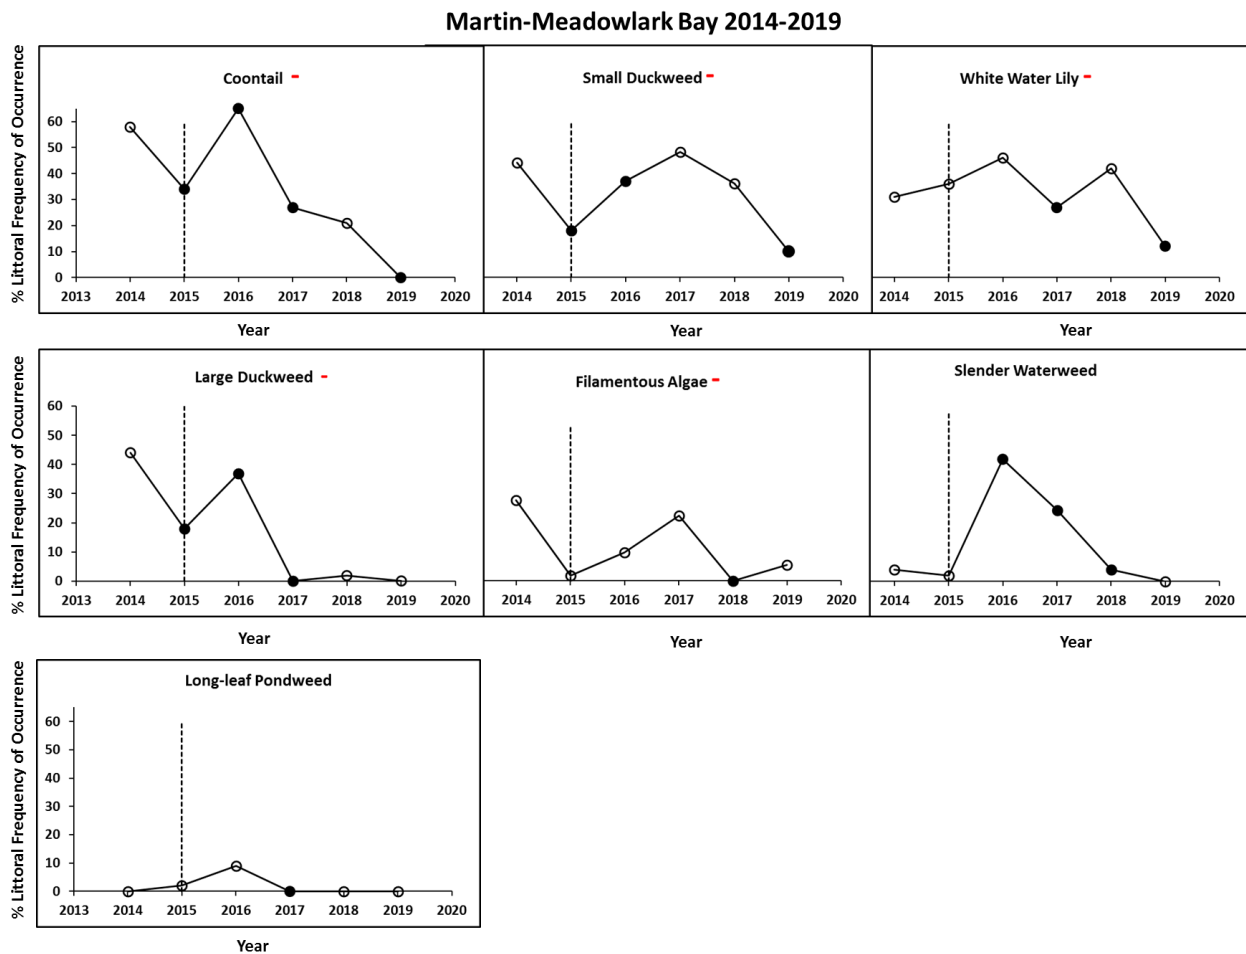
Percent littoral frequency (# sites plants found at points shallower than maximum rooting depth) is on the y-axis and each year a plant survey was completed is on the x-axis. Only species with a statically significant change (using Chi-squared tests) for at least one of the years are displayed. The dashed vertical lines represent years when herbicide treatments were done. Open circles represent *no* statistically significant change, solid circles represent a statistically significant change. Statistically significant changes between the first year of surveying and 2019 data are represented by + or - adjacent to plant names.
