Aquatic Plant Survey Report

Lake Redstone Bays

Sauk County, Wisconsin

Project initiated by:
Lake Redstone Protection District

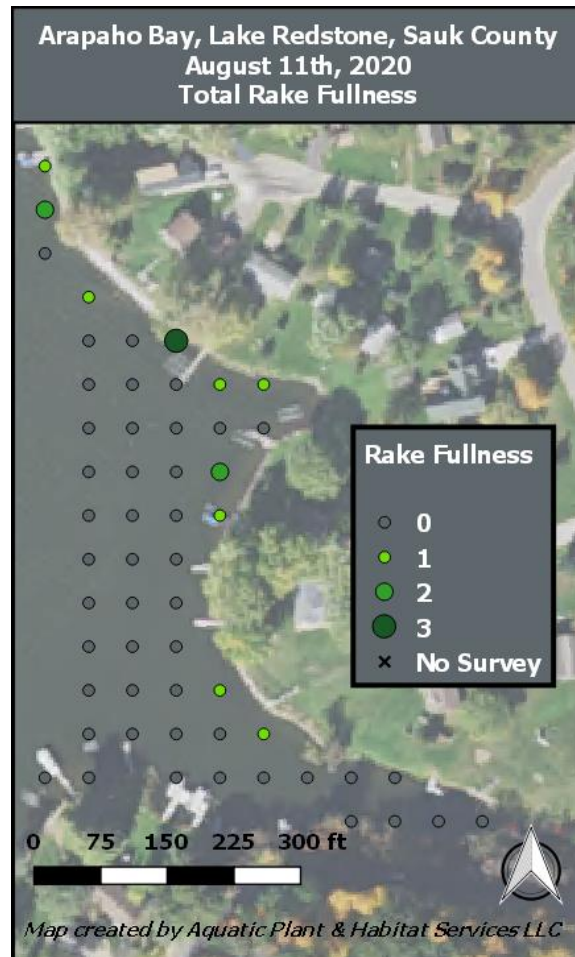
Figure 3 – Arapaho Bay Total Rake Fullness Map

This was the third survey of Arapaho Bay, the first taking place in 2015 using the name “Tanager Bay.” A total of 55 points were sampled and the maximum rooting depth was 6 feet compared to 8 feet in 2019. It is worth noting in 2019 that the maximum rooting depth of 8 feet occurred at only one sample point with the next deepest rooting depth of 5 feet. Twenty-nine sample points were ≤6 feet deep and only 10 of those sites had vegetation. A total of 5 species were found including EWM (maps in Appendix A). Similar to 2019 and 2015, Eurasian watermilfoil was the most common species found at 31% of littoral points in 2020, 24% in 2019, and 33% in 2015. After EWM, small pondweed and sago pondweed were the second-most common occurring species both at 7% of littoral points. Together they accounted for 86% of the total relative frequency, indicating the plant community is homogeneous as was the case in 2015 and 2019 (Table 3). The Simpson Diversity Index was 0.60 on a scale from 0 to 1. The FQI only factors species raked at survey points and does not include invasive species. Therefore, 4 species were counted yielding a floristic quality of 9.5 and an average C value of 4.8 (Table 6). Chi-squared tests revealed no statistically significant (SS) changes in the aquatic plant community when comparing 2019 to 2020 but there was a significant decrease in one native species (coontail) when comparing 2015 to 2020.

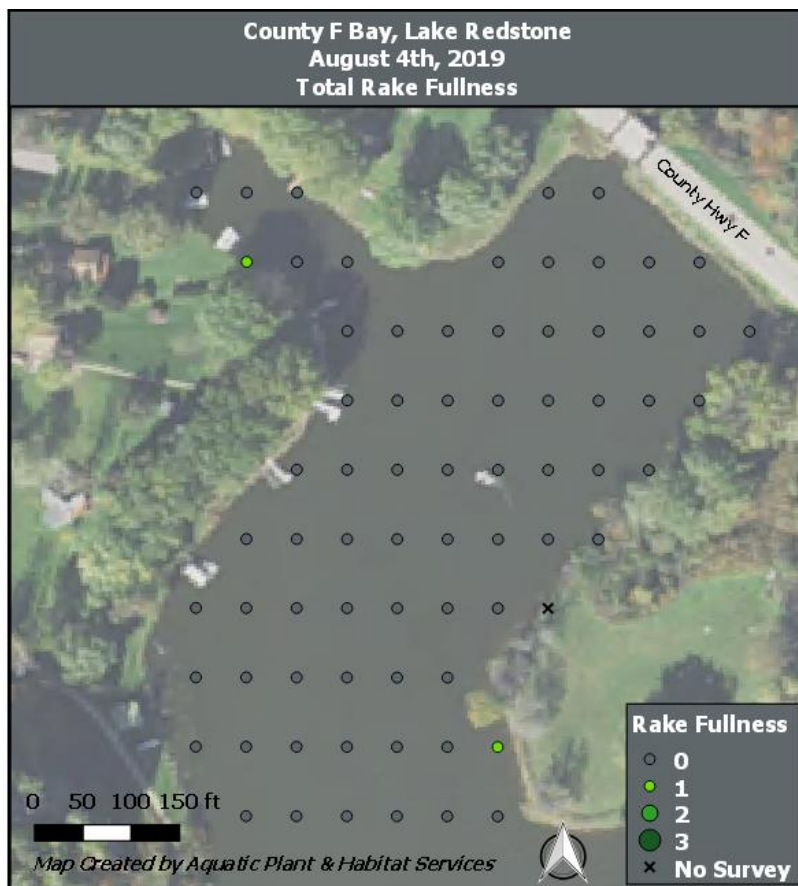
Figure 6 – County F Bay Total Rake Fullness Map

This was the second survey of the bay near County Highway F. There were 73 sample points attempted, 72 of which were actually surveyed because 1 site was terrestrial. The maximum rooting depth was very shallow at only 2.5 feet and only 6 sample points were 2.5 feet deep or shallower. The only species found was white water lily at two raked sample points (maps in Appendix D). Curly-leaf pondweed and filamentous algae were observed within 6 feet of sample points. Coontail and sago pondweed were also observed but not near any sample points. With only one species, the Simpson Diversity Index was zero on a scale of 0 to 1 and the floristic quality was 6 with an average C value of 6 (Table 6). Due to the very low plant occurrence in 2019 and 2020, it would be reasonable to suspend future sampling of this bay unless conditions change.

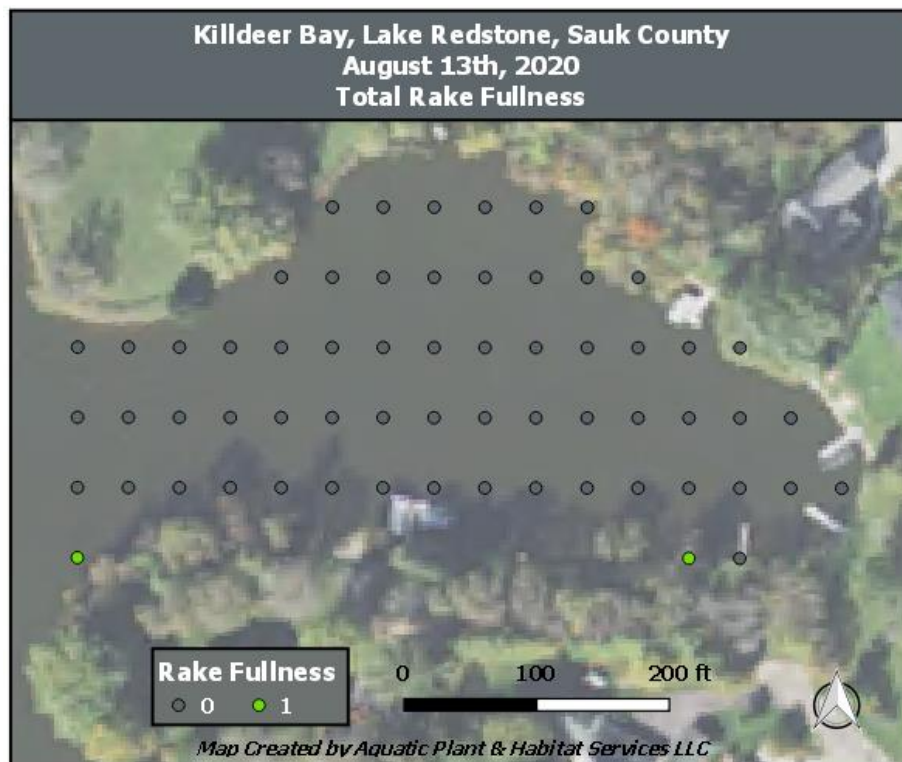
Figure 9 –Killdeer Bay Total Rake Fullness Map

This was the third survey of Killdeer Bay (2017, 2019 and 2020). All 62 points were surveyed and there were only 5 points the same depth or shallower than the maximum rooting depth of 2 feet and only 2 of those sites surveyed had vegetation (Table 5). A total of 4 species of aquatic plants were found but only one species (white water lily) was actually found at sample points while 3 were near sample points but not on the rake (maps in Appendix G). Since only one plant species was found, the Simpson Diversity Index was zero on a scale from 0 to 1. The floristic quality value was of 6 with an average C value of 6 (Table 4). Chi-squared tests revealed a statistically significant decrease in EWM in 2020 when compared to data from 2017 (Appendix N). Due to the very low plant occurrence in 2017 (5 points), 2019 (4 points), and 2020 (2 points), it would be reasonable to suspend future sampling of this bay unless conditions change.

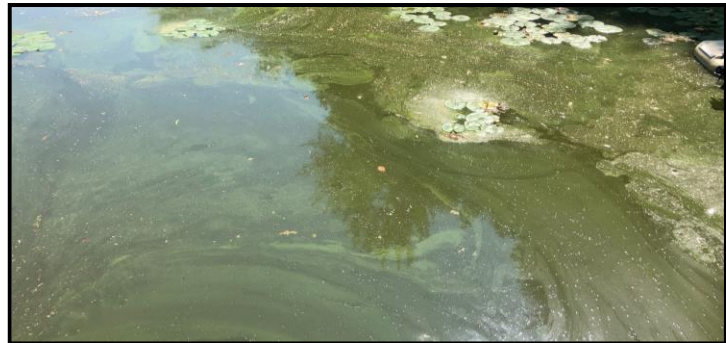
Figure 10 – Blue-green Algae in Martin Meadowlark Bay

Blue-green algae was observed in the farthest corner of Martin-Meadowlark Bay (Figure 10).

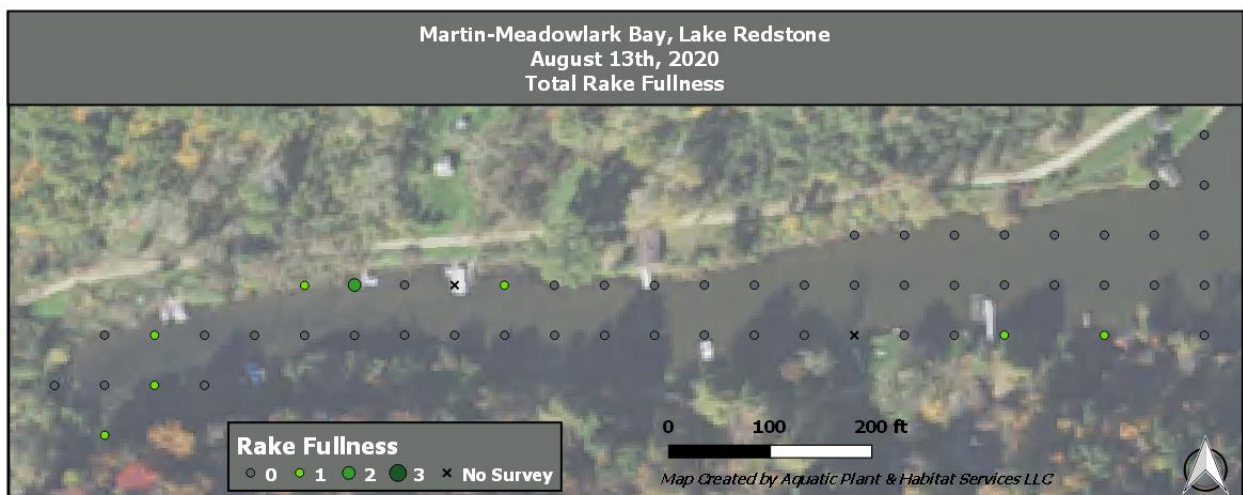
Figure 11 – Martin-Meadowlark Bay Total Rake Fullness Map

This was the seventh consecutive survey of Martin-Meadowlark Bay (2014-2020). Fifty-four points were surveyed and 33 were the same depth or shallower than the maximum rooting depth of 4 feet. Only 8 of those sites surveyed had vegetation (Table 5). A total of 7 species of aquatic plants were found, one of which (EWM) was observed in the bay but not near any sample points (Maps in Appendix H). White water lily and small duckweed were the most common species found at 9% and 12% of littoral survey points respectively. Together they accounted for 64% of the total relative frequency, indicating a homogeneous plant community (Table 4). Chi-squared tests of all plant species revealed a statistically significant (SS) decrease in the occurrence of EWM, coontail, small duckweed, white water lily, large duckweed, and filamentous algae when comparing 2020 and 2014 data. The Simpson Diversity Index for Martin-Meadowlark Bay was 0.76 on a scale from 0 to 1. The FQI only factors species raked at survey points and does not include visuals or aquatic invasive species. Therefore, 6 species were included in the calculation, yielding a floristic quality of 13.9 with an average C value of 5.6 (Table 6).

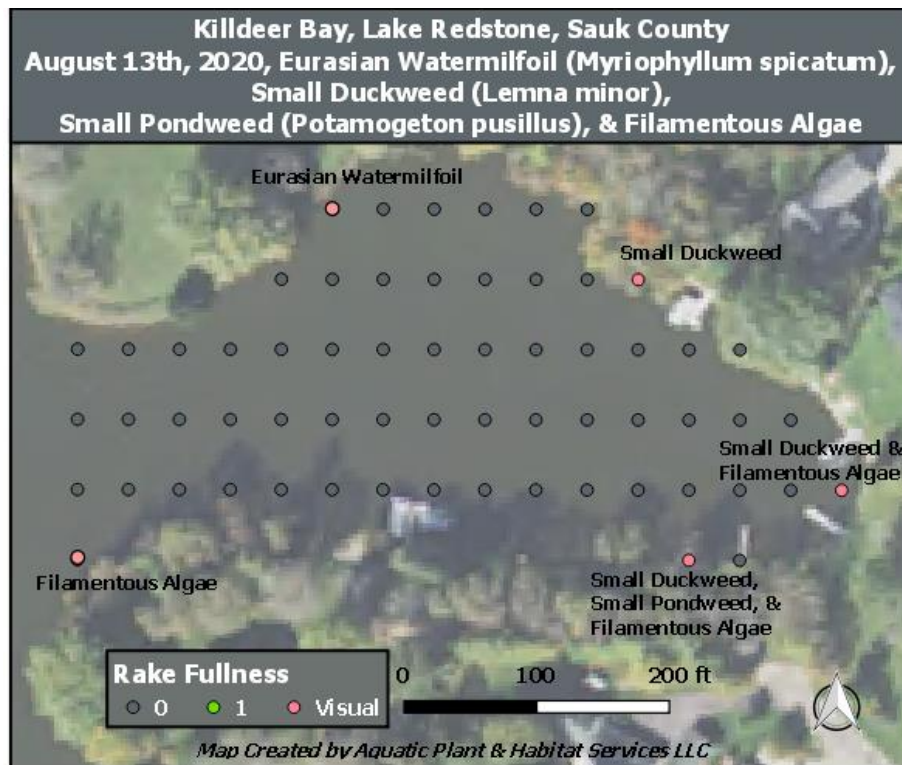
Figure 22 – Killdeer Bay Map of Eurasian Watermilfoil, Small Duckweed, Small Pondweed, & Filamentous Algae

EWM was uncommon in the bay with only 1 visual observation and was not found on the rake at any sample points. EWM littoral frequency was 0% in both 2019 and 2020 but at 40% in 2017 (but still only at 4 points). No herbicide treatment was done in Killdeer Bay. There was a statistically significant decrease in EWM in 2020 when compared to 2017 even though the reduction was only from 4 points to 0 points.

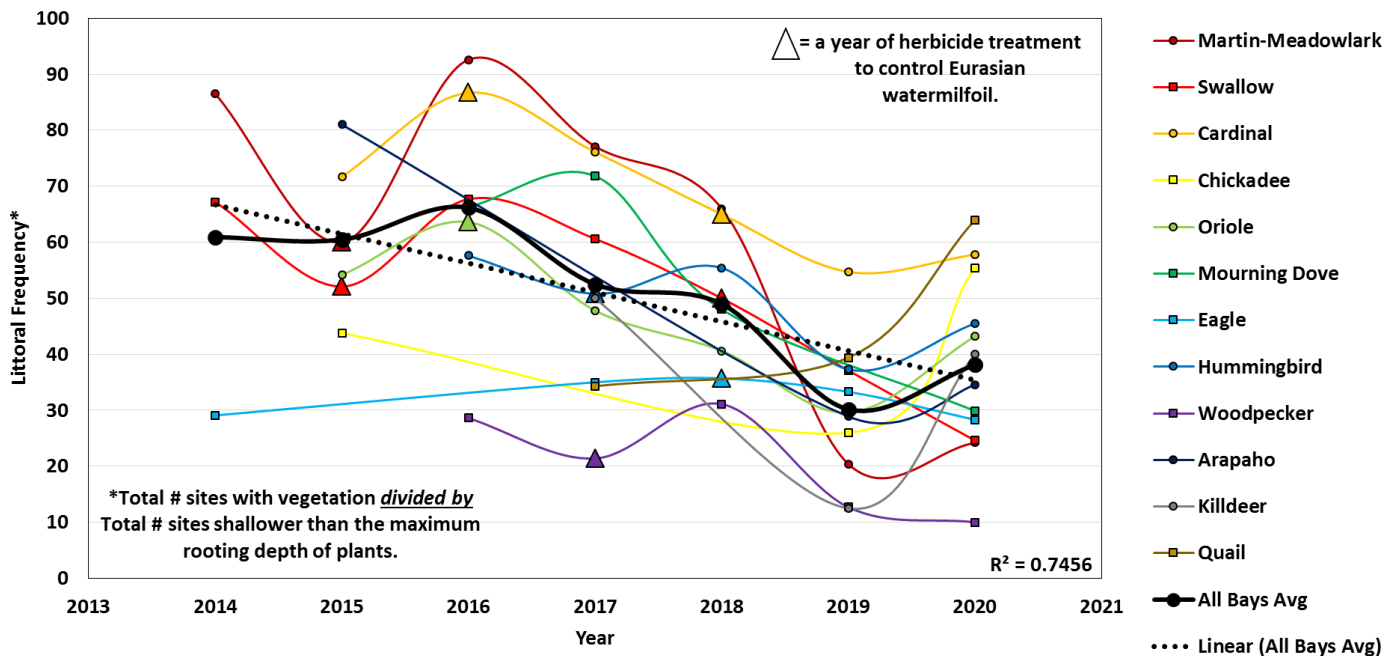
Figure 27 – Littoral Plant Frequency Graph

The graph in Figure 27 illustrates data already listed in Table 3 and Table 4 for bays surveyed for ≥ 3 years. The graph charts a function of the total number of sites where plants (native & non-native) *do* occur vs. the total number of sites where plants *could* occur, AKA littoral frequency, thereby factoring in water clarity because it only includes points that are equal to or shallower than the maximum depth of aquatic plants. In theory, if water clarity declines so do the number of points shallower than the maximum depth of plants. This graph shows that average littoral frequency⁶ was lowest in 2019 and somewhat higher in 2020. A linear trendline⁷ of the average littoral frequency among all bays except County F suggests the littoral frequency of aquatic plants (native and non-native) has been on a downward trend from 2014 through 2020 with an R2 value of 0.75.⁸ This trends could be due to environmental factors such as the historic flooding in the area in 2018 that also likely impacted aquatic plant growth the following year (2019). The trend does not appear to be consistent among all bays treated with herbicide. In other words, herbicide treatment in a given year does not appear to be a main factor in driving down littoral frequency, although it can't be ruled out as a contributing factor.

⁶ Littoral frequency of County F not included because it was only surveyed for two years. County F was among the lowest in littoral frequency and maximum rooting depth in 2019 and 2020.

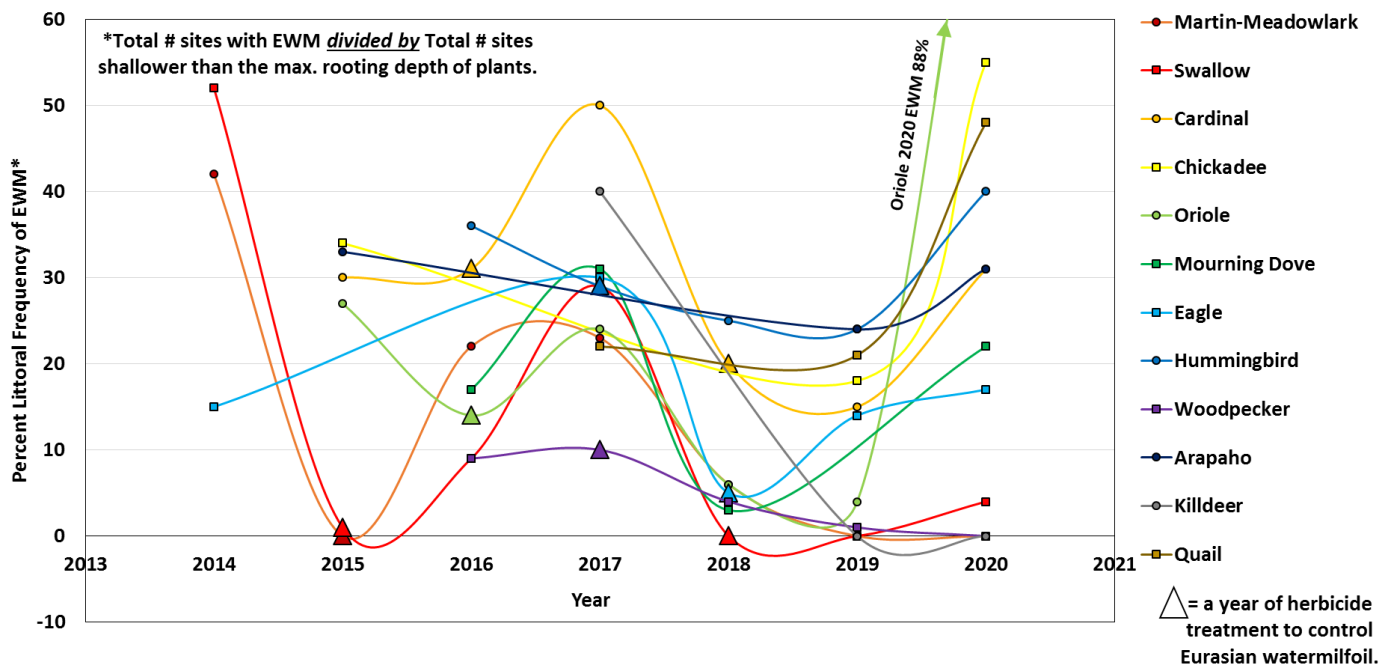
Figure 28 – Eurasian Watermilfoil Littoral Frequency Graph

Figure 28 illustrates EWM littoral frequency in all bays from 2014 through 2020. ***In summary, all 13 bays had higher or the same EWM occurrence in 2020 when compared to 2019⁹. The increase in EWM was statistically significant in 5 of those bays.*** This was unexpected because the act of dredging removes sediment and along with it come roots and seeds. Therefore, EWM was not expected to increase in 2020 compared to pre-dredging conditions. However, EWM and non-native/invasive species in general thrive in disturbed environments and the dredging may have opened a niche for EWM to recolonize more quickly than native species. Further potential explanation is that root balls not fully removed and/or fragments of EWM readily grew in the dredged areas. Regrowth from seed is likely not a primary mechanism of recovery for EWM, although the possibility of some EWM seed germination isn't ruled out. Furthermore, it may be worthwhile to have samples from Lake Redstone genetically tested to rule out the presence of hybrid milfoil, which is the genetic cross between Eurasian watermilfoil and native northern watermilfoil (*Myriophyllum sibiricum*). Although Lake Redstone does not have northern watermilfoil present, the introduction of the hybrid strain could occur through boat traffic. The most recent genetic testing of Lake Redstone EWM was done in 2013 with results concluding the milfoil was Eurasian and not hybrid. However, hybrid milfoil testing periodically is recommended to detect whether it has been introduced into the system.

⁹ Mourning Dove Bay was not surveyed in 2019 because dredging was already underway in July. Data from 2020 is compared to 2018 for Mourning Dove Bay. Woodpecker Bay had essentially the same EWM occurrence in 2020 at 0% compared to 1% in 2019.

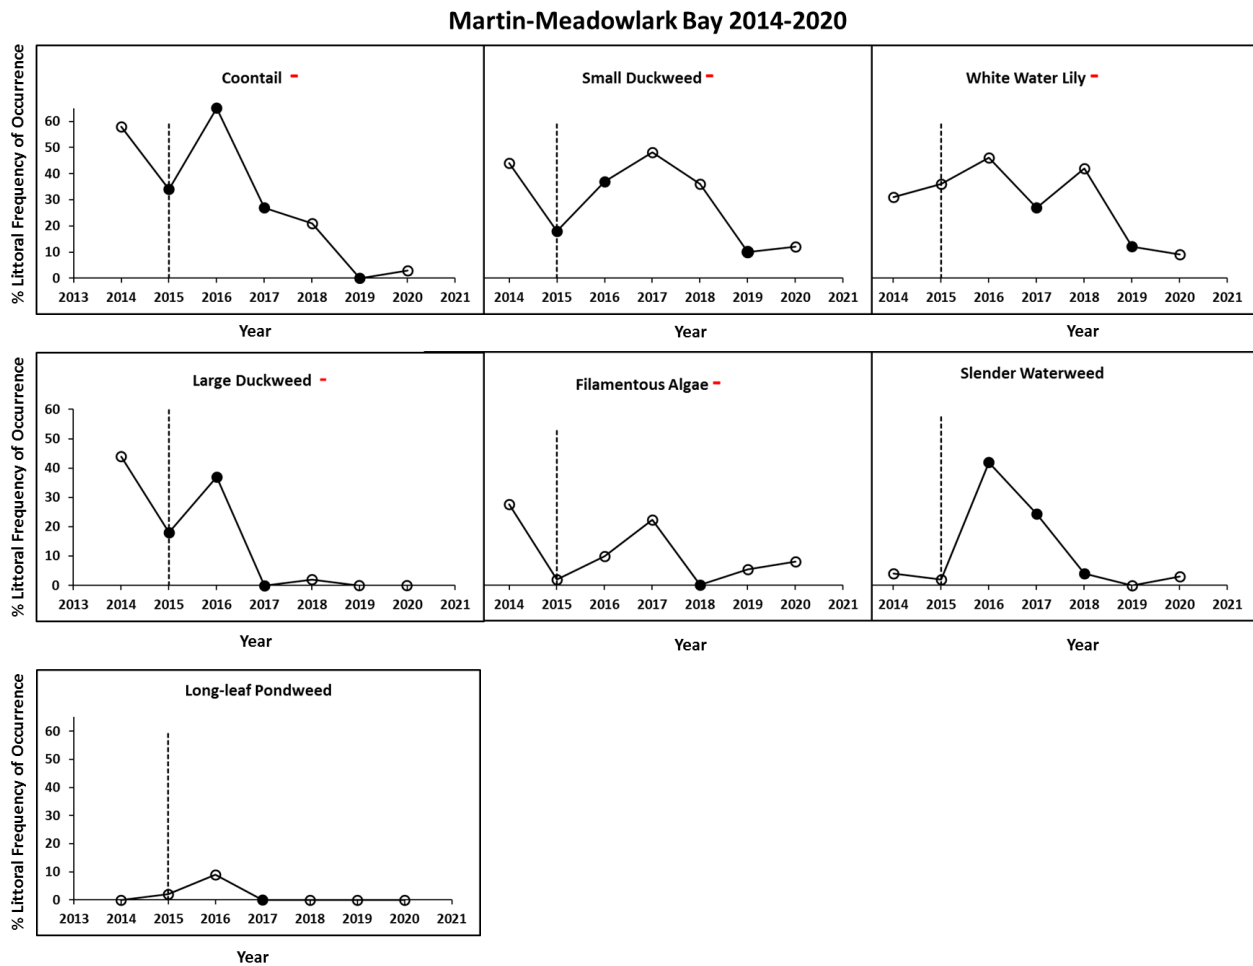
Percent littoral frequency (# sites plants found at points shallower than maximum rooting depth) is on the y-axis and each year a plant survey was completed is on the x-axis. Only species with a statically significant change (using Chi-squared tests) for at least one of the years are displayed. The dashed vertical lines represent years when herbicide treatments were done. Open circles represent *no* statistically significant change, solid circles represent a statistically significant change. Statistically significant changes between the first year of surveying and 2019 data are represented by + or - adjacent to plant names.
