**Eurasian water-milfoil (*Myriophyllum spicatum*)  
Late Summer Bed Mapping Survey  
Trego Lake (WBIC: 2712000)  
Washburn County, Wisconsin**

Endangered Resource Services, LLC  
Matthew S. Berg, Research Biologist  
Saint Croix Falls, Wisconsin  
August 25, 2020

In order to determine the level of infestation, the TLD, LEAPS, and the WDNR requested we complete a late-summer EWM bed mapping survey of the lake's visible littoral zone. These data will be used to determine the acreage and density of EWM to help guide any potential future management. This report is the summary analysis of that field survey conducted on August 25, 2020.

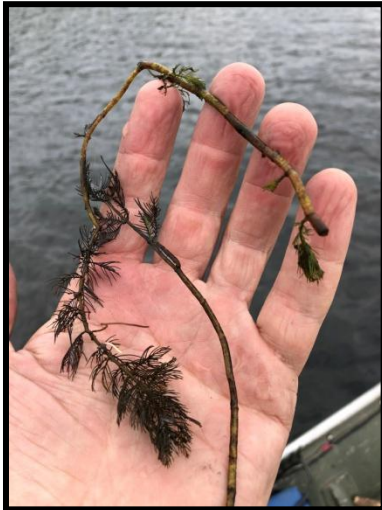
Typical unhealthy EWM seen 8/25/20

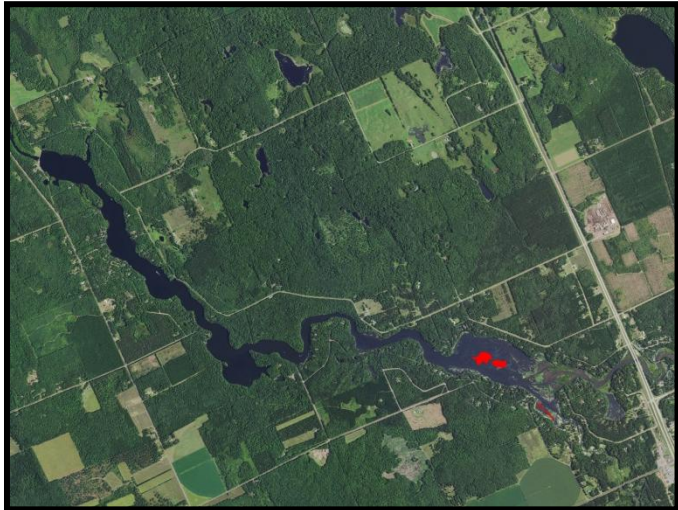
EWM beds on Trego Lake 8/25/20

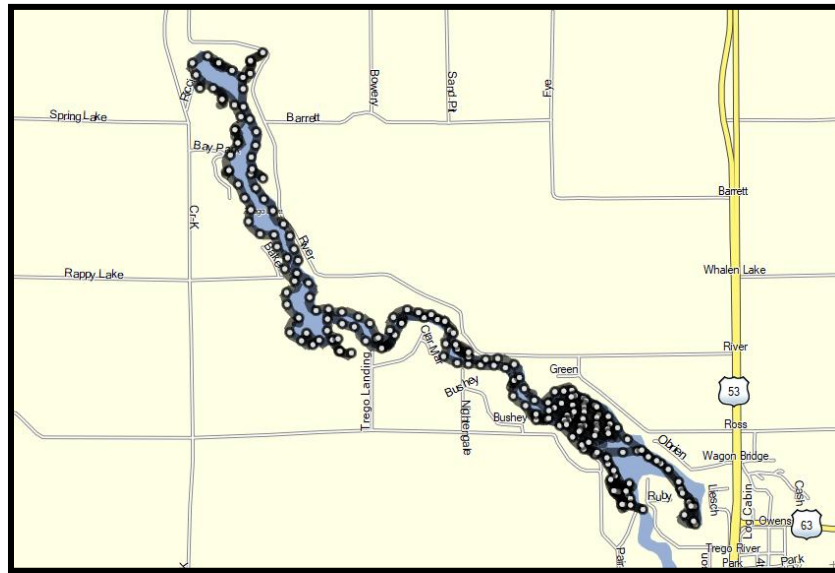
Figure 3: August 25, 2020 EWM Littoral Zone Survey – GPS Tracks

On August 25, 2020, we searched 35.7km (22.2miles) of transects throughout the lake's visible littoral zone (Figure 3). In total, we mapped three low density beds that covered 6.37 acres (1.66% of the lake's surface area) (Table 1). Outside of these areas, we marked just nine additional isolated plants with eight of these occurring outside the beds in the "lake" area near the Namekagon River Inlet. Downstream, we located and rake removed a single plant immediately upstream from the public landing. The only evidence of EWM downstream from the landing was a single floating fragment that we found in a side channel near the dam (Figure 4) (Appendix I).

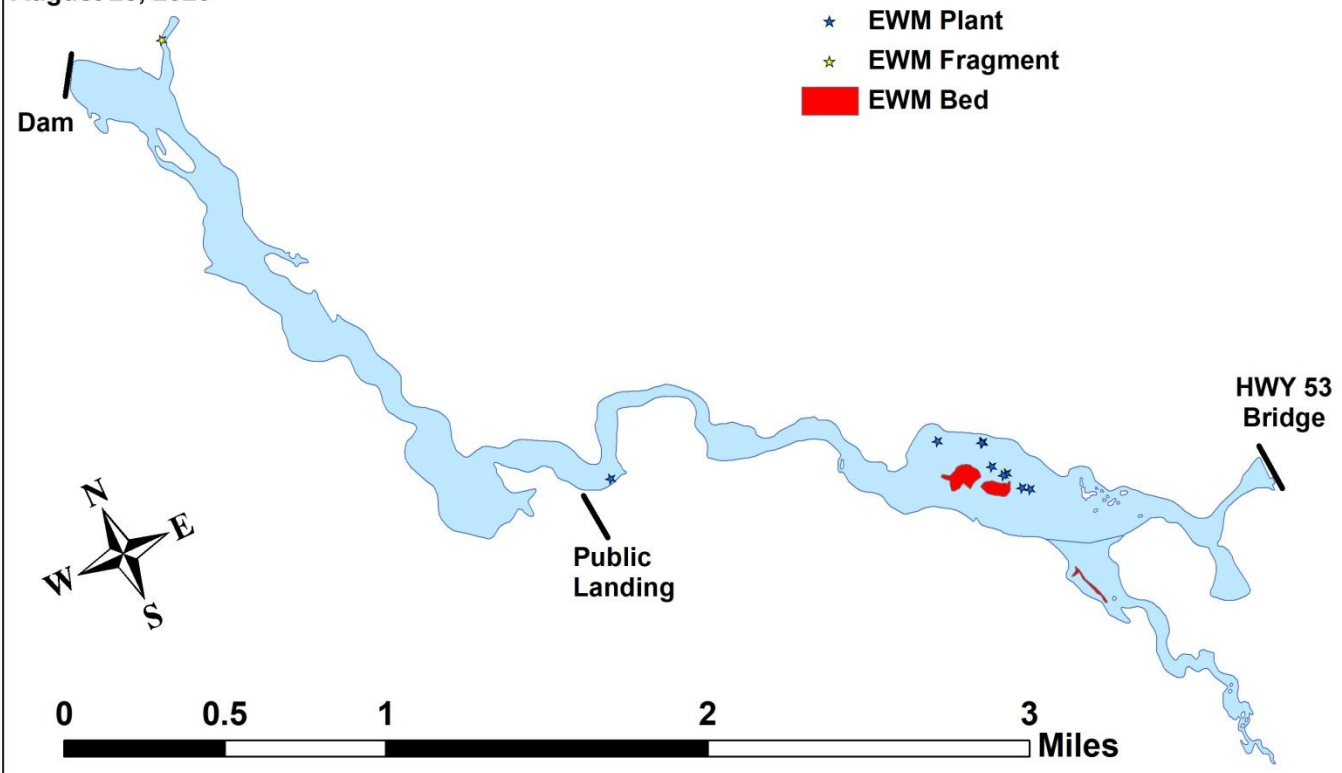
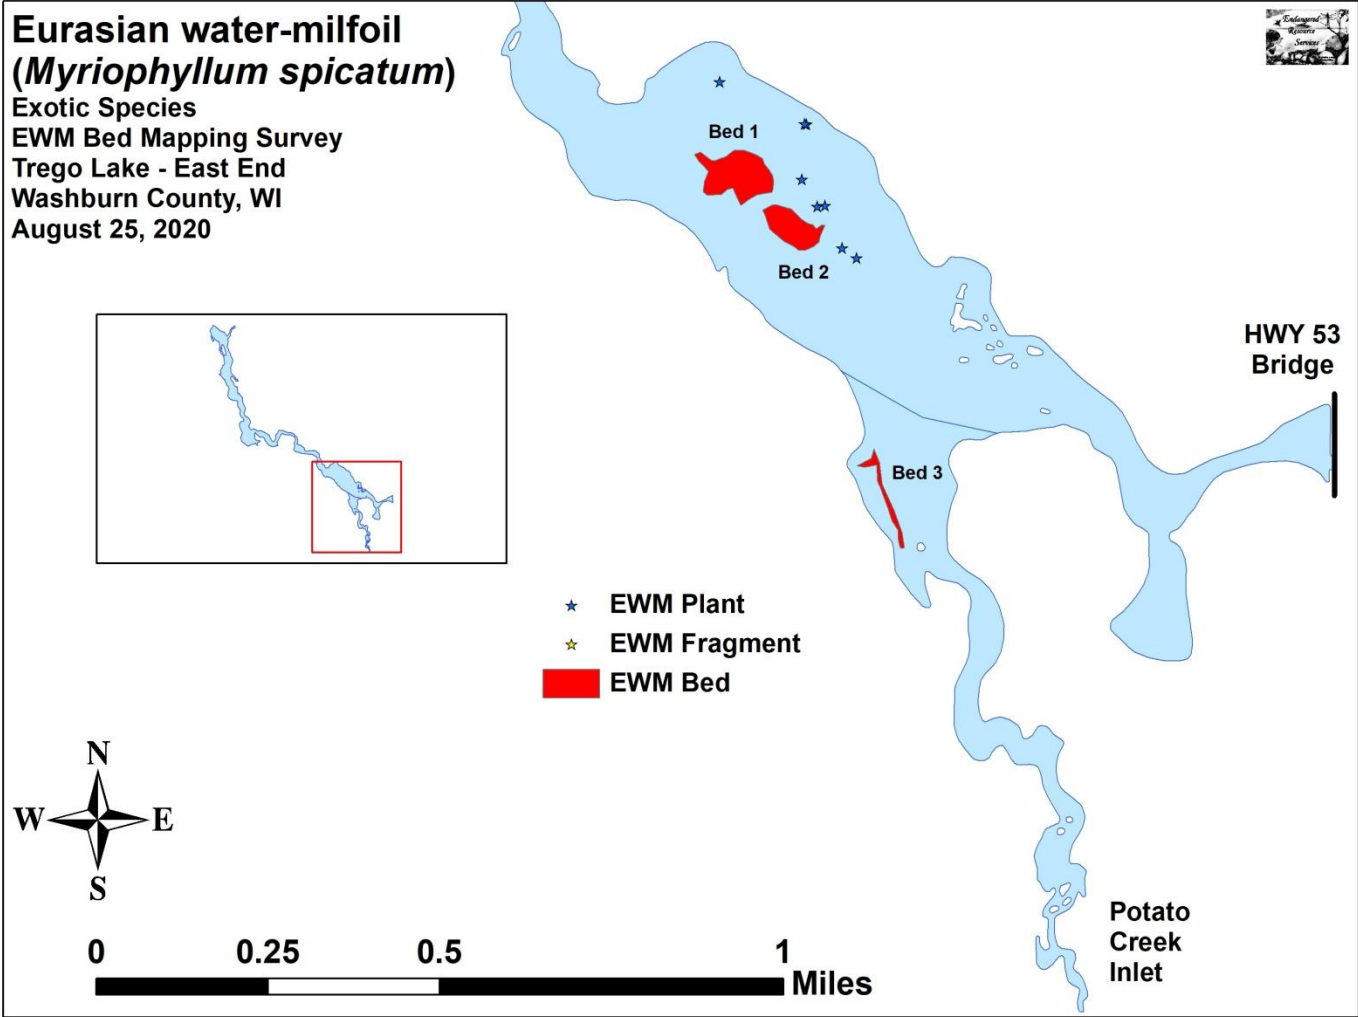
## **Appendix I: 2020 Eurasian Water-milfoil Bed Maps**

Exotic Species  
EWM Bed Mapping Survey  
Trego Lake  
Washburn County, WI  
August 25, 2020
