# MINONG FLOWAGE WASHBURN COUNTY

## 2022 MANAGEMENT SUMMARY REPORT WBIC: 2692900

Prepared by: Dave Blumer, Lake Educator

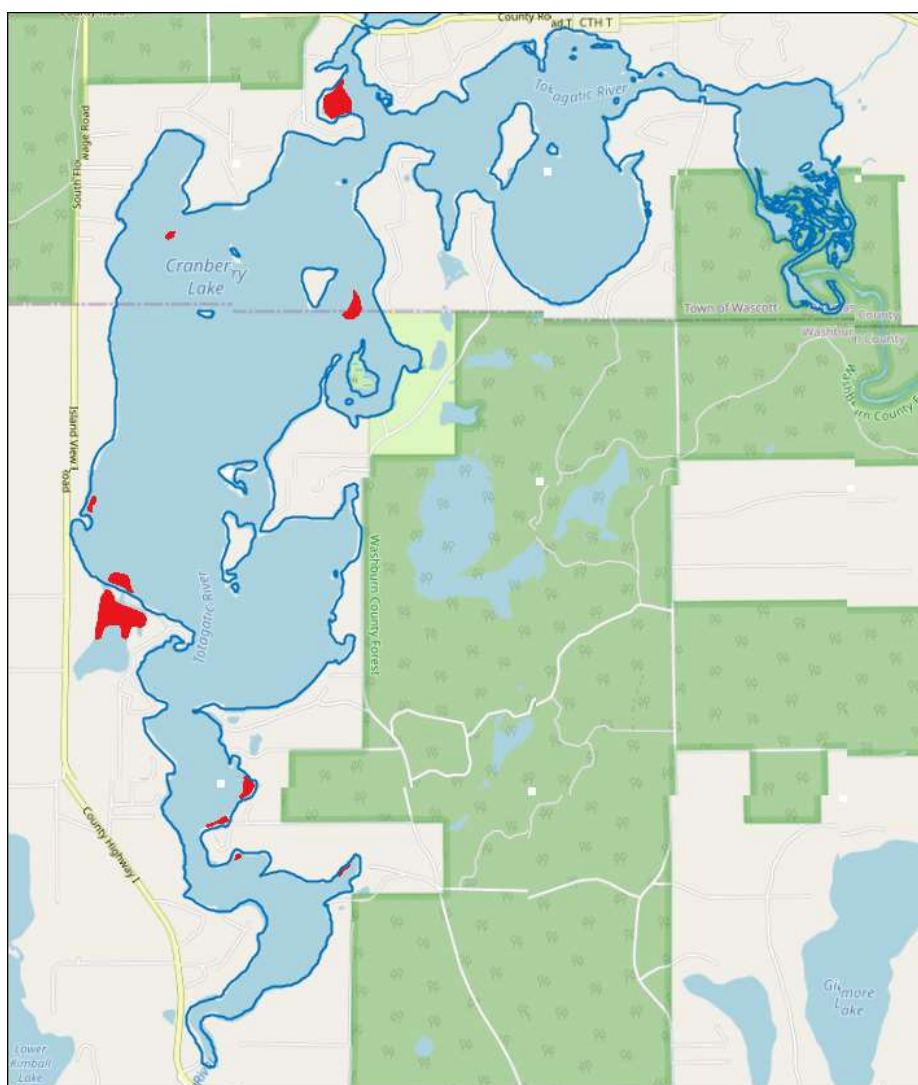
The LEAPS survey identified 10 beds of dense growth EWM totaling more than 20 acres, mostly in water deeper than 5-ft (Figure 1). This was a major disappointment and as mentioned did not even include what is usually the three worst areas for EWM. The good news was that there was almost no EWM in water <5-ft deep, strongly suggesting that the 5-ft winter drawdown effectively controlled EWM in shallow water, but not in deeper water.

**Figure 1: June 27, 2022 EWM meandering bed mapping survey - LEAPS**

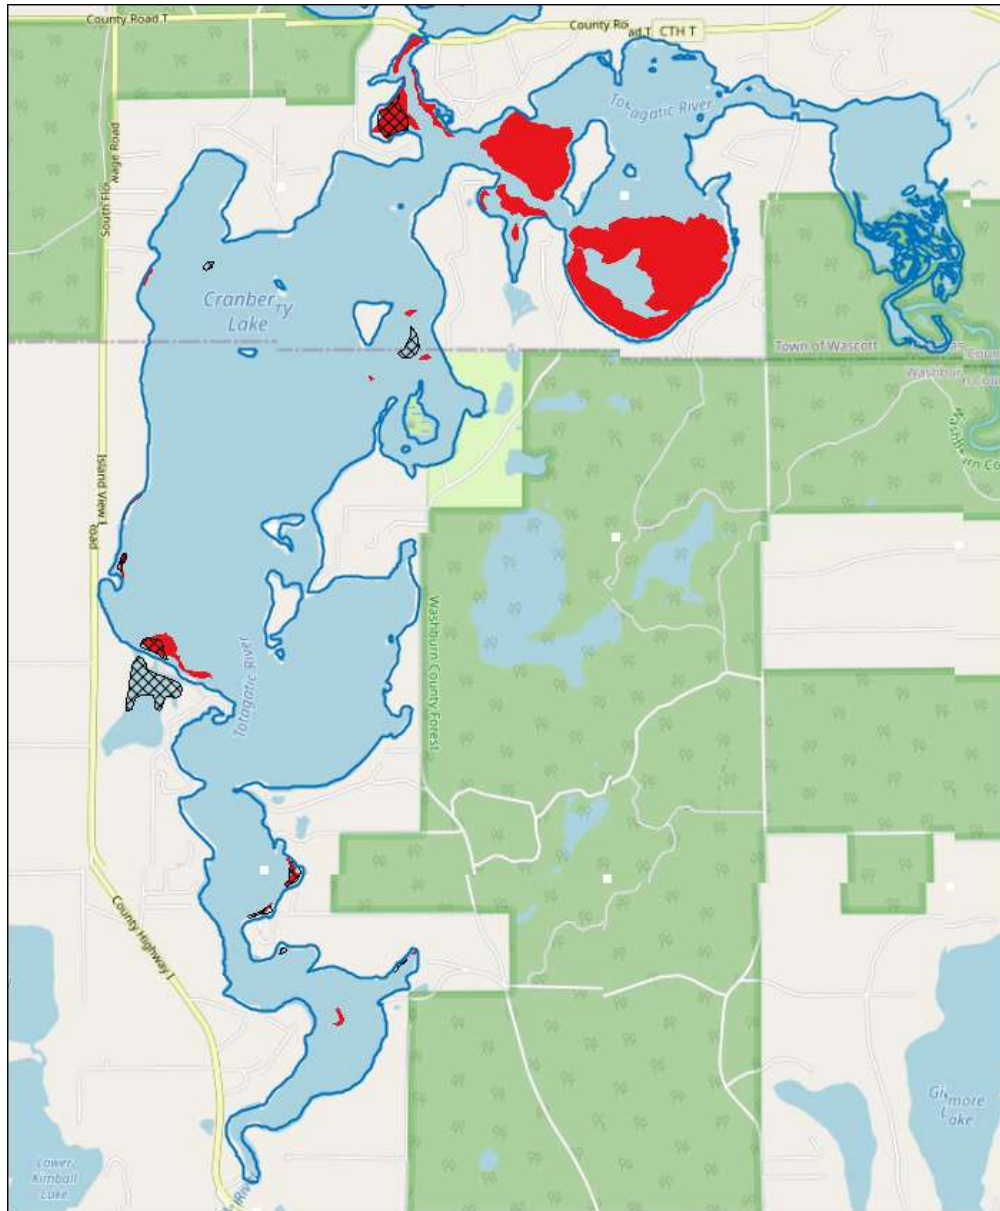
Endangered Resource Services completed a whole-lake, meandering survey on September 24, 2022. The ERS survey basically found the same thing that LEAPS did in late June. EWM was under control in water <5-ft, but growing aggressively in water deeper than that. In total, ERS mapped 19 beds totaling 116.9 acres. Nearly all of the areas mapped in June had expanded, and the North Basin and Serenity Bay had a lot of EWM. EWM was also found

**Figure 2: September 24, 2022 meandering EWM bed mapping survey – ERS (red polygons) Black hash polygons – June 27 LEAPS survey results)**

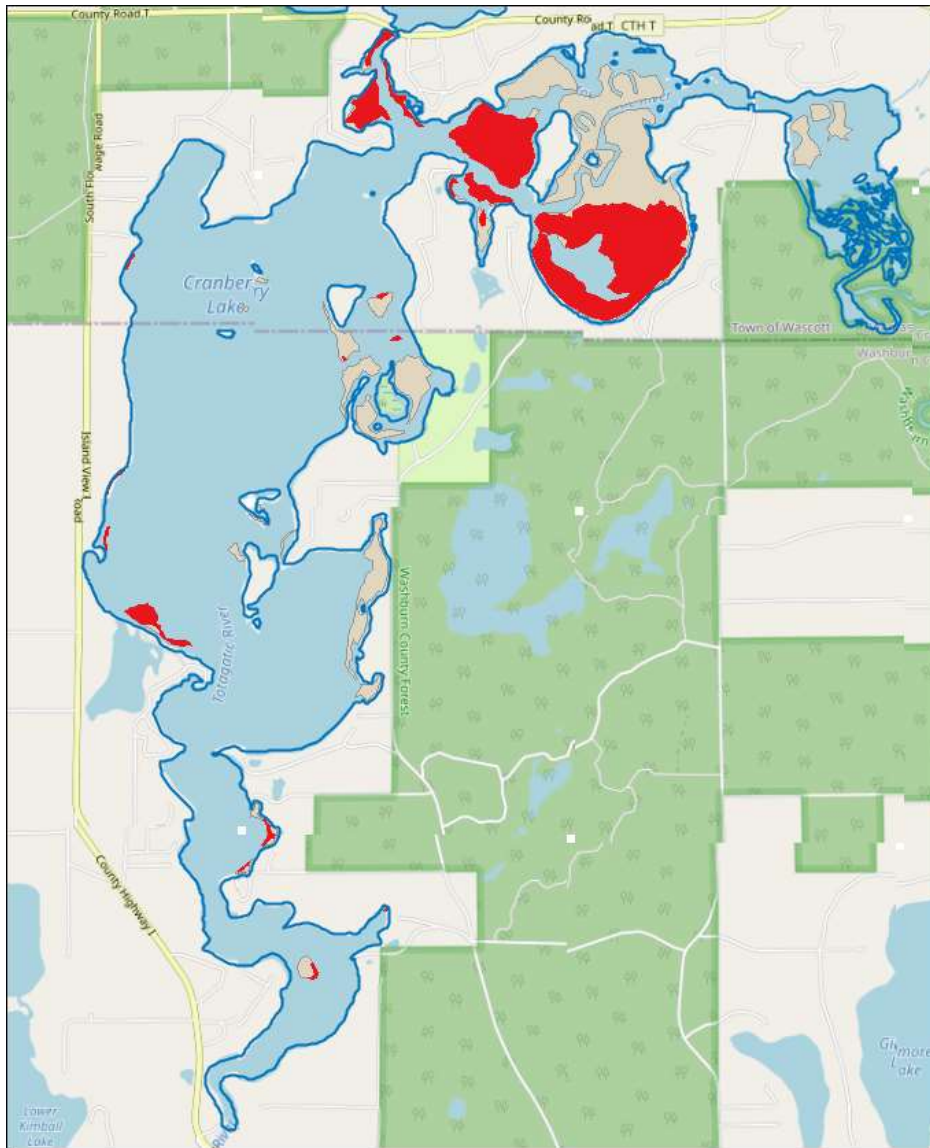
in the East Basin past Smith’s Bridge, but it was not considered a “bed” at the time of the survey. This survey showed a reduction in the total acreage of EWM in the 2021 survey of 44% (89.61 acres). The 2021 fall bed mapping survey identified 205.7 acres (Figure 3). All of the reduction was seen in areas of the Flowage that had water depths <5-ft (Figure 4).

Figure 3: 2021 bed mapping results (tan polygons) and 2022 bed mapping results (red polygons)

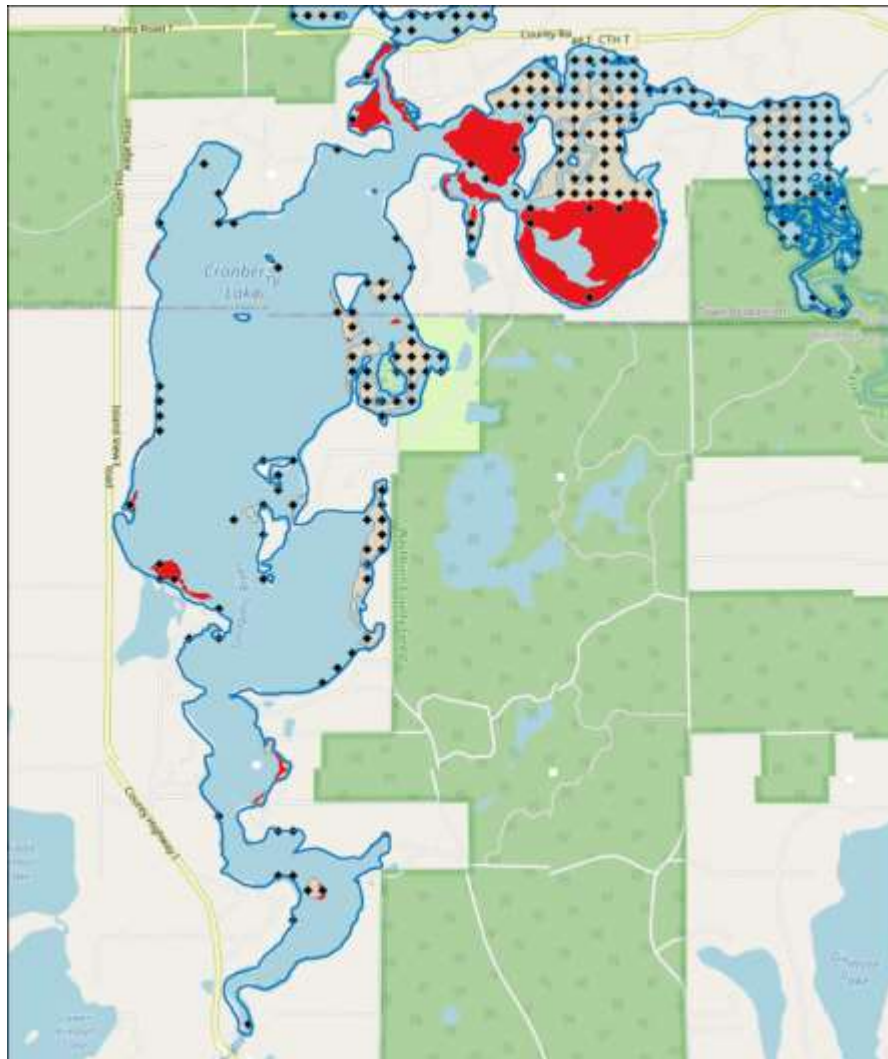
Figure 4: 2021 bed mapping (tan), 2022 bed mapping (red), and water <5-ft deep (black points)

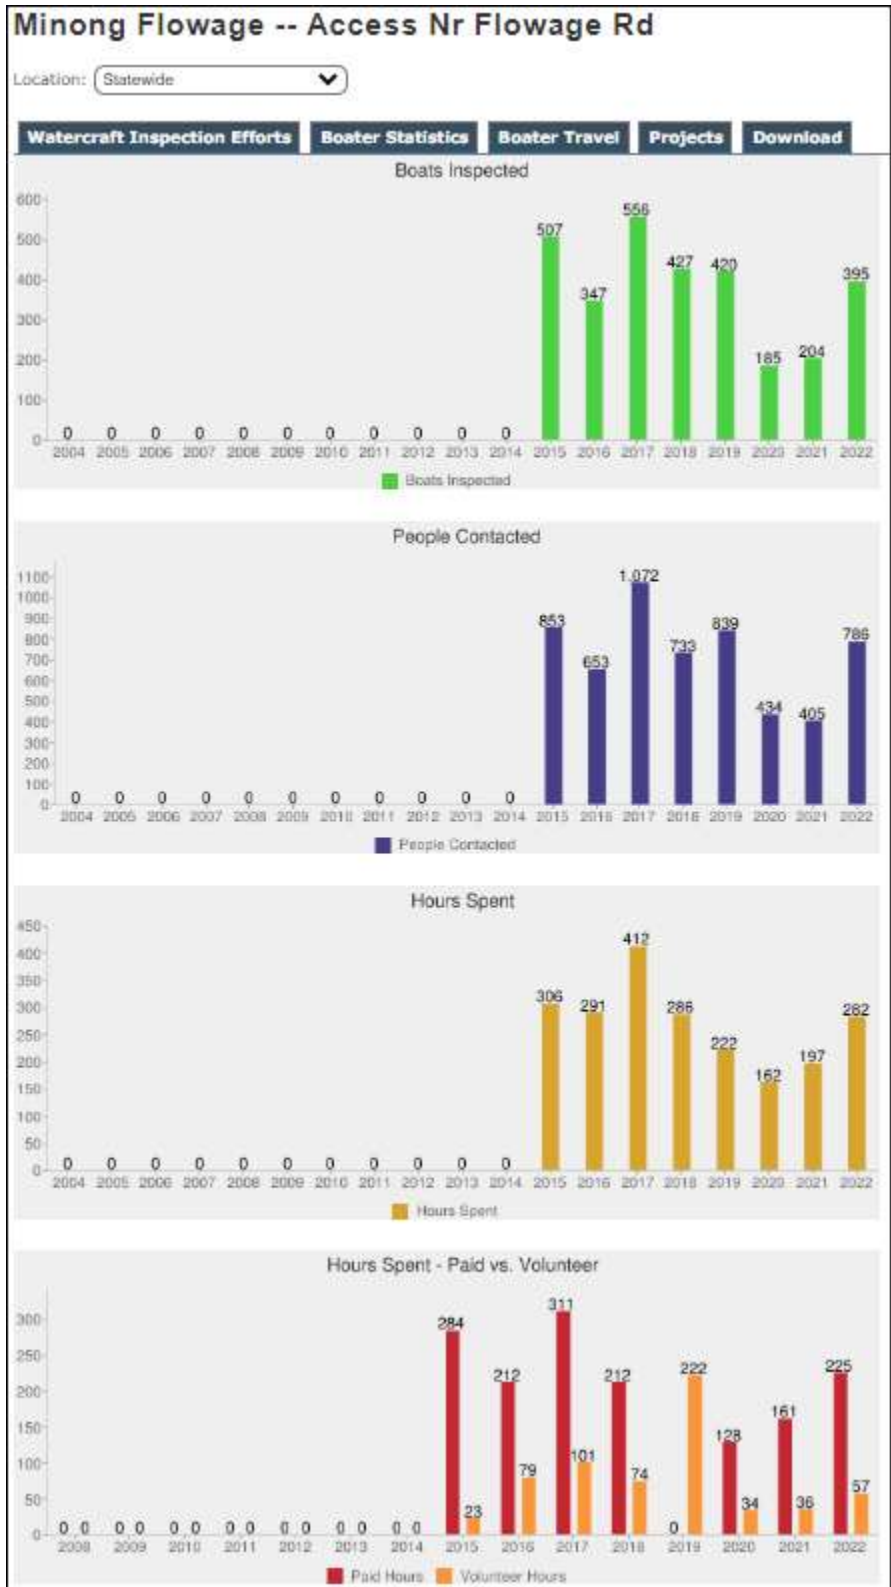
Several AIS prevention and monitoring activities were completed by the MFA in 2022. Watercraft inspection through the Clean Boats Clean Waters program was supported by the MFA at the WDNR Landing. Watercraft inspectors contacted 395 boats, 786 people, and spent 282 hours, paid and volunteer covering the landing (Figure 5).

Figure 5: CBCW numbers from the WDNR landing on the Minong Flowage

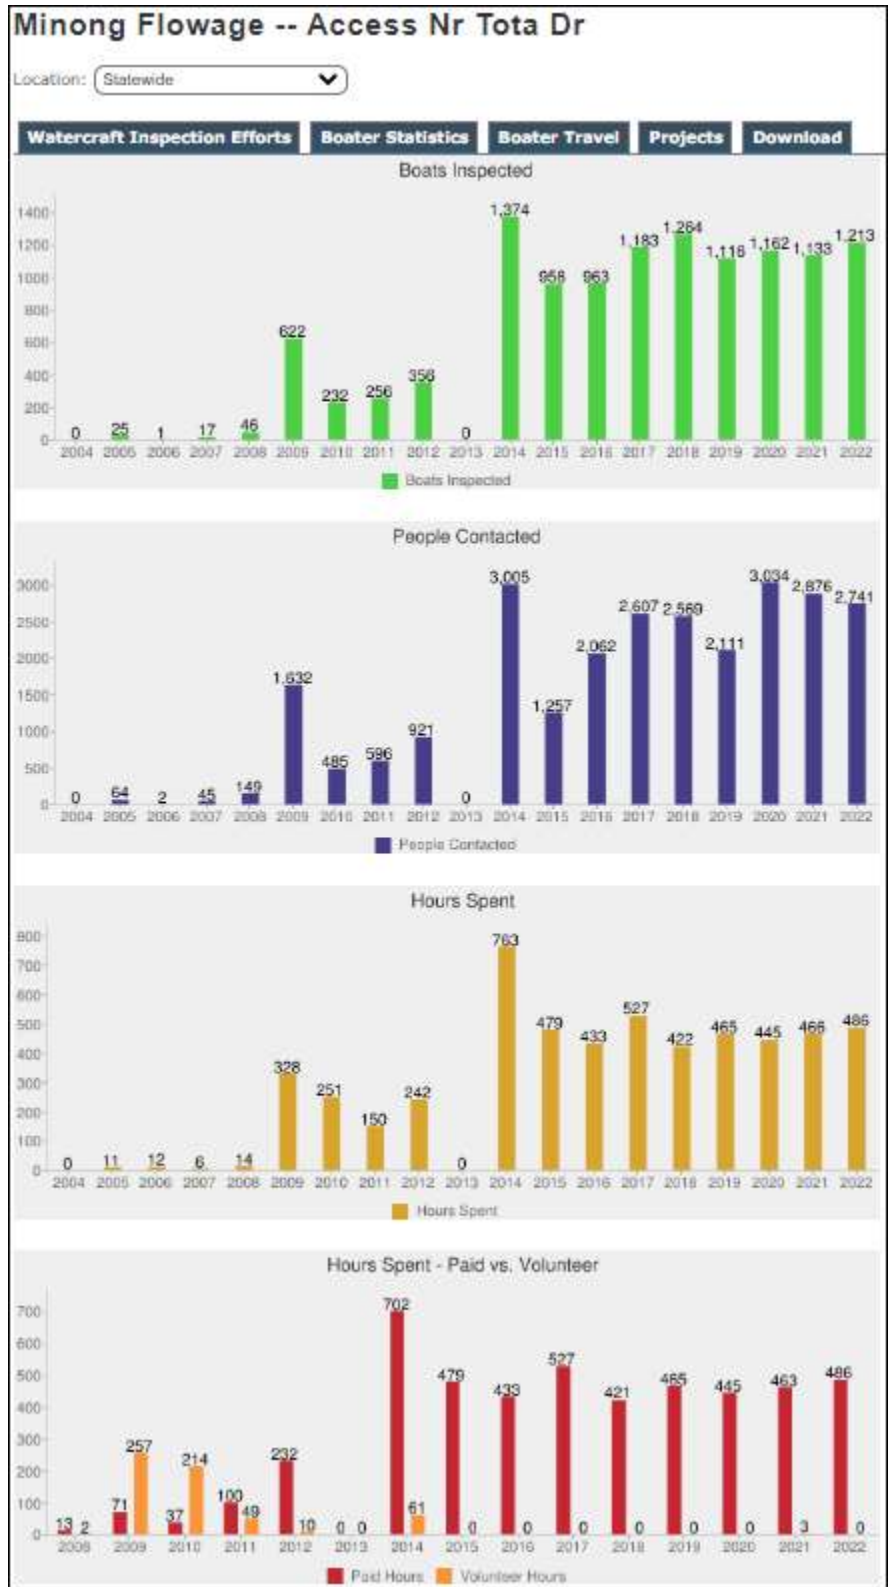
Another landing on the Minong Flowage at the County Campground was covered by the Town of Minong in 2022. An additional 486 hours of watercraft inspection time was completed there. Watercraft inspectors contacted 1,213 boats and 2,741 people (Figure 6).

Figure 6: CBCW numbers from the public landing at the Washburn County Campground

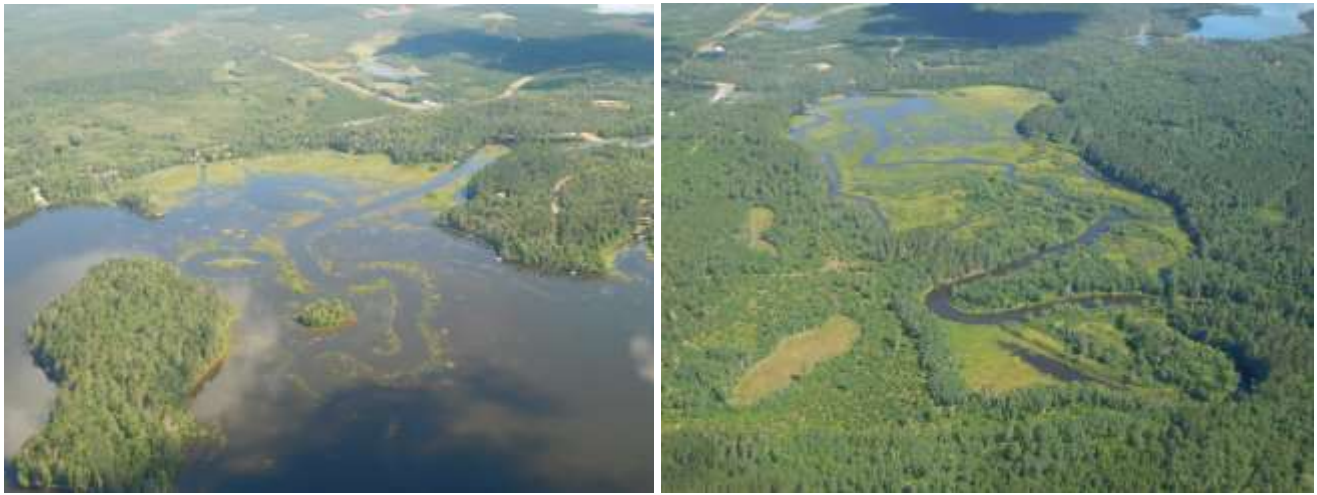
While no active/on-the-water mapping of wild rice was completed in 2022, the MFA partnered with GLIFWC in an effort to get them to share results from their aerial assessment of wild rice. According to GLIFWC rice experts, the wild rice in the Minong Flowage was considered average in its 2022 aerial assessment (Figure 8). Comments made by locals suggested that wild rice was more abundant in 2022 than it has been in many years.

**Figure 8: 2022 aerial wild rice survey results. Left – Serenity Bay, Right – East Basin past Smith's Bridge (GLIFWC)**

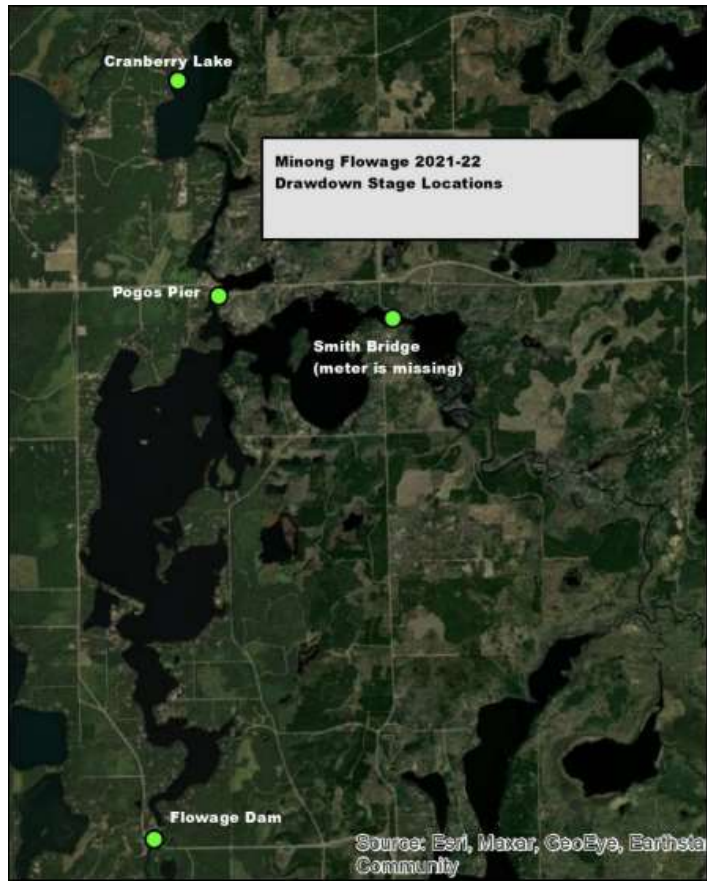
Due to concerns about changes in water level brought about by the winter drawdown and just every day weather events, Ecological Integrity Services (EIS) was contracted with to install staff gauges and pressure transducers at three different sites on the Minong Flowage: near the dam, near Pogos and the inlet from the Cranberry Flowage, at Smith Bridge between the east basin and Serenity Bay, and in Cranberry Lake. Steve Schieffer installed the hardware in mid-June 2021 and they remained in place until after the winter drawdown and refill was completed in early 2022. The purpose of the transducers was to document changes in water level prior to, during, and after the winter drawdown. A summary report of the findings was completed by EIS in 2022.

Figure 9: Site locations for the pressure transducers recording lake level changes

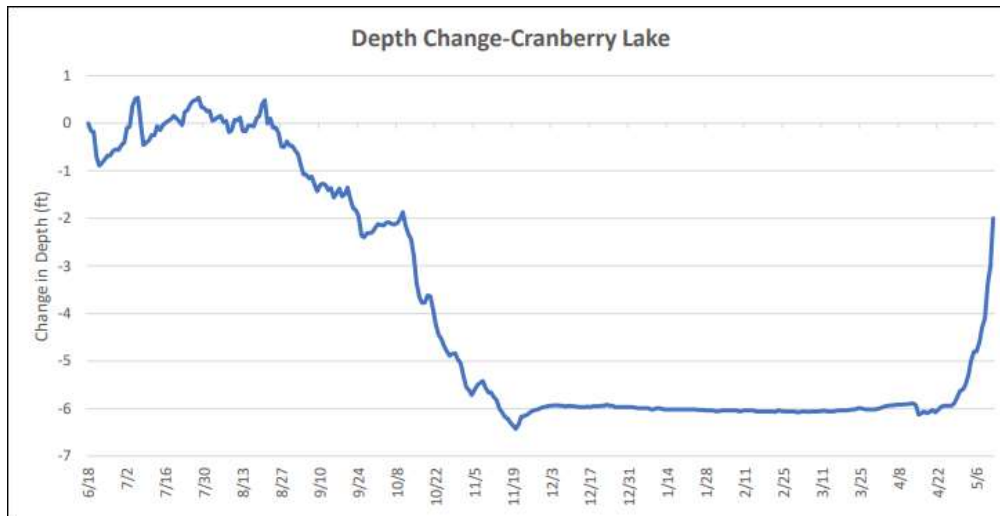
Figure 10: Lake level changes in Cranberry Lake

The following figures (9-13) represent the fluctuations in water level at the four sites monitored by the pressure transducers. For a while, immediately following ice out in 2022, the transducer put in place by Smith's Bridge disappeared. The buoy holding it was later found by a MFA volunteer and retrieved by EIS. These figures are from the EIS report on the results. For the most part, water levels throughout the drawdown fluctuated between 4 and 5 feet. It is easy to see the increase in water level in late March due to the heavy rain and snowmelt event. The same increase is not noticeable in Cranberry Lake, primarily because it does not receive water from the Totogatic River.

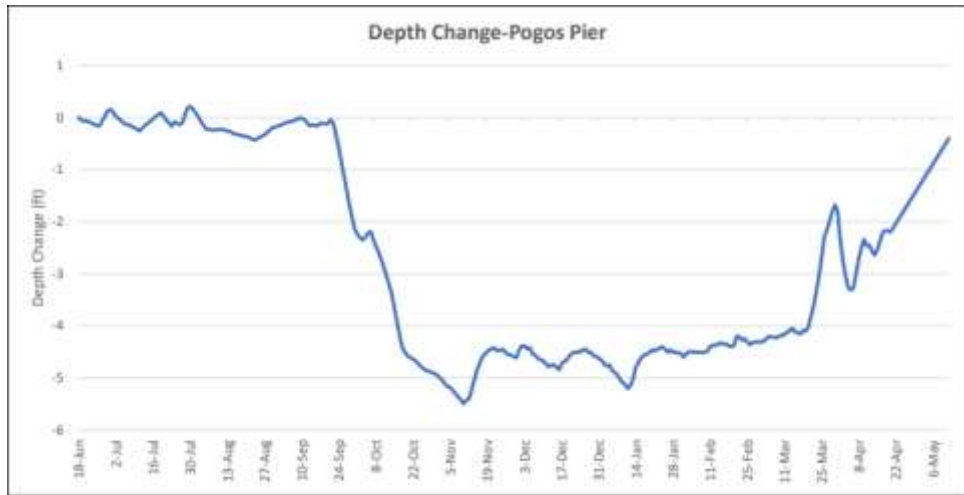
Figure 11: Lake level changes at Pogos Pier

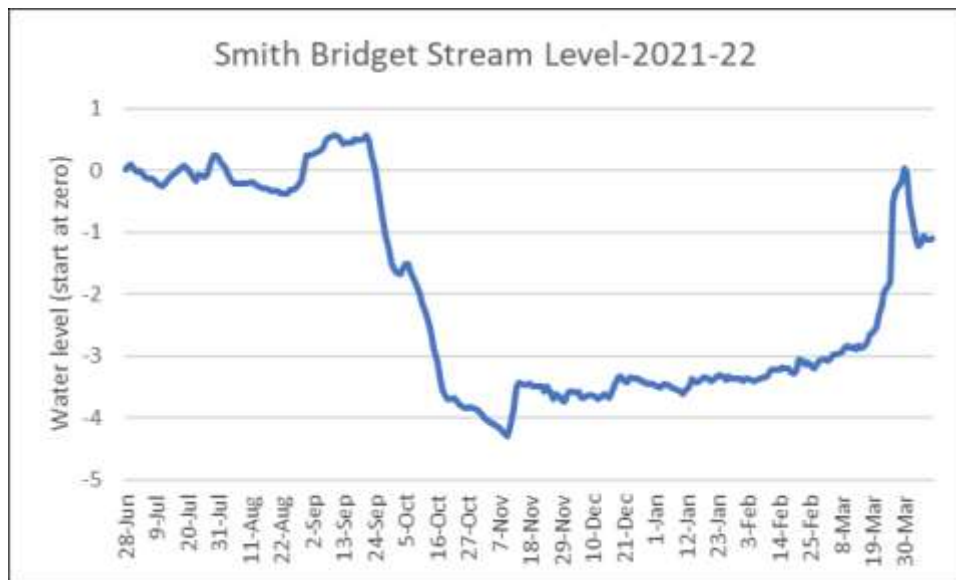
Figure 12: Lake level changes at Smith's Bridge

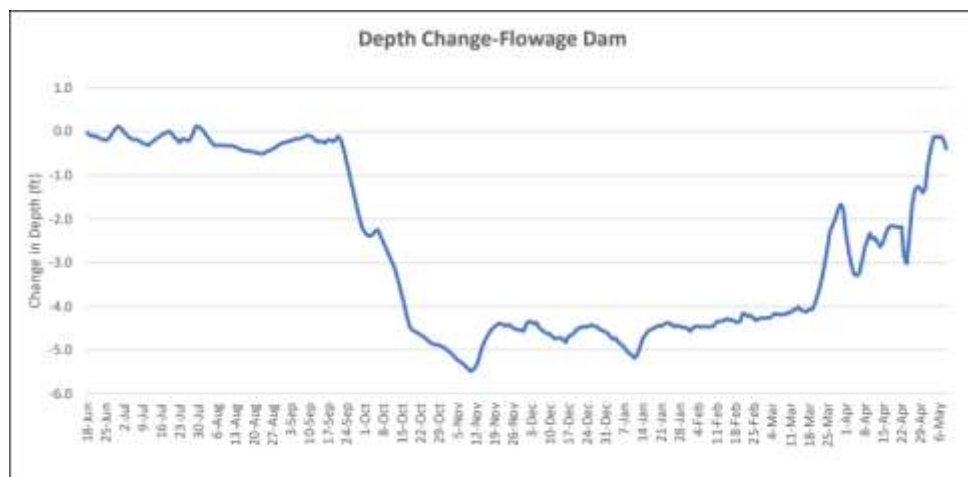
Figure 13: Lake level changes at the Dam

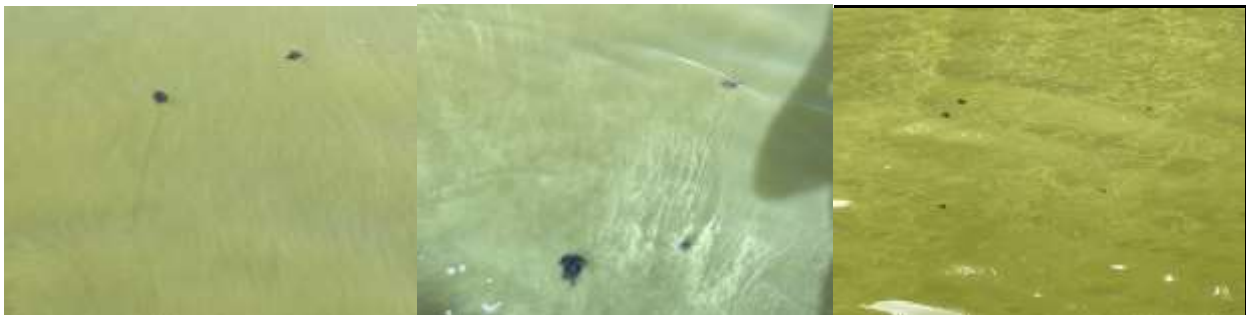
Minong Flowage - Site A-Central Basin - NW Of Youth Camp was sampled 4 different days during the 2022 season. Parameters sampled included TP and Chl. Sampling to collect water chemistry data includes TP collected over four months, and Chl over three months. In the Central Basin, the average summer Chl was 31.5µg/l. The average summer TP was 39.1µg/l. Impoundments like the Minong Flowage that have more than 30µg/l of TP may experience noticeable algae blooms. This was definitely the case in the Central Basin. Figure 14 shows photos of water quality in August in the Central Basin.

**Figure 14: Photos from the Central Basin – August 2022 – photo credit Ron and Jeanne Brown**

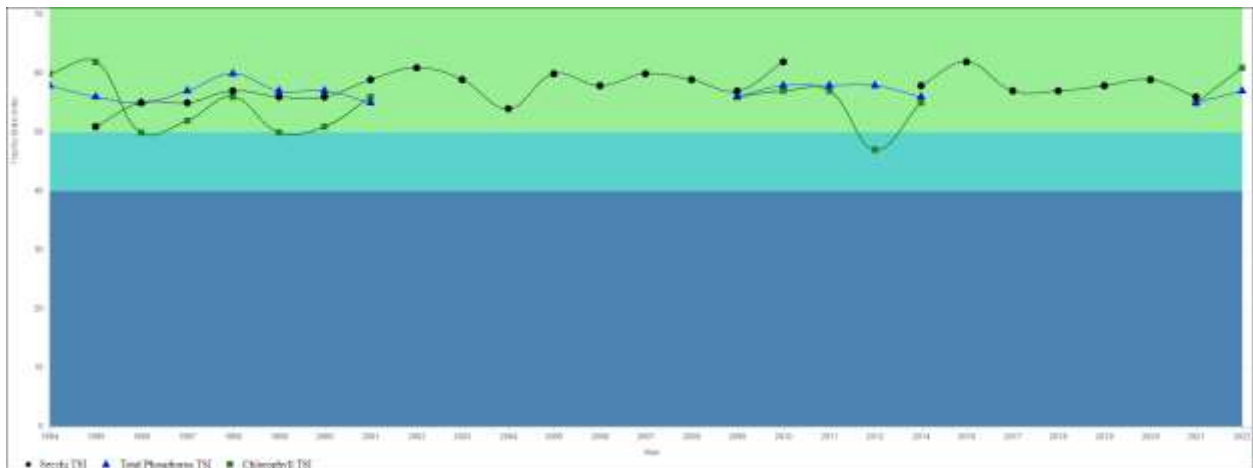
The overall Trophic State Index (based on chlorophyll) for Minong Flowage - Central Basin was 61. This TSI suggests that Minong Flowage - Central Basin was eutrophic. This TSI usually suggests blue-green algae become dominant and algal scums are possible, extensive plant overgrowth problems possible. Figure 15 reflects long-term trend monitoring TSI values for all parameters monitored in the Central Basin. All of the values fall in the light green, or eutrophic part of the spectrum.

**Figure 15: Historic TSI values from the Central Basin of the Minong Flowage - CLMN**

Water quality data from these two sites strongly indicate that the Minong Flowage is a nutrient rich, eutrophic body of water. On a TSI scale from 0-100, values in the Minong Flowage are consistently in the mid-50s or higher. In the figures below, dark blue is considered oligotrophic (TSI value 0-40); light blue is considered mesotrophic (TSI value 40-50); and green is considered eutrophic (TSI value >50).

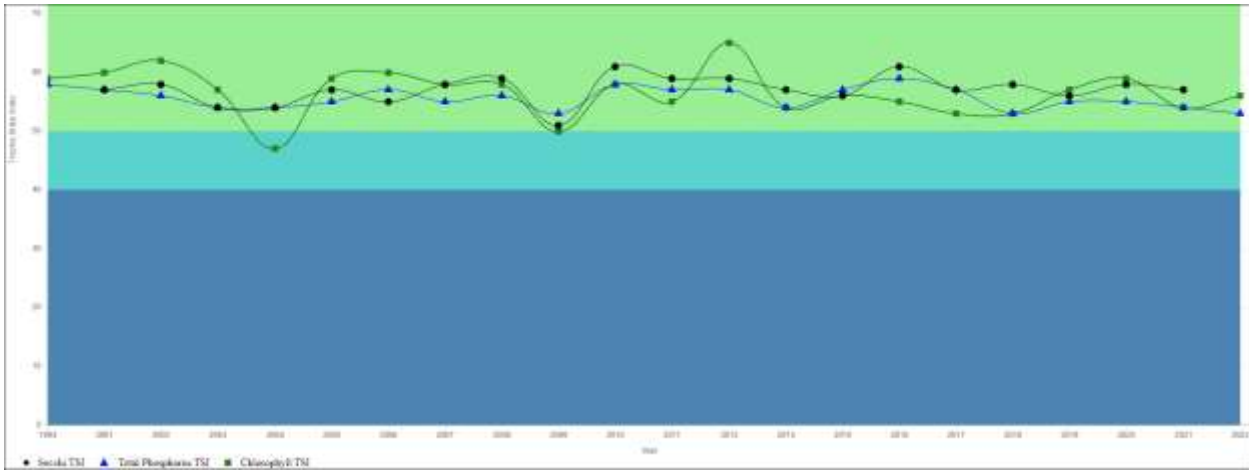
The overall Trophic State Index (based on chlorophyll) for Minong Flowage - Central Basin was 56. This TSI suggests that Minong Flowage – Deep Hole was eutrophic. This TSI usually suggests decreased clarity, fewer algal species, oxygen-depleted bottom waters during the summer, plant overgrowth evident, warm-water fisheries (pike, perch, bass, etc.) only. Figure 16 reflects long-term trend monitoring TSI values for all parameters monitored in the Deep Hole. All of the values fall in the light green, or eutrophic part of the spectrum.

**Figure 16: Historic TSI values from the Deep Hole of the Minong Flowage - CLMN**

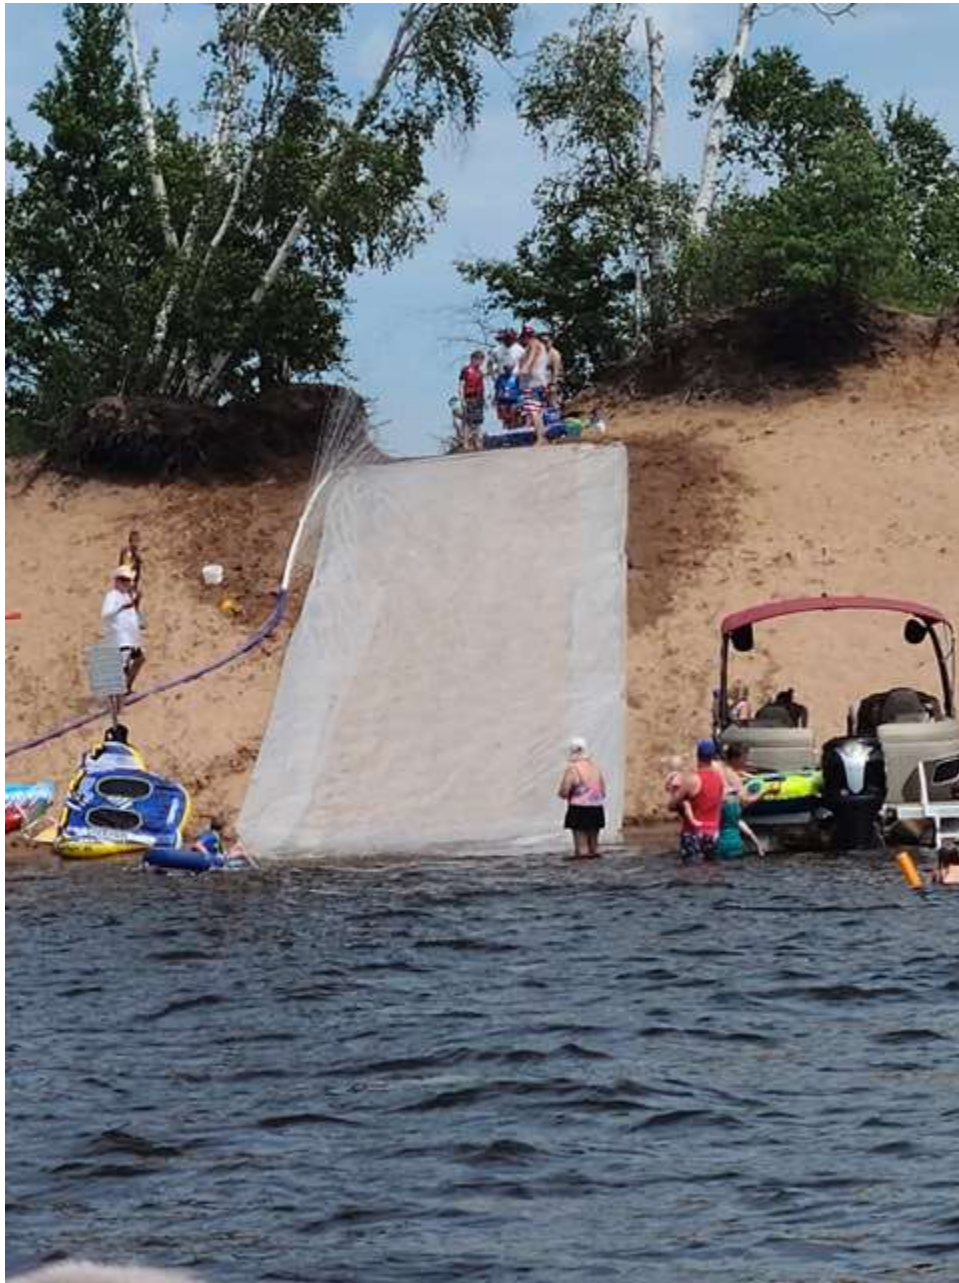
One of the concerns voiced by the MFA constituency and board is how rapidly the sand islands within the Minong Flowage are disappearing. Essentially, they are being “loved” to death by lake users and visitors to the lake. During the hot summers, it is not unusual to see a dozen boats anchored off the main island in the Central Basin with swimmers and picnickers utilizing the shores. The MFA began a signing campaign in 2021 whereby informative signs were placed on the island in an effort to get lake users to become more aware of the problem and take measures to minimize their impacts. Unfortunately, signage is not apparently successfully spreading the message about island protection from misuse. The photo in Figure 17 shows a large slip-n-slide that was set up on Sand Island

by visitors to the lake. It does not take a water scientist to know that this type of behavior on a delicate sand island is detrimental to its health. More needs to be done.

**Figure 17: Sand Island “fabricated slip-n-slide” over the 4<sup>th</sup> of July holiday 2022 – photo credit – Steve Johnson**
