# **2023-2027 AQUATIC PLANT MANAGEMENT PLAN**

**Lower Vermillion Lake**

**Vermillion Lakes Association**

**October 2022**

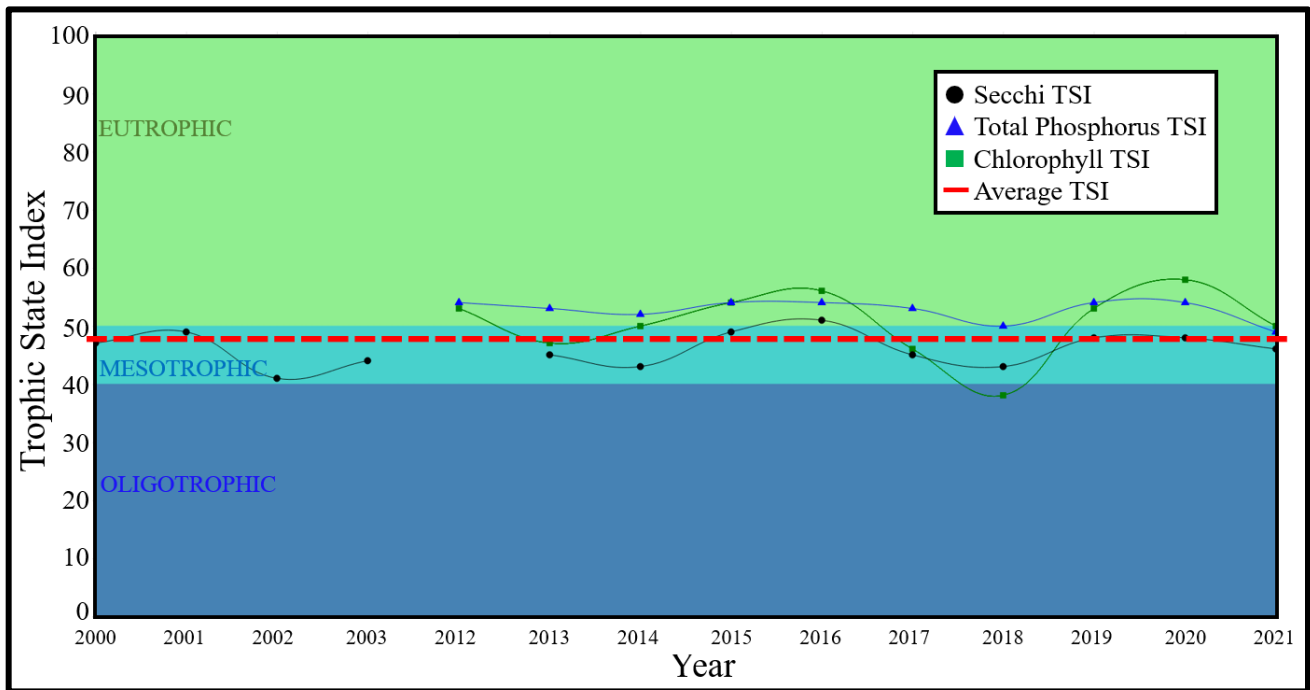
Figure 8. Vermillion Lake trophic status index data (WDNR)

Lower Vermillion Lake was placed on the Wisconsin 303d Impaired Water List in 2022 because phosphorus and chlorophyll levels were both above listing thresholds as outlined in 2022 WisCALM.<sup>3</sup>

Circled values indicate the average water quality measurements and corresponding TSI scores for Lower Vermillion Lake from data collected by citizen volunteers. This figure is adapted from Carlson and Simpson 1996, information from the WDNR, and publicly available CLMN water quality data.

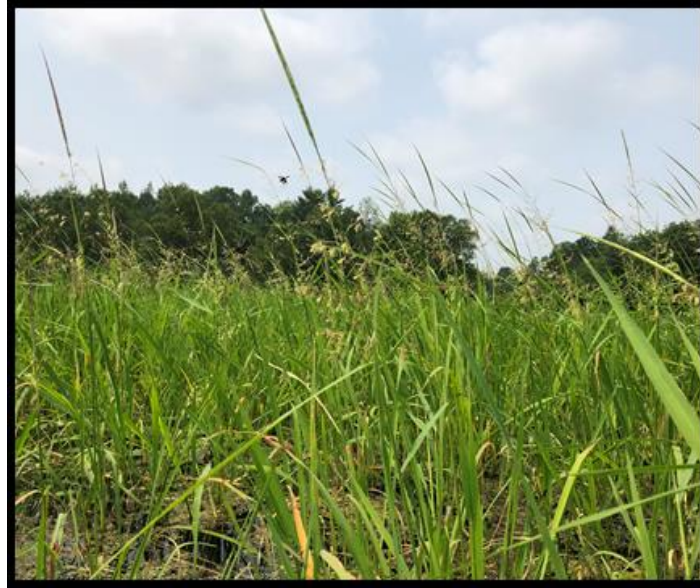
**Figure 23. Maximum Northern wild rice Density in the Southeast Outlet Bay 7/20/21 (Berg, 2021)**

However, in 2009, Northern wild rice was documented at four points (mean rake 1.75) in a patchwork bed that covered nearly one acre in the southeast outlet bay (Figure 22). The 2016 survey found rice at a single point, and it was noted that the population had shrunk to just a few hundred goose-cropped plants that were scattered along the shoreline. In 2021, rice occurred at two points with a mean rake of 1.75, and a general thickening of the total bed relative to 2016 levels was observed (Figure 23).

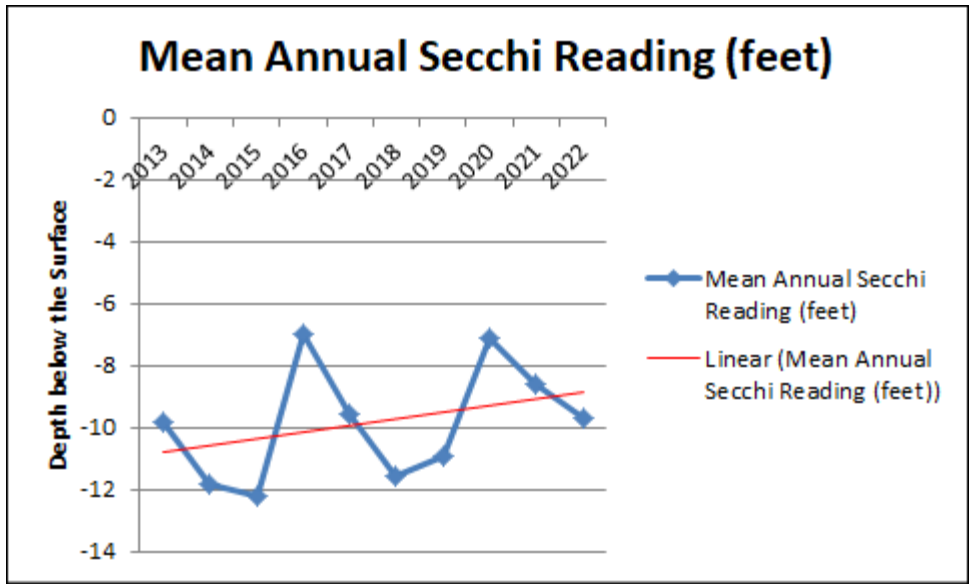
Figure 25: Annual average of all Secchi disk readings collected between 2013 and 2022

The reasons for these changes in aquatic vegetation may best be explained by a reduction in water clarity in the lake over time. CLMN reports are somewhat misleading in that the graphs produced for water clarity are based only on July and August Secchi disk readings. Figure 10 reflects the summer Secchi disk averages over time. Figure 25 reflects the average of all Secchi disk readings taken in each year from 2013 to 2022. This figure clearly shows a decline in water clarity over this time period. It is also interesting to note that the worst water clarity was measured in 2016 and 2020. The year 2021 had the third worst water clarity over this time period. The correlation of this poor water clarity in the years that the last two PI surveys were completed is worth noting. In addition, the aquatic plant surveyor suggested in his report that most of the changes in the aquatic plant community in 2021 appeared to be on the deep water edges of the littoral zone.

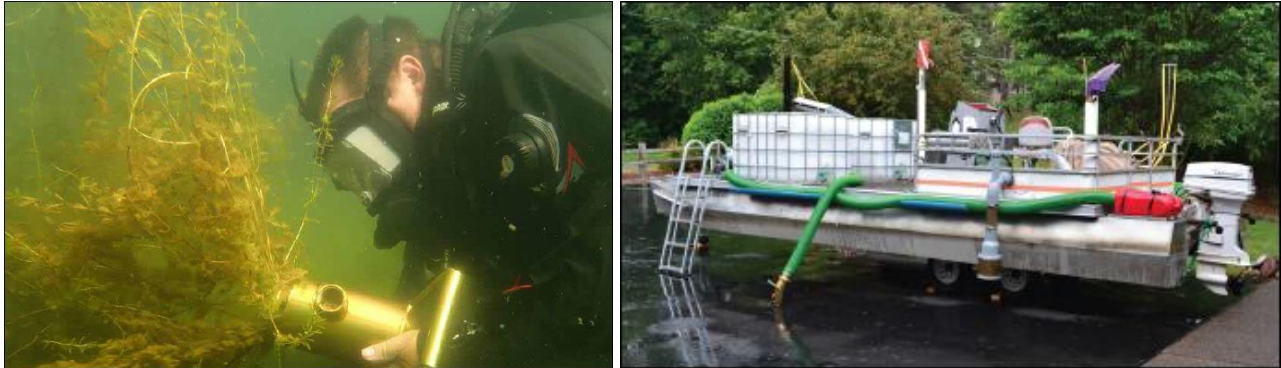
**Figure 39. DASH – Feeding EWM into the underwater Suction Hose (Marinette Co.); and a sample DASH Pontoon Boat (Beaver Dam Lake Management District)**

Removal of EWM using DASH was completed in large-scale in 2022 on Lower Vermillion Lake. A contracted DASH service spent four days in July removing EWM from Lower Vermillion Lake. The DASH crew removed 168 large onion bags of EWM from the lake for a total of about \$12,000.00. Unfortunately, a lot of EWM was missed or has already come back in the areas where DASH was implemented.

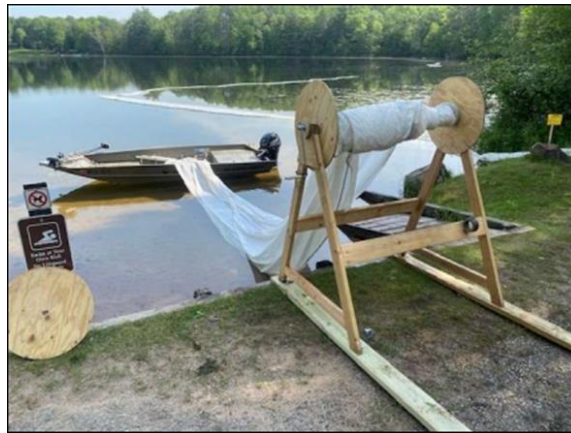
**Figure 40. Limno-curtain material on a roll before installation (photo from Marinette Co. LWCD)**

Small-scale herbicide applications can be made more effective by installing a limno-barrier or curtain around a treatment area to help hold the applied herbicide in place, longer. By doing so, the herbicide/target species contact time is increased. The curtain is generally a continuous sheet of plastic that extends from the surface to the bottom of the lake (Figure 40). The surface edge of the curtain is generally supported by floatation devices. The bottom of the curtain is held in place by some form of weighting. The curtain or barrier, sometimes thousands of feet of it, is installed around the proposed treatment area with the purpose of holding the herbicide in place longer by preventing dilution and drift away from the treated area (Figure 41).

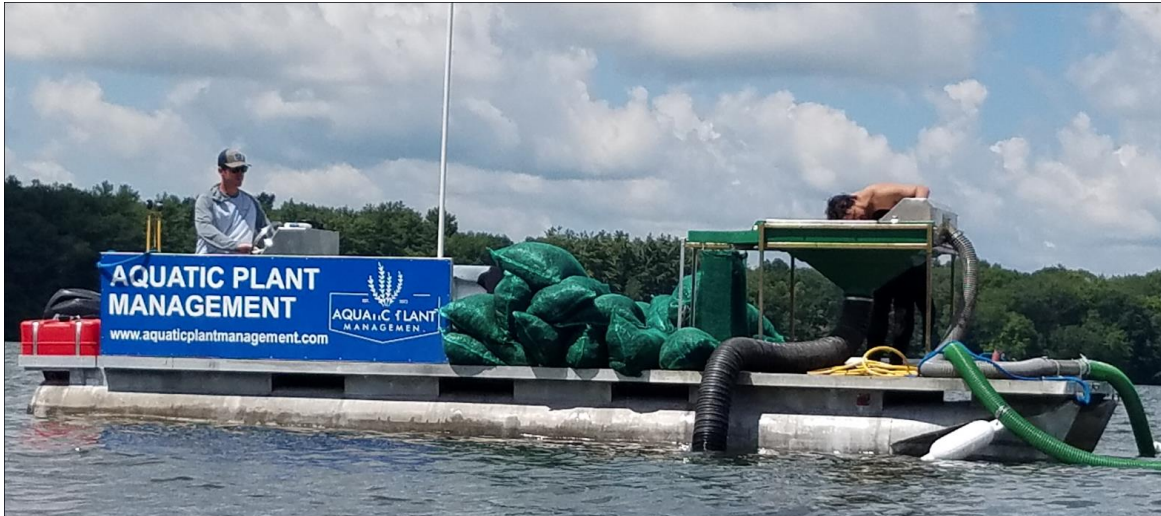
**Figure 43: Onion bags full of EWM pulled from Lower Vermillion Lake**

As a result, the VLA contracted with a DASH service in 2022 to provide 4 days of diver-assisted suction harvest. In these four days 168 large onion bags were filled with EWM removed from the lake (Figure 44). The total acreage covered by the DASH divers was estimated to be around 1.5 acres.
