LAKE EDUCATION AND PLANNING SERVICES, LLC
110 N 1ST STREET
PO BOX #26
CAMERON, WISCONSIN 54822

HORSESHOE LAKE, BARRON AND POLK COUNTIES

2023-27 AQUATIC PLANT MANAGEMENT PLAN WDNR WBIC: 2630100

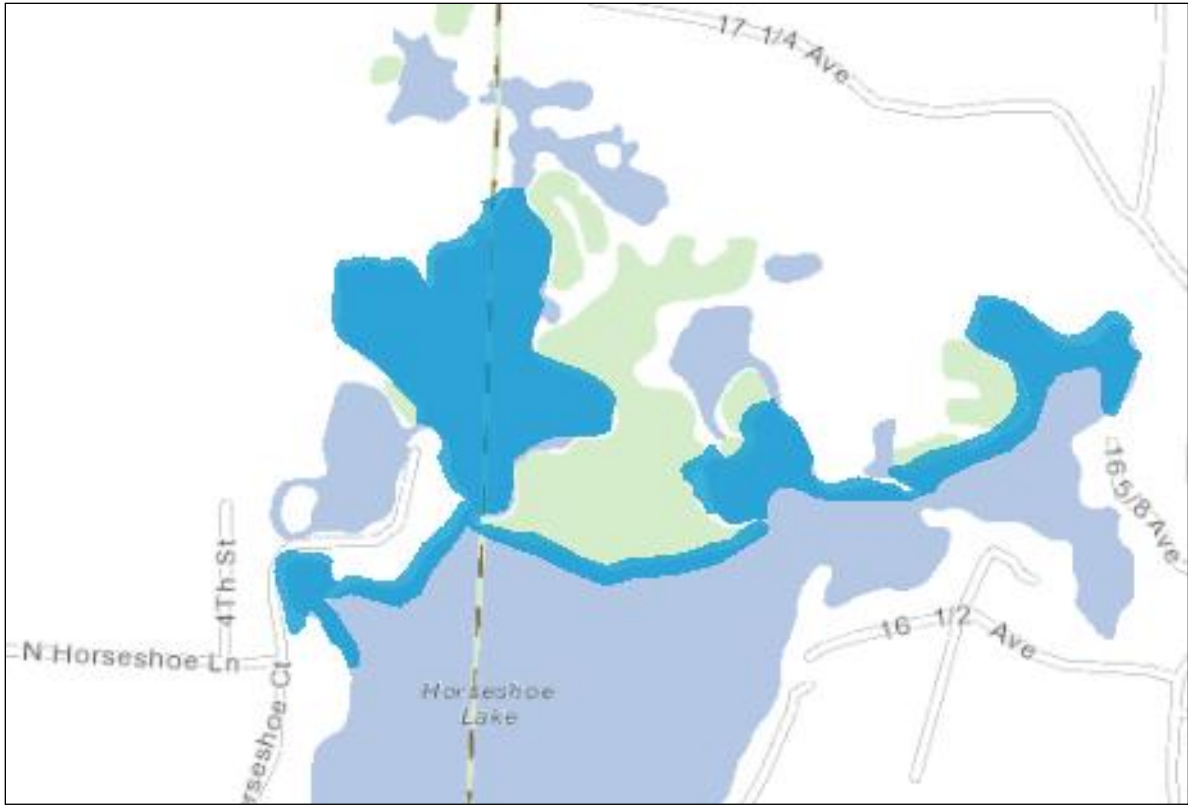
Figure 1: Public land (green) and designated sensitive areas (blue) on Horseshoe Lake

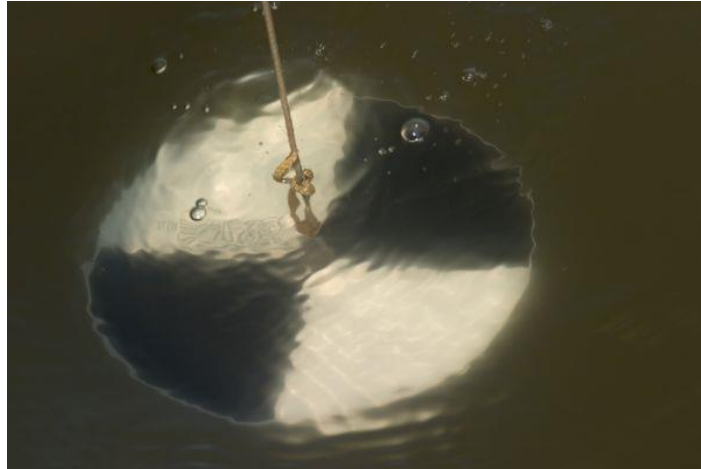
Figure 7: Black and white Secchi disk

Water clarity is a measurement of how deep sunlight can penetrate into the waters of a lake. It can be measured in a number of ways, the most common being an 8” disk divided into four sections, two black and two white, lowered into the lake water from the surface by a rope marked in measurable increments (Figure 7). The water clarity reading is the point at which the Secchi disk when lowered into the water can no longer be seen from the surface of the lake. Water color (like dark water stained by tannins from nearby bogs and wetlands), particles suspended in the water column (like sediment or algae), and weather conditions (cloudy, windy, or sunlight) can impact how far a Secchi disk can be seen down in the water. Some lakes have Secchi disk readings of water clarity of just a few inches, while other lakes have conditions that allow the Secchi disk to be seen for dozens of feet before it disappears from view.

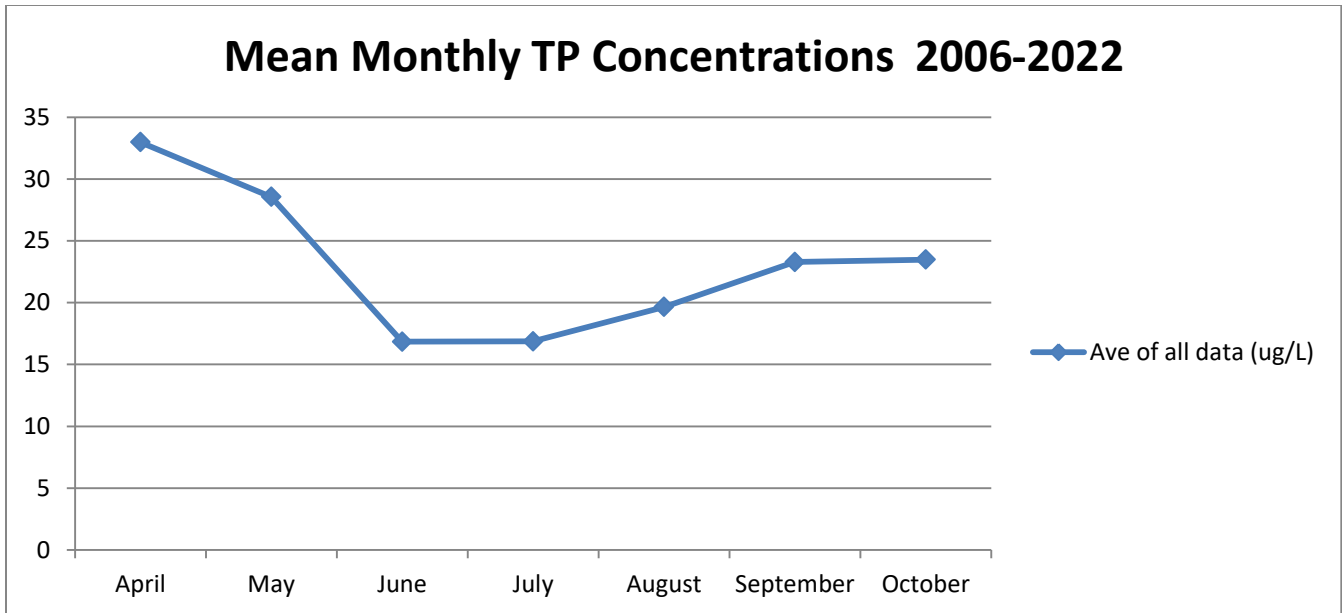
Figure 11: Mean monthly TP concentrations from 2006 to 2022 (CLMN)

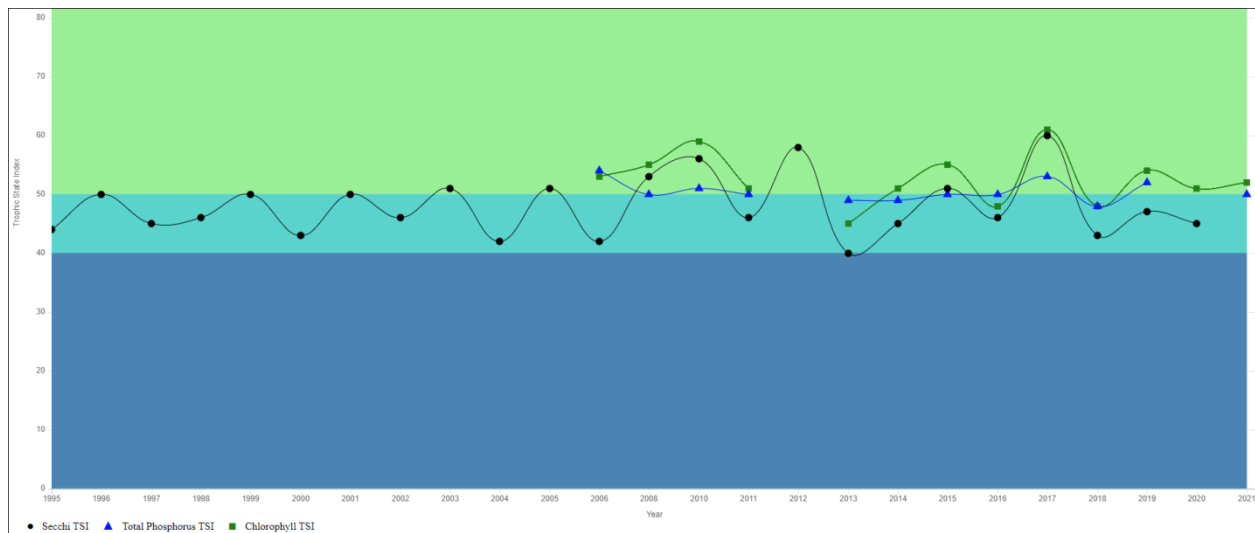
Figure 15: Summer (July and August) TSI values for total phosphorus and chlorophyll-a at the Deep Hole on Horseshoe Lake

Of note in Horseshoe Lake is that TSI values for TP and Chla are generally the same, but much higher than the TSI values for Secchi depth. This is one of several familiar patterns that often emerge when comparing these three values (Carlson & Havens, 2005). This pattern suggests that large chlorophyll-containing particulates, such as Aphanizomenon (a type of algae) flakes, dominate the surface water. As such, there does not exist a good potential to control algal blooms with food web manipulation, unless that manipulation directly affects nutrient inputs to the water column (Carlson & Havens, 2005).

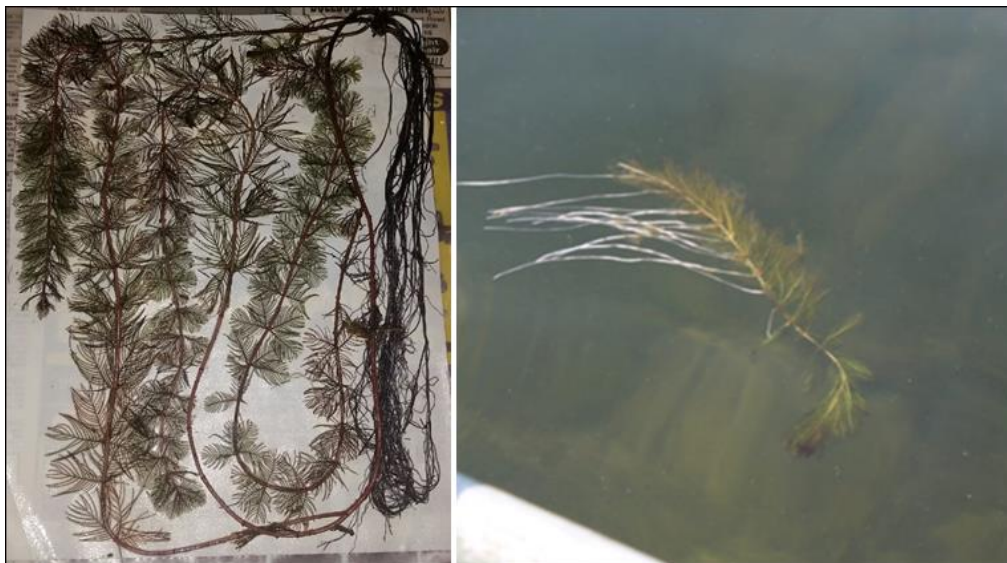
Figure 25: EWM complete root and stem and floating fragment with adventitious roots

EWM (Figure 25) is a submersed aquatic plant native to Europe, Asia, and northern Africa. It is the only non-native milfoil in Wisconsin. Like the native milfoils, the Eurasian variety has slender stems whorled by submersed feathery leaves and tiny flowers produced above the water surface. The flowers are located in the axils of the floral bracts, and are either four-petaled or without petals. The leaves are threadlike, typically uniform in diameter, and aggregated into a submersed terminal spike. The stem thickens below the inflorescence and doubles its width further down, often curving to lie parallel with the water surface. The fruits are four-jointed nut-like bodies. Without flowers or fruits,

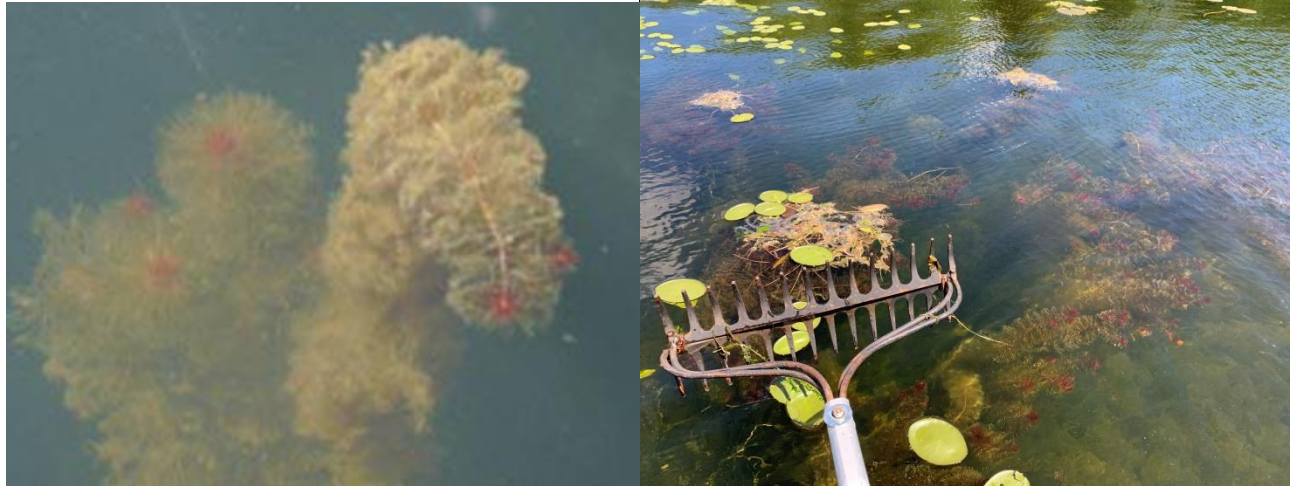
Figure 26: Hybrid EWM in Horseshoe Lake, early in the 2000's (left), 2022 (right)

Like pure Eurasian Water Milfoil, EWM-NWM hybrids grow very quickly and can choke waterways, hampering boat access, fish passage, and water supply intakes. The plants fragment easily, and fragments attached to watercraft can take root in un-infested lakes. Pure Northern Water Milfoil is a species that is native to Wisconsin and it is not considered invasive. At least one study (LaRue, 2012) provides compelling evidence that hybrid lineages between introduced EWM and native NWM are more invasive than pure parental EWM, especially in novel habitats resulting from the application of the herbicide 2,4-D, which is routinely used to control nuisance populations of watermilfoil. Specifically, it was shown that hybrid watermilfoil genotypes exhibited faster vegetative growth and reduced sensitivity to 2,4-D in two laboratory experiments, and that they occurred more frequently than parental watermilfoil species in lakes with a history of 2,4-D treatment. Furthermore, comparisons of multiple, genetically distinct hybrid and EWM demonstrates that increased vegetative growth and reduced 2,4-D sensitivity are generally associated with hybridity in invasive watermilfoils. Hybrid water milfoil is the species most present in Horseshoe Lake (Figure 26).

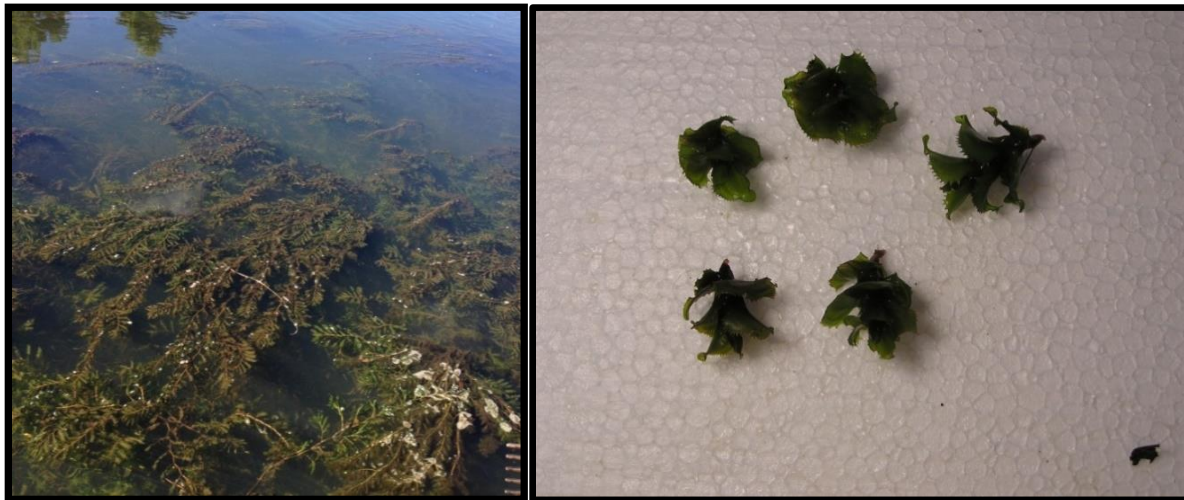
Figure 28: CLP plants and turions

CLP spreads through burr-like winter buds (turions), which are moved among waterways (Figure 28). These plants can also reproduce by seed, but this plays a relatively small role compared to the vegetative reproduction through turions. New plants form under the ice in winter, making curly-leaf pondweed one of the first nuisance aquatic plants to emerge in the spring. It becomes invasive in some areas because of its tolerance for low light and low water temperatures. These tolerances allow it to get a head start on and outcompete native plants in the spring. In mid-summer, when most aquatic plants are growing, CLP plants are dying off. Plant die-offs may result in a critical loss of dissolved oxygen. Furthermore, the decaying plants can increase nutrients which contribute to algal blooms, as well as create unpleasant stinking messes on beaches. CLP forms surface mats that interfere with aquatic recreation (Figure 24).

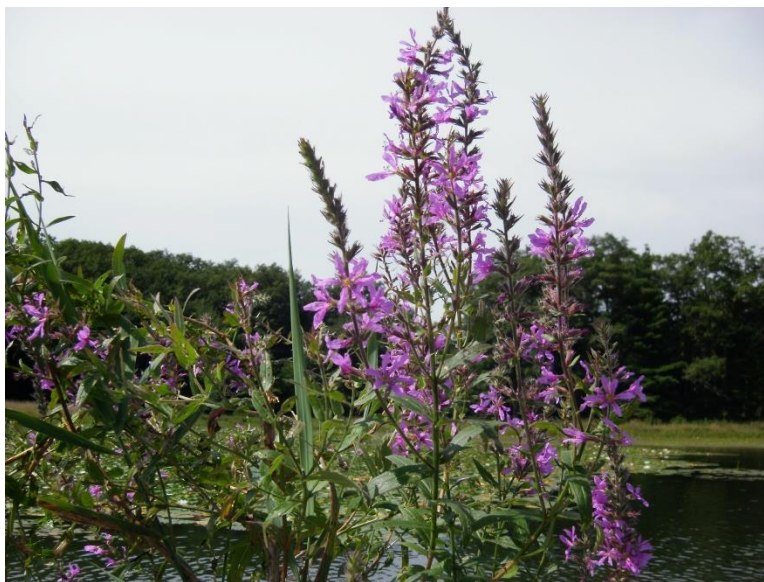
Figure 29: Purple loosestrife from Horseshoe Lake

Purple loosestrife (Figure 29) is a perennial herb 3-7 feet tall with a dense bushy growth of 1-50 stems. The stems, which range from green to purple, die back each year. Showy flowers that vary from purple to magenta possess 5-6 petals aggregated into numerous long spikes, and bloom from August to September. Leaves are opposite, nearly linear, and attached to four-sided stems without stalks. It has a large, woody taproot with fibrous rhizomes that form a dense mat. By law, purple loosestrife is a nuisance species in Wisconsin. It is illegal to sell, distribute, or cultivate the plants or seeds, including any of its cultivars.

Purple loosestrife has been identified and removed from several locations in Horseshoe Lake, but still persists.

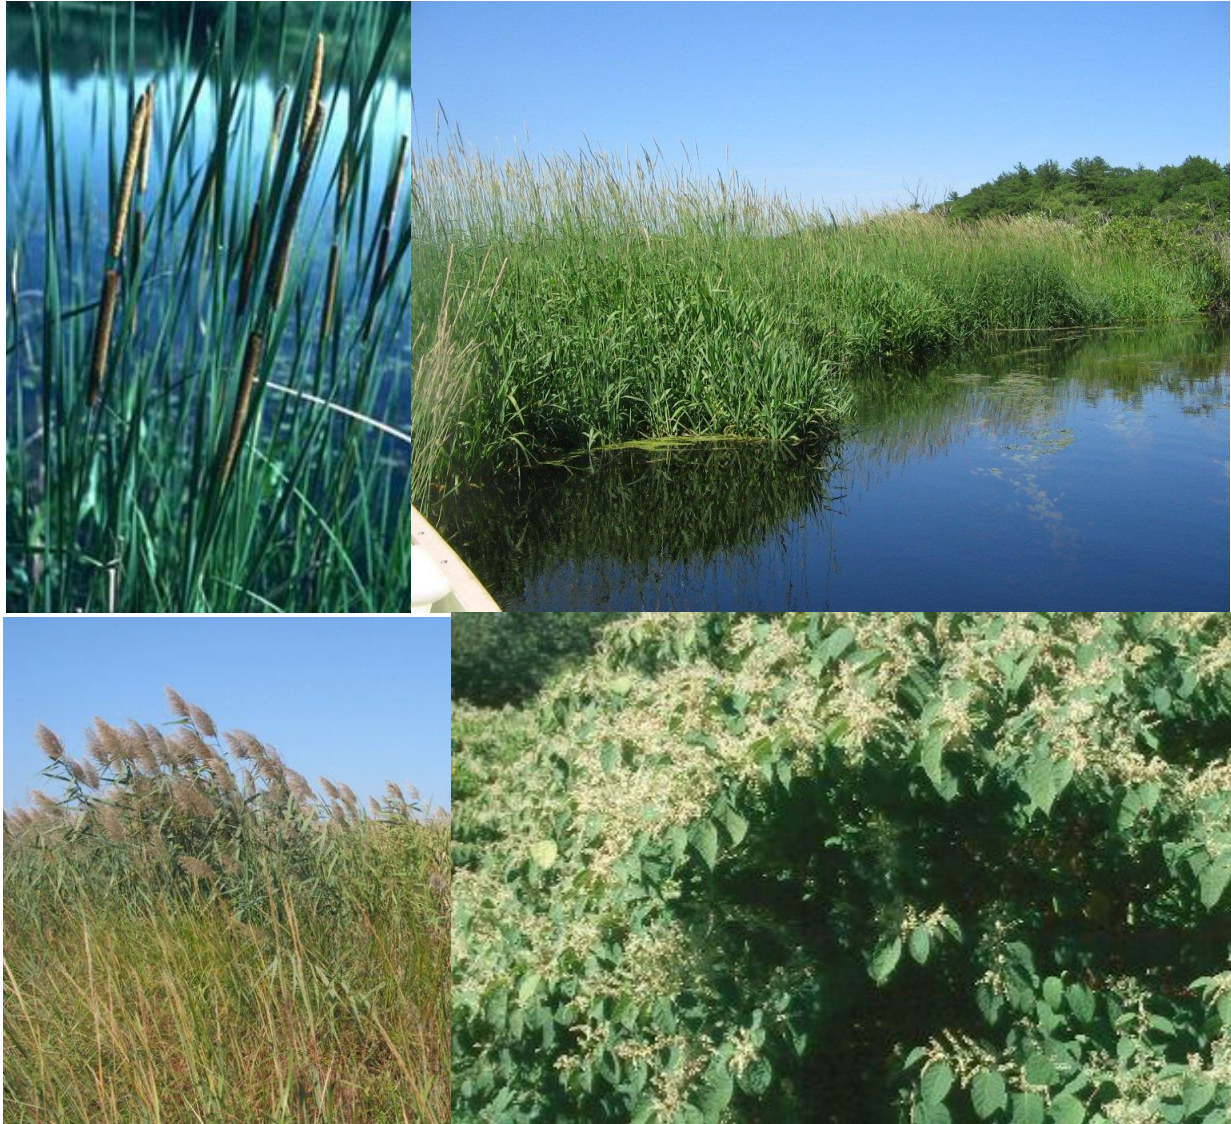
Figure 30: Narrow-leaf cattail (upper left), Reed canary grass (upper right), Phragmites (lower left), and Japanese knotweed (lower right)

The following species could be introduced to the lake and should be monitored for (Figure 30).

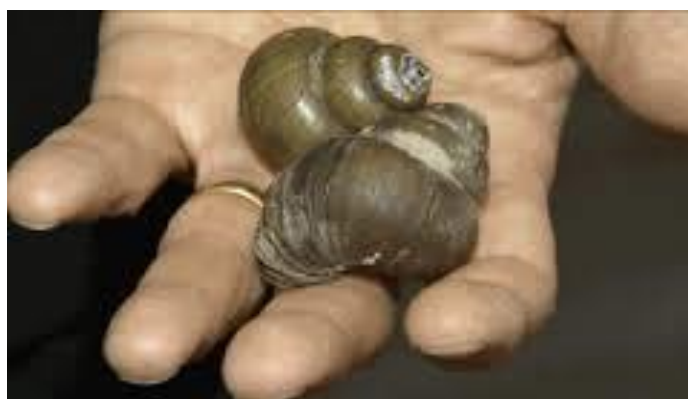
Figure 31: Chinese Mystery Snails

The Chinese mystery snails and the banded mystery snails (Figure 31) are non-native snails that have been found in a number of Wisconsin lakes. There is not a lot yet known about these species, however, it appears that they have a negative effect on native snail populations. The female mystery snail gives birth to live crawling young. This may be an important factor in their spread as it only takes one impregnated snail to start a new population. Mystery snails thrive in silt and mud areas although they can be found in lesser numbers in areas with sand or rock substrates. They are found in lakes, ponds, irrigation ditches, and slower portions of streams and rivers. They are tolerant of pollution and often thrive in stagnant water areas. Mystery snails can be found in water depths of 0.5 to 5 meters (1.5 to 15 feet). They tend to reach their maximum population densities around 1-2 meters (3-6 feet) of water depth. Mystery snails do not eat plants. Instead, they feed on detritus and in lesser amounts algae and phytoplankton. Thus removal of plants in your shoreline area will not reduce the abundance of mystery snails.

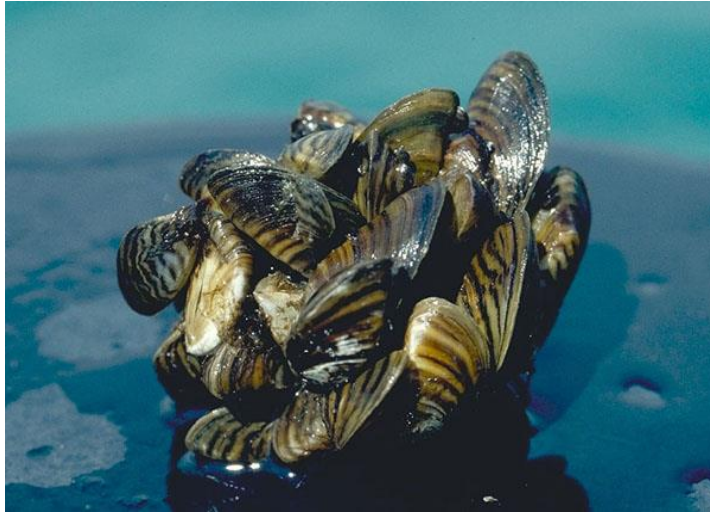
Figure 33: Zebra Mussels (not from Horseshoe Lake)

Zebra mussels (Figure 33) are an invasive species that have inhabited Wisconsin waters and are displacing native species, disrupting ecosystems, and affecting citizens' livelihoods and quality of life. They hamper boating, swimming, fishing, hunting, hiking, and other recreation, and take an economic toll on commercial, agricultural, forestry, and aquacultural resources. The zebra mussel is a tiny (1/8-inch to 2-inch) bottom-dwelling clam native to Europe and Asia. Zebra mussels were introduced into the Great Lakes in 1985 or 1986, and have been spreading throughout them since that time. They were most likely brought to North America as larvae in the ballast water of ships that traveled from fresh-water Eurasian ports to the Great Lakes.

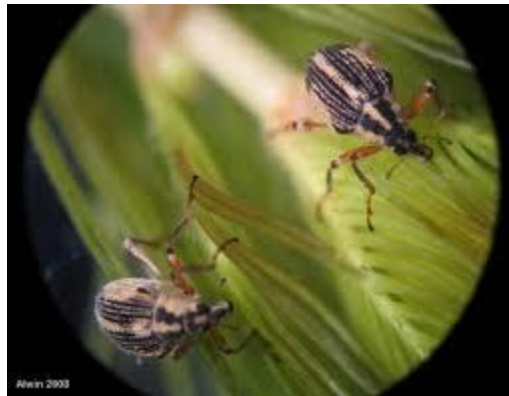
Figure 36: EWM weevil

While many biological controls have been studied, only one has proven to be effective at controlling EWM under the right circumstances. *Eubrychiopsis lecontei* is an aquatic weevil native to Wisconsin that feeds on aquatic milfoils (Figure 36). Their host plant is typically northern watermilfoil; however they seem to prefer EWM when it is available. Milfoil

weevils are typically present in low numbers wherever northern or Eurasian water milfoil is found. They often produce several generations in a given year and over winter in undisturbed shorelines around the lake. All aspects of the weevil's life cycle can affect the plant. Adults feed on the plant and lay their eggs. The eggs hatch and the larva feed on the plant. As the larva mature they eventually burrow into the stem of the plant. When they emerge as adults later, the hole left in the stem reduces buoyancy often causing the stem to collapse. The resulting interruption in the flow of carbohydrates to the root crowns reduces the plant's ability to store carbohydrates for over wintering reducing the health and vigor (Newman et al. (1996).

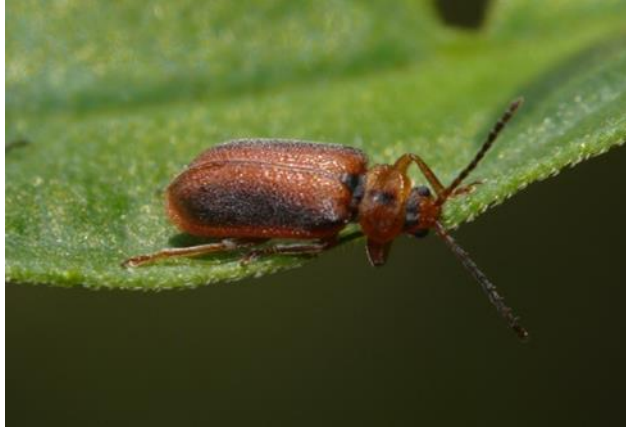
Figure 37: Galerucella beetle

Galerucella beetles are currently approved for the control of purple loosestrife in Wisconsin (Figure 37). The entire lifecycle of Galerucella beetles is dependent on purple loosestrife. In the spring, adults emerge from the leaf litter below old loosestrife plants. The adults then begin to feed on the plant for several days until they begin to reproduce. Females lay their eggs on loosestrife leaves and stems. When the larvae emerge from these eggs they begin feeding on the leaves and developing shoots. When water levels are high these larvae will burrow into the loosestrife stems to pupate into adult beetles. These new adults emerge and begin feeding on the loosestrife again (Sebolt, 1998). Galerucella beetles do not forage on any plants other than purple loosestrife. Because of this the populations, once established, are self-regulating. When the purple loosestrife population drops off, the beetle population also declines. When the loosestrife returns, the beetle numbers will usually increase. These beetles do not eradicate purple loosestrife entirely, but do help to reduce its dominance which will allow other native plants to recover.

Using Galerucella beetles for control of purple loosestrife is recommended for Horseshoe Lake. Some beetles have been released on the lake in the past. Beetles could be reared by volunteer and then distributed on the lake, or potentially collected from nearby locations in Turtle Lake and then released on Horseshoe Lake. In both cases, WDNR permitting would be needed.

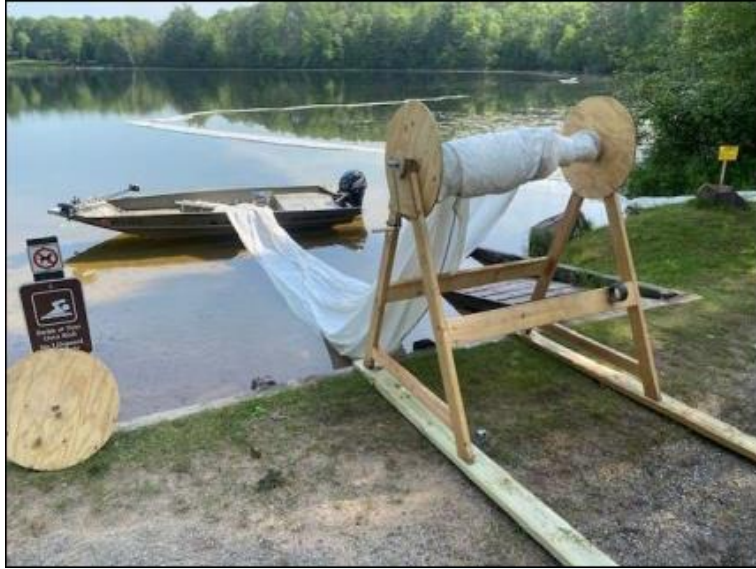
Figure 38: Limno-curtain material on a roll before installation (photo from Marinette Co. LWCD)

Small-scale herbicide applications can be made more effective by installing a limno-barrier or curtain around a treatment area to help hold the applied herbicide in place, longer. By doing so, the herbicide/target species contact time is increased. The curtain is generally a continuous sheet of plastic that extends from the surface to the bottom of the lake (Figure 38). The surface edge of the curtain is generally supported by floatation devices. The bottom of the curtain is held in place by some form of weighting. The curtain or barrier, sometimes thousands of feet of it is installed around the proposed treatment area with the purpose of holding the herbicide in place longer by preventing dilution and drift away from the treated area (Figure 39).

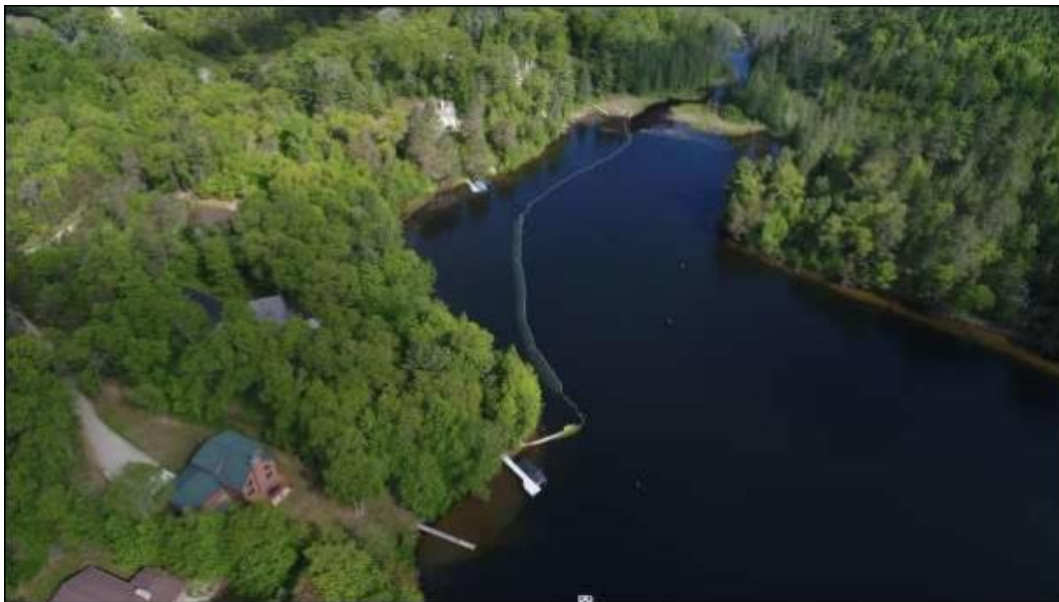
Figure 39: Limno-curtain installed on Thunder Lake (photo from Marinette Co. LWCD)

In the Thunder Lake, Marinette County limno-curtain trial completed in 2020, a curtain was installed around two small areas (0.9 and 2.9 acres) of dense growth EWM prior to chemical treatment. Liquid 2,4-D was applied at 4.0ppm inside the barrier. The barriers stayed in place until 48 hours after treatment. Herbicide concentration testing (see following section) was completed within the treated areas to determine how long the herbicide stayed in place and at what concentration. Figure 40 reflects what happened to the herbicide that was applied within the barrier in Thunder Lake. Herbicide concentrations stayed relatively high for a longer period of time (48 hrs). Once the curtain was removed, the herbicide dissipated rapidly. Similar studies have been completed on other lakes with similar results.

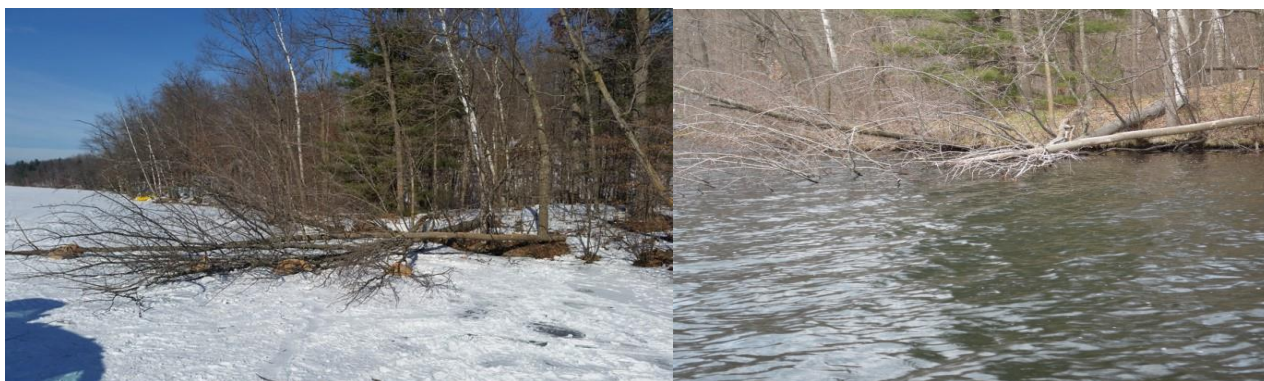
Figure 41: Fishsticks installation (left) and after ice out (right)

Fish Sticks involve taking trees from the inland area of the lake, and installing them in the lake to mimic shore trees that will eventually fall into the lake (Figure 41). The trees used must be taken from a minimum of 35 feet inland and are then secured to the shore with cables for approximately 3 years. This provides habitat for fish, birds, and many other animals. In addition to providing habitat, fish sticks help protect the shoreline from bank erosion. Fish sticks project costs range anywhere from \$100 to \$1000, averaging about \$500. These are very low maintenance because it is only necessary to occasionally check the cables to ensure they are secure. This practice would work well for almost any of the developed parcels on Horseshoe Lake.

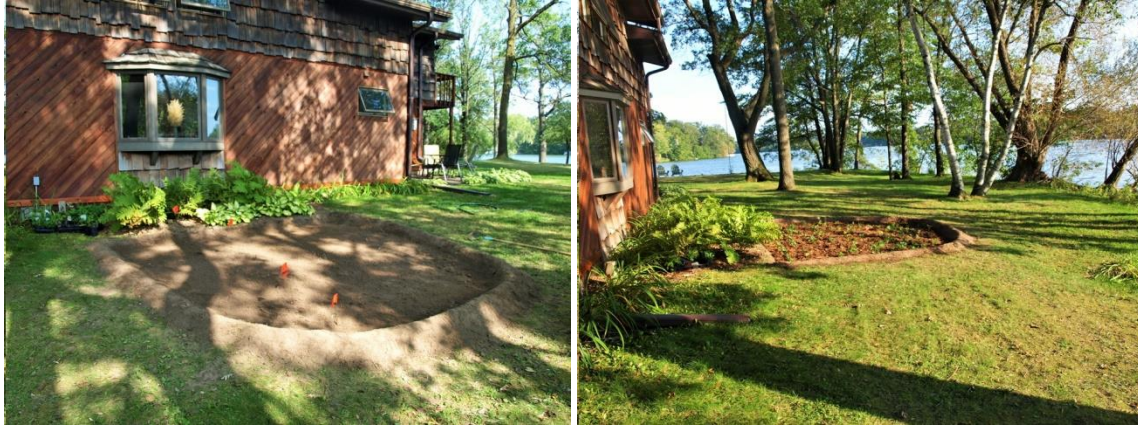
Figure 42: Rain garden installation (left) and upon completion (right)

Rain gardens are shallow depressions that contain loose soil and native plants (Figure 42). These are intended to capture the runoff, allowing the water to be filtered, naturally through the ground instead of flowing directly into the lake. Rain gardens are designed to allow the rainwater to soak into the ground with 1-2 days, to prevent any of the issues created by standing water. The project cost for rain garden range anywhere from \$500 to \$9,500, but this is very dependent on the size of the rain garden. The maintenance is fairly low, only requiring watering for about two weeks, until the plants have established, and weeding is occasionally needed during the first year. This project is best suited to parcels on a smaller incline to catch rainwater runoff that would otherwise run into the lake.

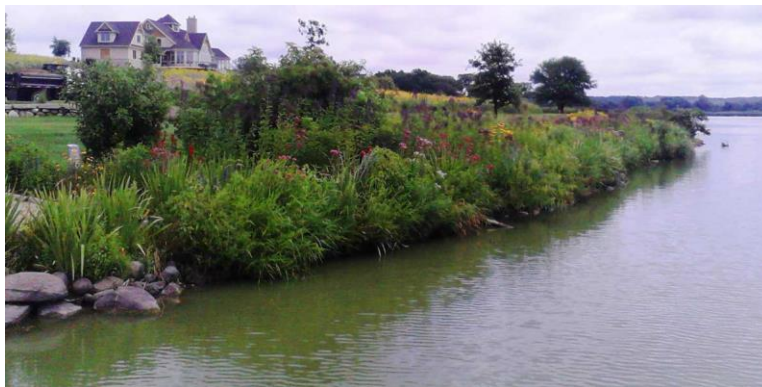
Figure 43: Completed native planting (photo from HealthyLakesWI.com)

Native plantings (Figure 43) are intended to establish a buffer zone between the developed portion of a parcel and the lake. The buffer helps filter and slow rainwater runoff so much of it filters into the ground. This buffer zone is created by changing a strip of turf grass, at least ten feet wide, along the shoreline to a natural area composed of native shoreline plants. Similar to rain gardens, these are fairly low maintenance requiring water only until the plants have become established. The only ongoing maintenance is the removal of any invasive species that find their way into the planting. On average, native plantings cost around \$1000. This project will work for almost any developed parcel that does not have a sand beach as the primary frontage.

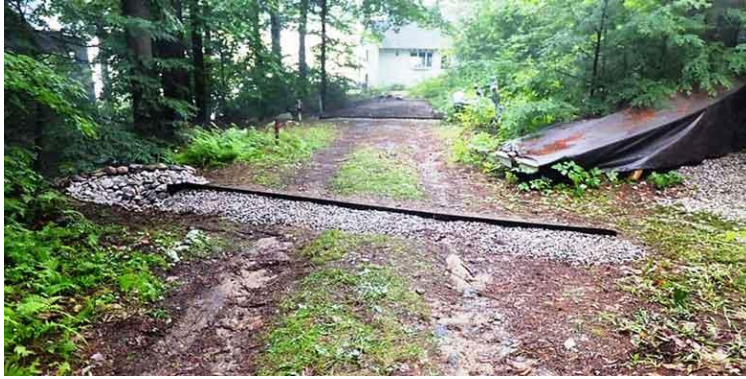
Figure 44: Completed diversion (photo from HealthyLakesWI.com)

Diversions (Figure 44) are placed across a sloping path or driveway to divert runoff water to an area where it can be absorbed into the ground instead of flowing directly into the lake. In addition to helping improve lake health, these can also reduce the effects of erosion on the paths that the diversions are installed on. Diversions are created by entrenching a log or creating a small earthen berm approximately 30 degrees from the angle of the slope. The cost of these range anywhere from \$25 to \$3,750, but the average diversion costs \$200. These are very low maintenance, and only require some debris removal that could get stuck in the diversion and occasionally ensuring everything is still secure and in place. This practice does not work well for the purposes of this particular survey, but it is mentioned here as a nod to projects that could be completed further inland than this survey was meant to assess.

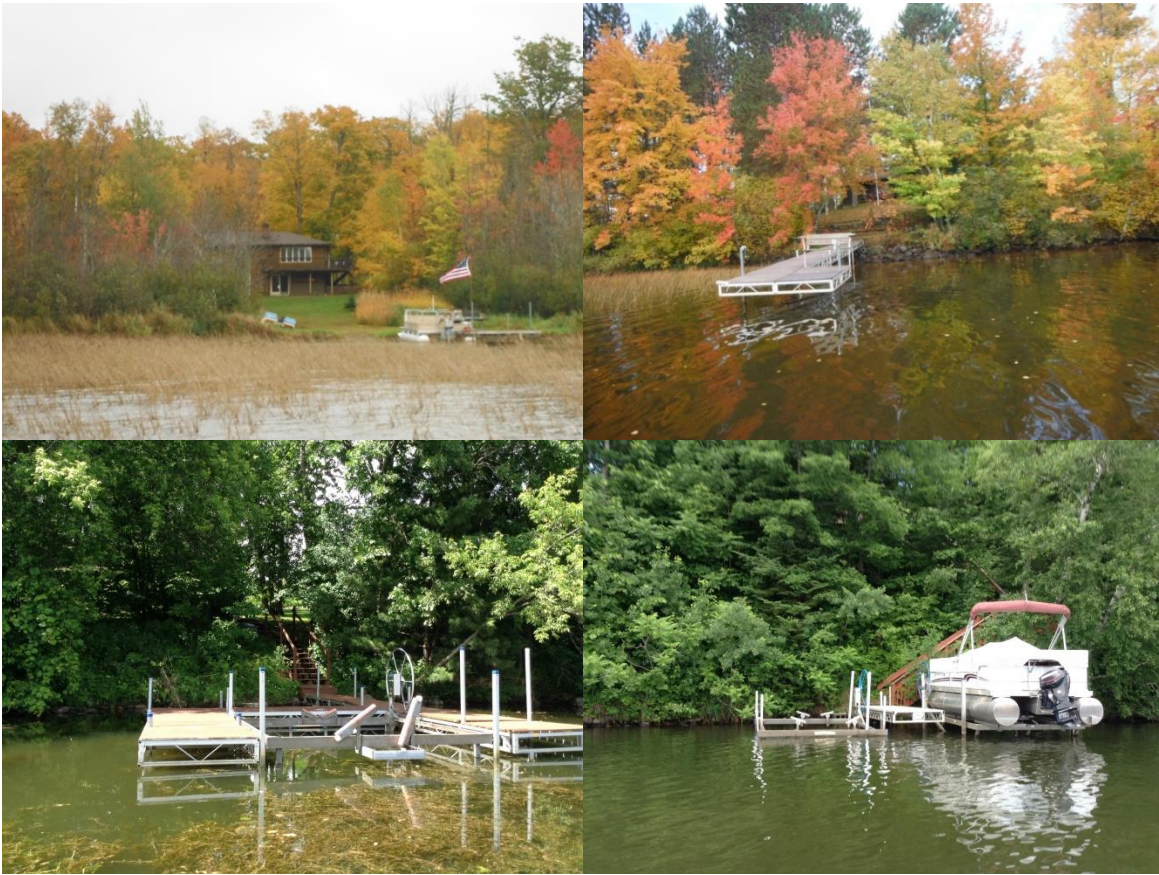
Figure 46: Developed Parcels with low or little potential (or need) for restoration projects

These parcels are simply meant to give an idea of properties that would have low or no significant potential to implement shoreland habitat improvement or runoff reduction projects. The properties shown in Figure 46 have been assessed with the same protocol as the properties surrounding Horseshoe Lake, and have been deemed as having little or no potential for additional projects. Each property is a little different, but in each parcel, the majority of the land within the riparian zone is comprised of undisturbed, native vegetation. The parcels that are level have some manicured lawn within that zone, but this is treated more like a well-maintained trail. For parcels with a steep slope, having a trail or stairway down to the lake while leaving the rest of the area as native vegetation works best. Not only is this the most lake-friendly approach, but the maintenance and general upkeep of this area becomes much safer, easier, and cost effective.
