**Eurasian water-milfoil (*Myriophyllum spicatum*)
Late Summer Bed Mapping Survey
Red Lake (WBIC: 2492100)
Douglas County, Wisconsin**

Endangered Resource Services, LLC
Matthew S. Berg, Research Biologist
St. Croix Falls, Wisconsin
September 4, 2022

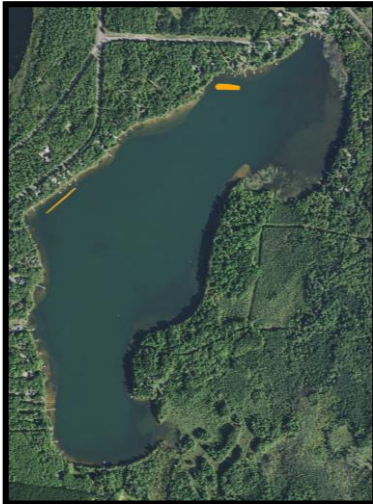
Red Lake 2022 treatment areas (in orange)

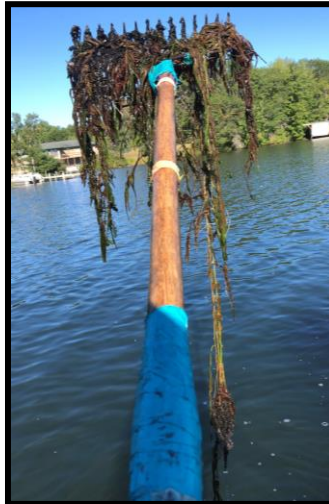
Clean rake of EWM 9/4/22

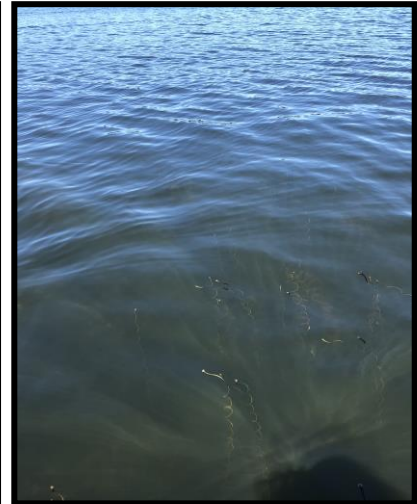
Subcanopy EWM among Wild celery 9/4/22

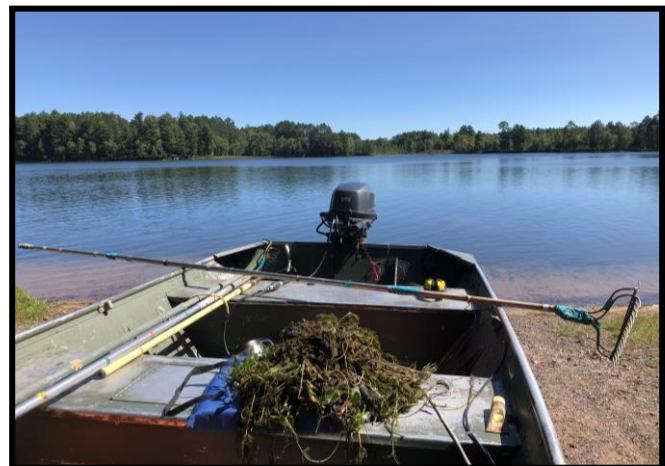
Rake removed EWM 9/4/22
