AQUATIC PLANT MANAGEMENT PLAN

Kirby Lake

Kirby Lake Management District

August 2021

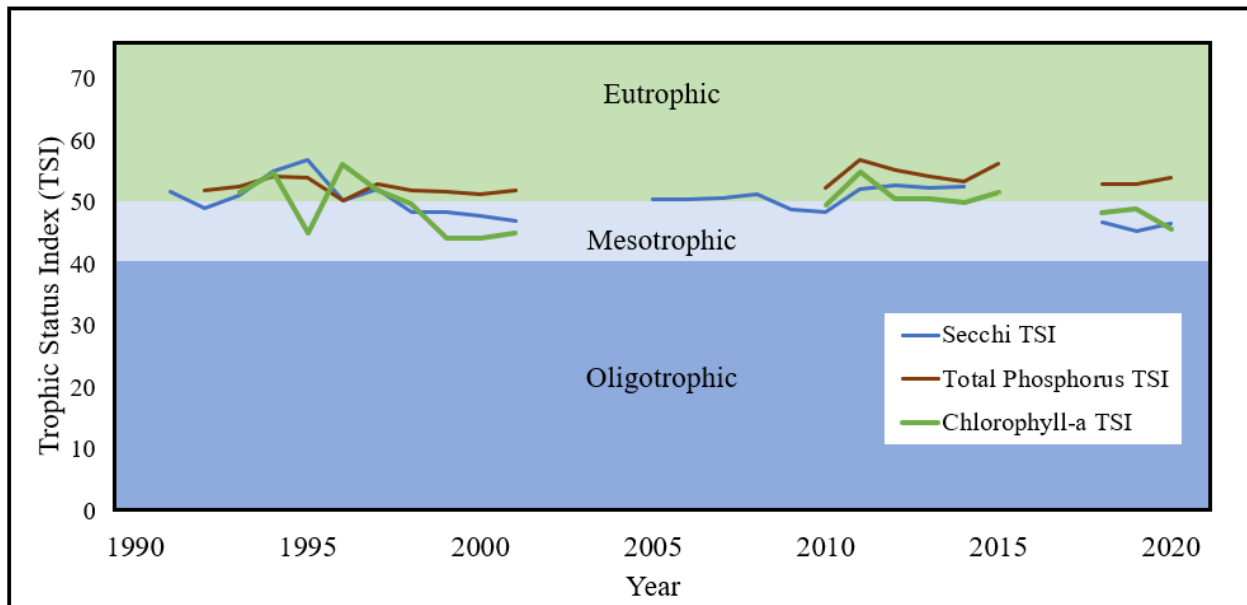
Figure 4. Kirby Lake Trophic Status Index from 1990-2020
